**AIRPROX REPORT No 2018016**

Date: 01 Feb 2018 Time: 1211Z Position: 5403N 00115W Location: Linton-on Ouse-airfield

**PART A: SUMMARY OF INFORMATION REPORTED TO UKAB**

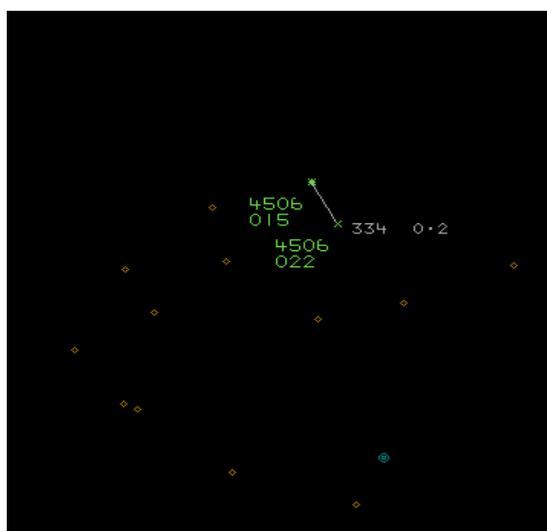
Figure 4 1210:50 - CPA.
