**AIRPROX REPORT No 2018024**

Date: 16 Feb 2018 Time: 1241Z Position: 5045N 00315W Location: 6nm E Exeter airport

**PART A: SUMMARY OF INFORMATION REPORTED TO UKAB**

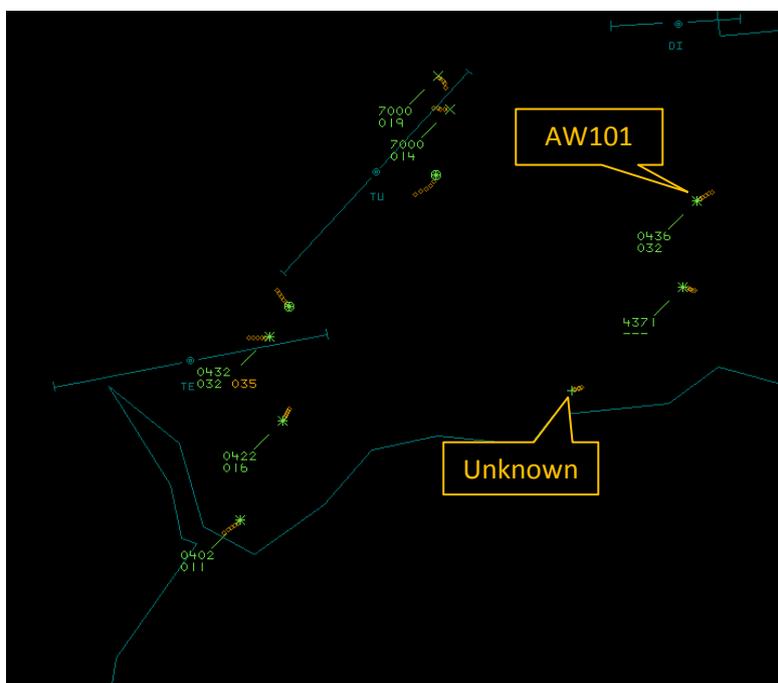
Figure 1 – 1233:18.

At 1233:50 the controller passed Traffic Information on traffic converging, (code 4371 on Figure 1), from the south which the pilot of the AW101 acknowledged and then subsequently reported visual-with at 1234:20.

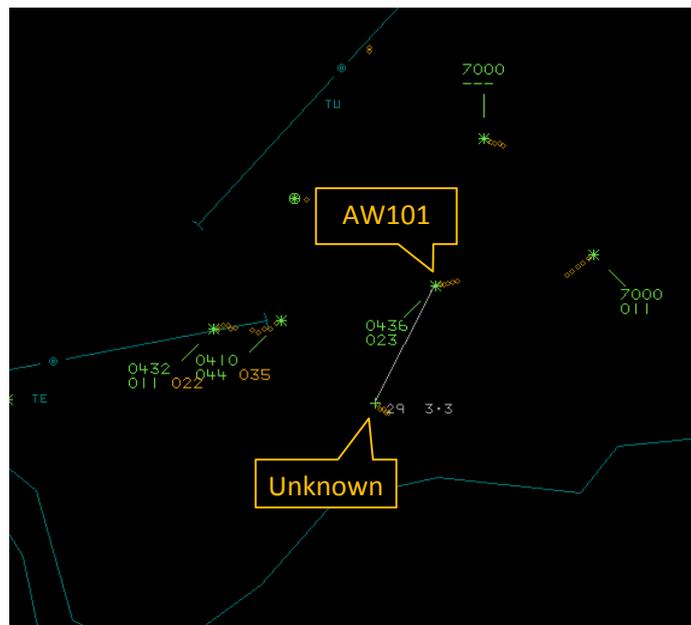
Figure 2 – 1239:20.

At 1237:40 the controller passed Traffic Information to the AW101 pilot on traffic descending in the hold above them. The controller then became involved with a pilot who had free-called them, as well as another aircraft leaving the frequency to go en-route. The situation at 1239:20 is shown in Figure 2.

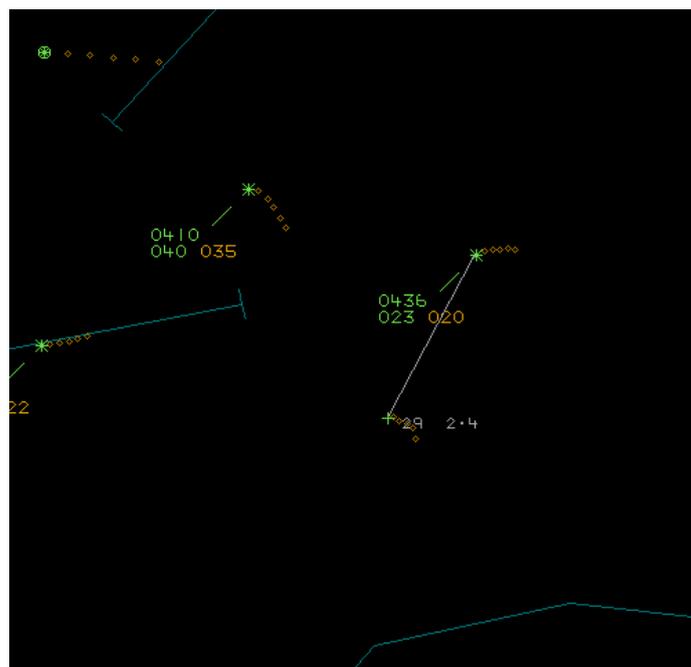
Figure 3 – 1240:05.

At 1240:05, the controller passed Traffic Information to the AW101 pilot on the unknown aircraft, advising incorrectly that it was crossing from the AW101's right to left (Figure 3).

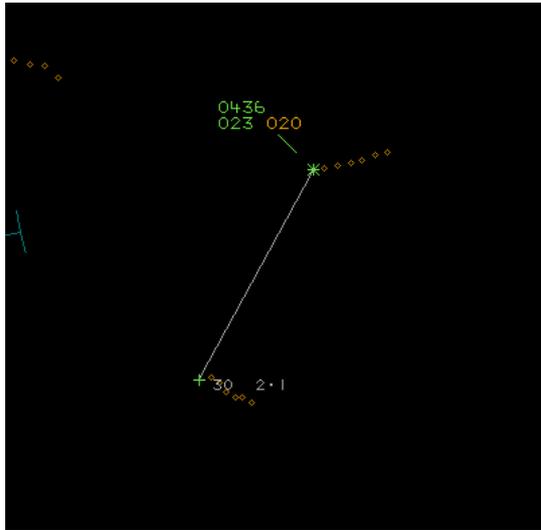
Figure 4 – 1240:18.

At 1240:18 although not updating the actual position of the unknown aircraft in relation to the AW101, the controller corrected themselves by advising the AW101 pilot that the unknown traffic was crossing from left to right, (Figure 4).

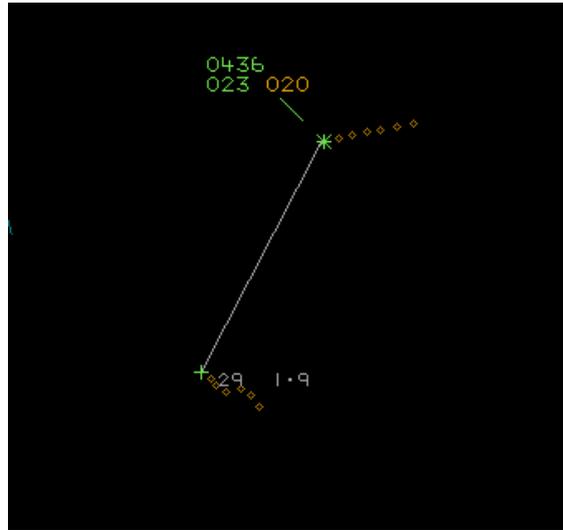
Figure 5 – 1240:30.

At 1240:30 the pilot of the AW101 reported visual with the traffic (Figure 5).

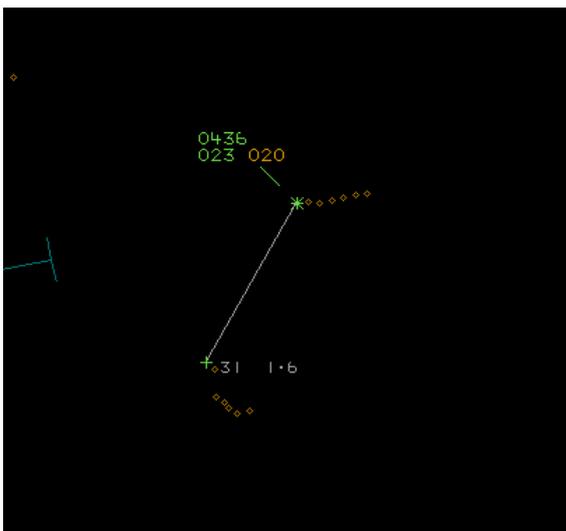
Figure 6 – 1240:38.

At 1240:38 the pilot of the AW101 reported the traffic to be 300ft above them (Figure 6).

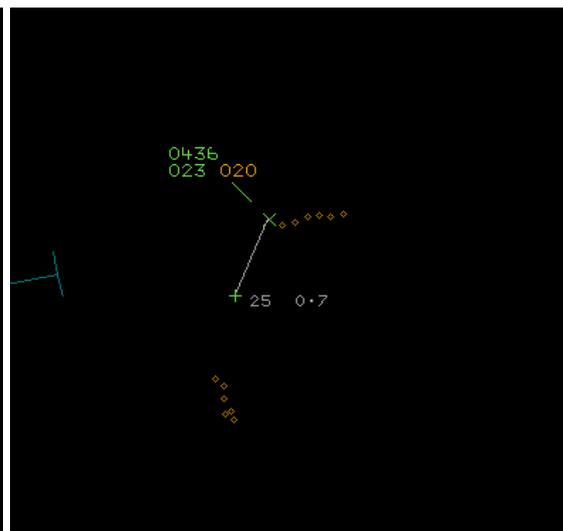
Figure 7 – 1240:50.

At 1240:50 the radar controller instructed the AW101 pilot to contact Exeter Tower.

Due to limited coverage in this area of the area radar used by ATSI, at this point the radar return of the unknown aircraft had become intermittent. However, comparing it with the Exeter radar recording, Figure 7 appears to show the last observed position of the unknown aircraft.

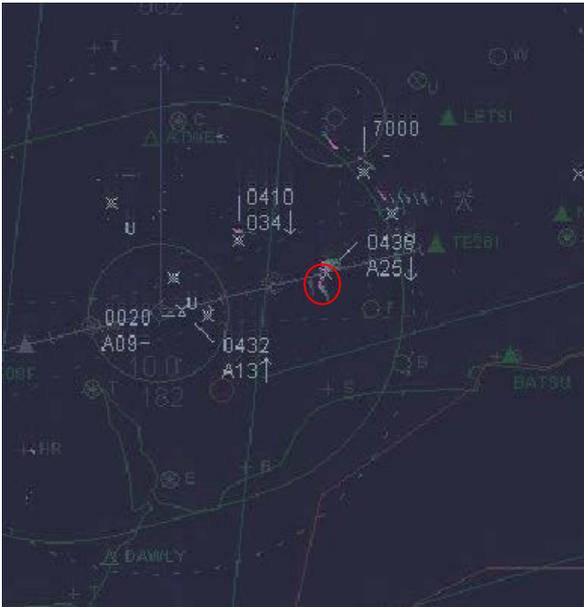
Figure 8 – 1241:08

The AW101 pilot established contact with Exeter Tower at 1241:08, and was instructed to continue approach as they were number two to another helicopter. At 1241:28 the pilot of the AW101 reported that the unknown aircraft was at the same level as them, and seen to be taking avoiding action to pass behind. They confirmed with the Aerodrome controller that they had previously been passed Traffic Information on the aircraft by the Radar controller. The unknown aircraft did not reappear on the area radar recording until 1242:22. Figures 8-10 show the Exeter Radar recordings during this period (unknown aircraft ringed), but do not give a true representation of the display available to the controller, as some shots are close-ups of the event.
