**AIRPROX REPORT No 2018121**

Date: 09 Jun 2018 Time: 1443Z Position: 5239N 00218W Location: RAF Cosford – elev 272ft

**PART A: SUMMARY OF INFORMATION REPORTED TO UKAB**

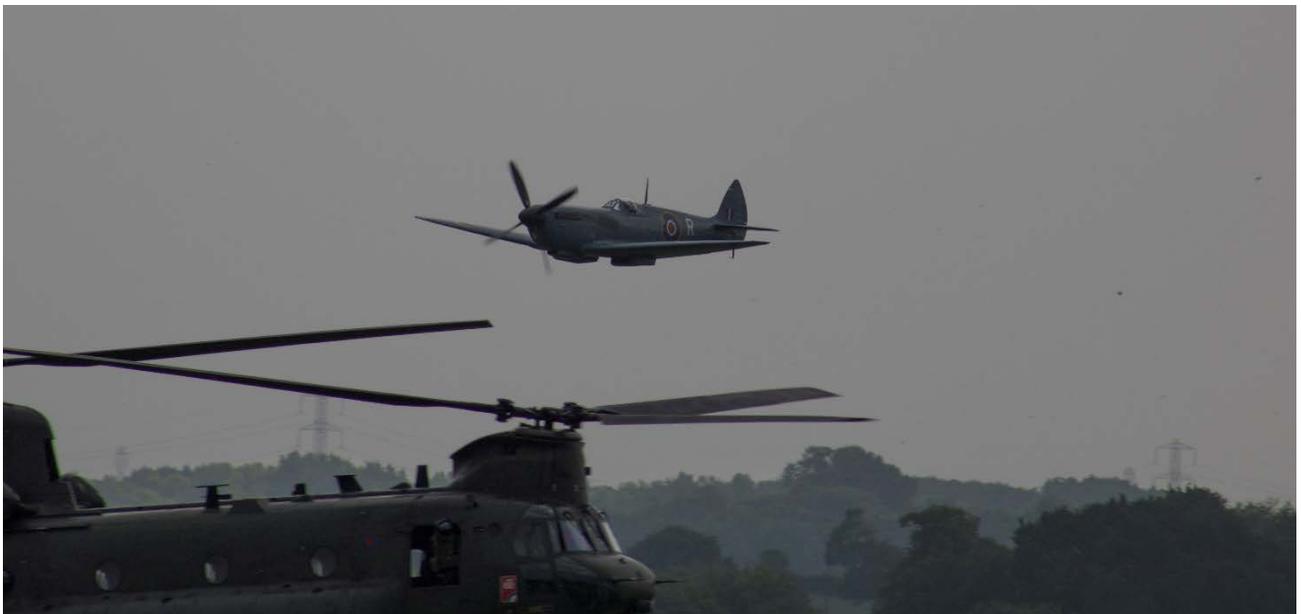
The Spitfire pilot believed that the clearance for a 'run-and-break' also included clearance for a 'display' arrival and did not appear to assimilate the Traffic Information provided by the Cosford ADC on the Chinook. As such, the Spitfire pilot conducted the run-and-break at about 30ft, the same height at which the Chinook pilot was hover-taxiing to park. The Chinook co-pilot noted the impending confliction and ordered an 'immediate' vacating of the runway after which the Spitfire reportedly flew through the airspace which the Chinook had just vacated.

Due to the reported heights of the aircraft involved, the radar replay did not show the Spitfire. However, the photograph below was taken at the time of the incident:

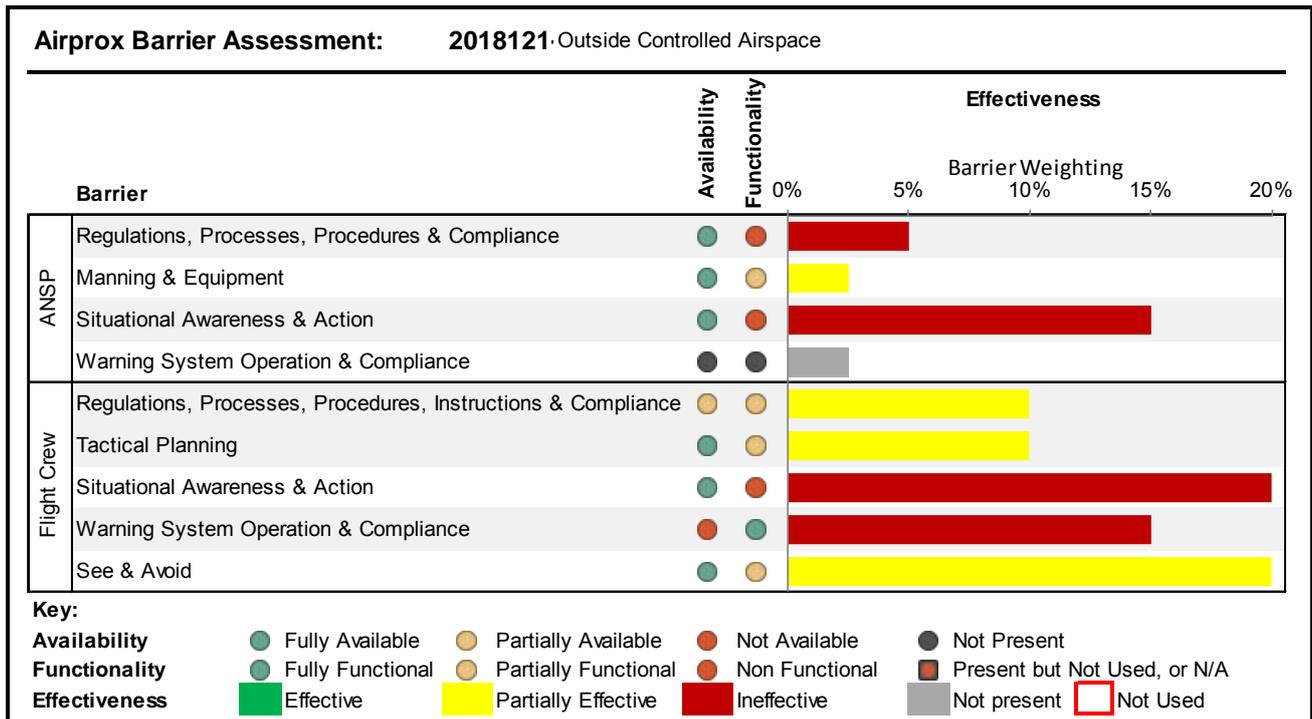
<sup>10</sup> The UK Airprox Board scheme for assessing the Availability, Functionality and Effectiveness of safety barriers can be found on the [UKAB Website](#).

**Warning System Operation and Compliance** were assessed as **ineffective** because the Spitfire SSR transponder was not operating and the Chinook TCAS could not provide appropriate SA or an alert.

**See and Avoid** were assessed as **partially effective** because although the Chinook co-pilot saw the Spitfire in sufficient time to afford an increase in separation at CPA, the Spitfire pilot most likely did not see the Chinook in time to afford similar action.
