**AIRPROX REPORT No 2018123**

Date: 09 Jun 2018 Time: 1545Z Position: 5235N 00224W Location: Cosford

**PART A: SUMMARY OF INFORMATION REPORTED TO UKAB**

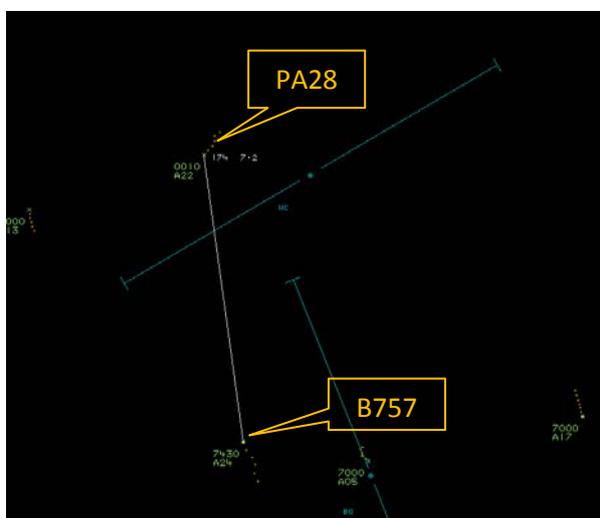
Figure 1: 1541:30

At 1541:30 (Figure 1), the Birmingham controller established communication with the PA28 which was displaying the SSR code 0010, assigned to aircraft that are monitoring the Birmingham Radar frequency. The controller informed the pilot that the RA(T) around Cosford was about to become active and suggested that they route to the west. The pilot acknowledged and stated that they would now route west.

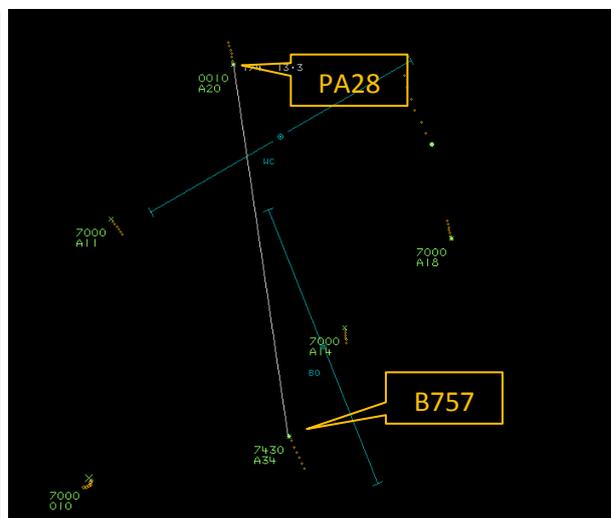
Figure 2: 1542:58

At 1542:58 (Figure 2), the B757 established communication with the Cosford controller reporting at 2000 feet. The Cosford controller passed the ATIS, runway and QFE, which was readback correctly by the pilot.

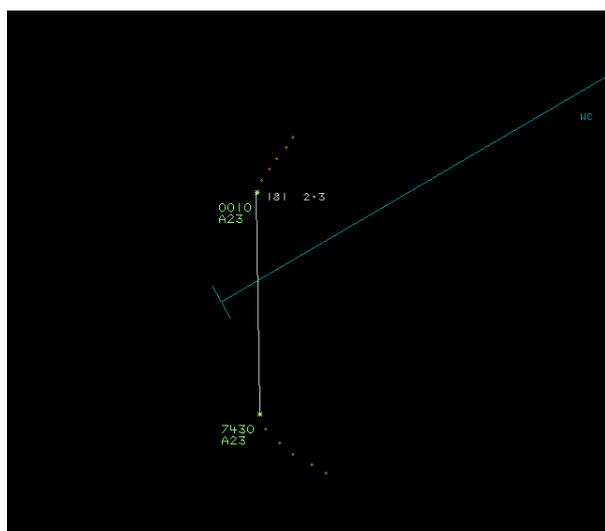
Figure 3: 1544:00

At 1544:00 (Figure 3), the Birmingham controller passed traffic information to the PA28 on the B757. The pilot reported that they were visual with the B757, were descending, and that they had received a TCAS (RA).

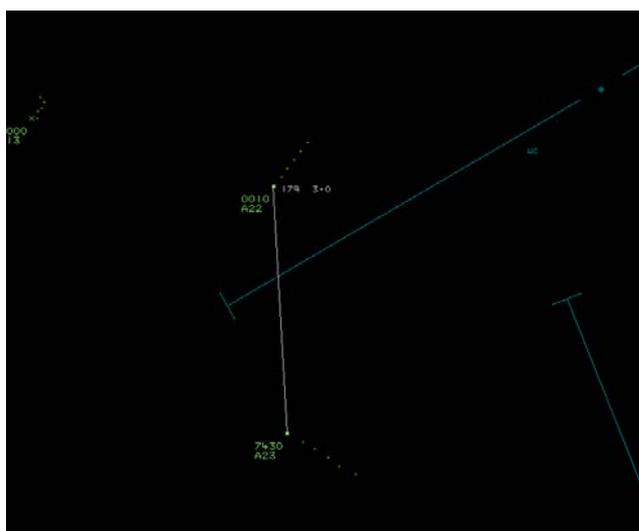
Figure 4: 1544:12

At 1544:12 (Figure 4) the Birmingham controller informed the Cosford controller that the PA28 was descending to 1500ft. The Cosford controller updated the traffic information to the B757 to reflect this. The Birmingham controller informed the Cosford controller that the PA28 was visual with the B757 and passed the callsign. The Birmingham controller then stated that the PA28 was leaving the RA(T) and that they would transfer the PA28 to the Cosford Frequency.

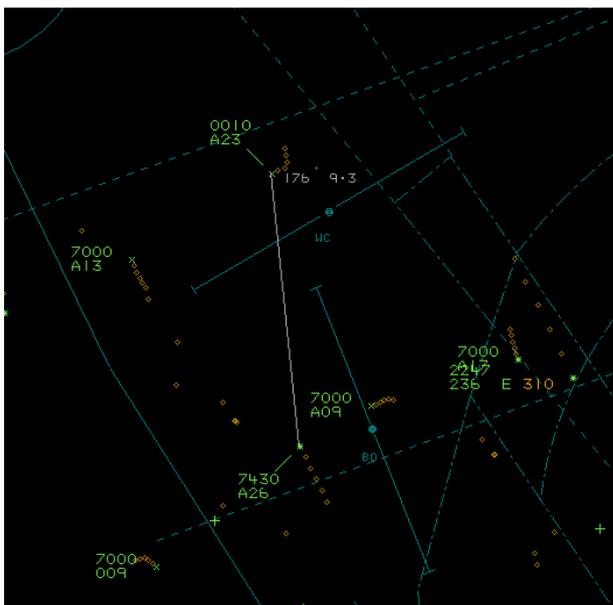
Figure 7: timed at 1442:03

At 1442:03 (Figure 7), the Cosford Approach Controller noticed on the Air Traffic Monitor that an aircraft squawking 0010 (Birmingham listening Squawk) had infringed the RA(T) from the north and began the process (through the Cosford Approach Assistant) of establishing contact with Birmingham to ascertain the intentions of the aircraft. The B757 was receiving a Deconfliction Service from Shawbury. The B757 had reported visual with the aerodrome and was therefore in the process of being transferred to the Cosford Approach frequency.

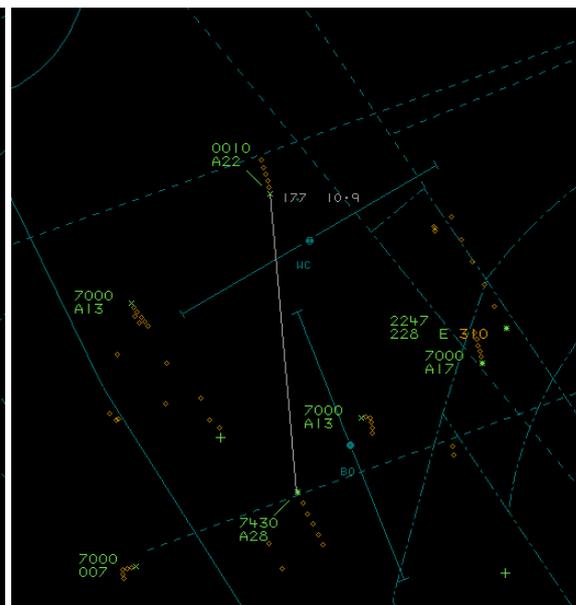
Figure 8: timed at 1542:08

Co-incidentally, the Birmingham Radar Controller noted that an aircraft squawking 0010 had infringed the RA(T) and, via Mode S, were able to identify and speak to the PA28, suggesting a westerly heading to clear the RA(T), there is 9nm separation at this point.

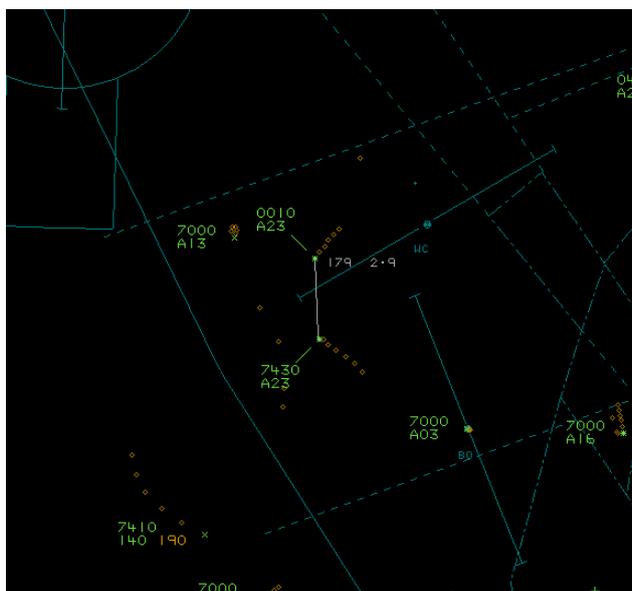
Figure 9: timed at 1543:01

At 1543:01, the B757 called the Cosford Approach Frequency and was passed the relevant airfield details and requested to confirm POB.

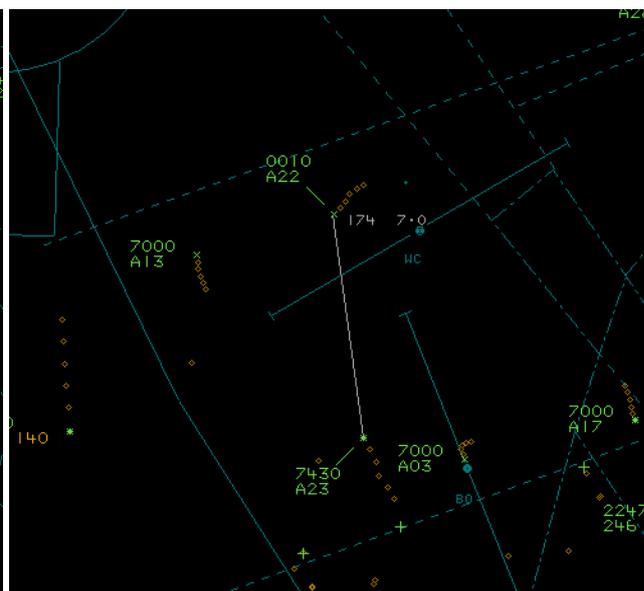
Figure 10: timed at 1544:03

Following a discussion between the Birmingham Radar Controller and the Cosford Approach Assistant, the Birmingham Radar controller passed Traffic Information to the PA28 at 1543:55 who subsequently reported visual with the B757. Some 8 secs later, the Cosford Approach Controller, utilising the information provided by the Air Traffic Monitor, passed Traffic Information to the B757.

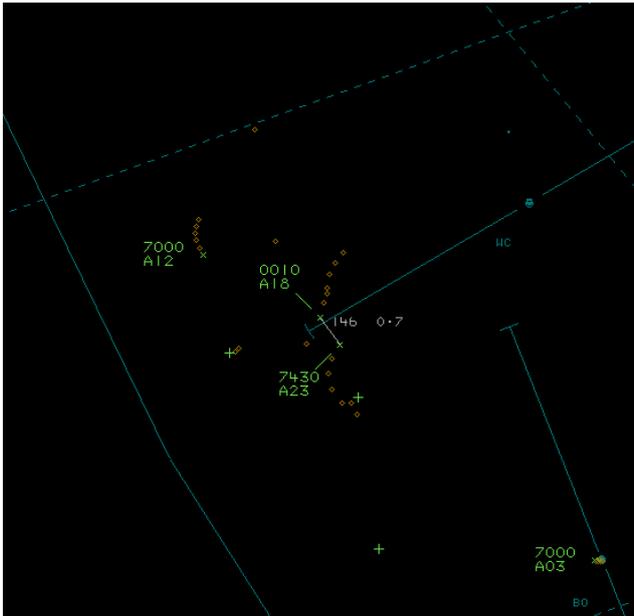
Figure 11: timed at 1544:33

CPA [2] occurred at 1544:33 and was measured at 0.7nm lateral and 500ft vertical separation [UKAB note: Using a different radar, UKAB determined the separation as 500ft vertically and 0.6nm horizontally].
