AIRPROX REPORT No 2018145

Date: 27 Jun 2018 Time: 0919Z Position: 5331N 00030W Location: ivo Hibaldstow parachuting site

PART A: SUMMARY OF INFORMATION REPORTED TO UKAB

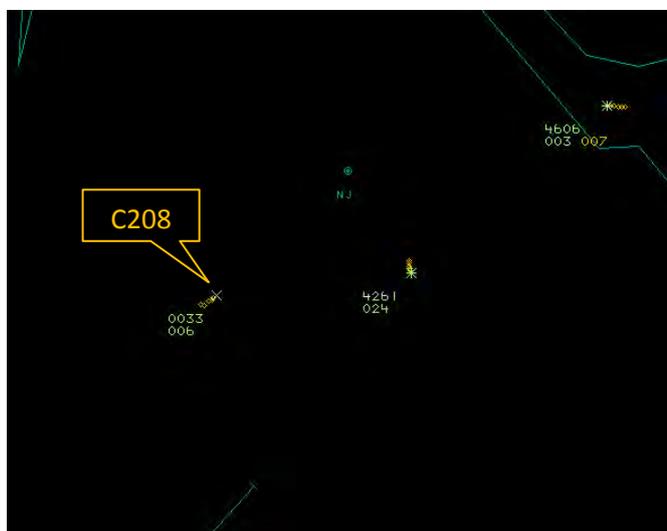
Figure 1 – 0909:29.

At 0909:29 (Figure 1) the C208 pilot, a parachute aircraft, established communication with the Humberside Radar controller requesting a Traffic Service and a climb to FL130. The controller identified the aircraft and a Traffic Service was agreed.

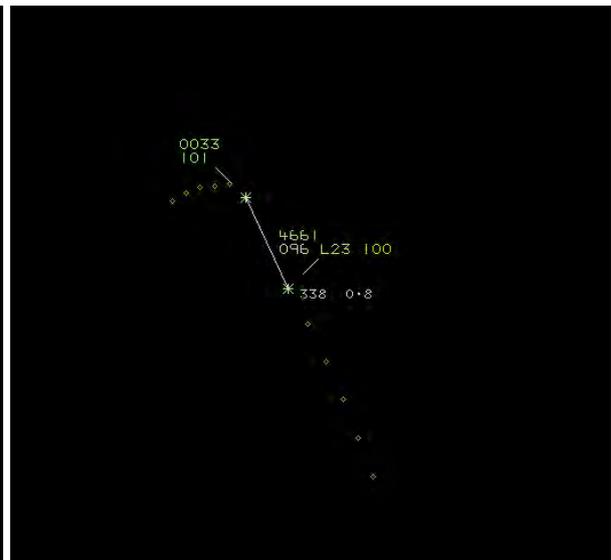
Figure 7 – 0918:43.

At 0918:43 (Figure 7) the radar indicated that the KC135 pilot had commenced a descent.

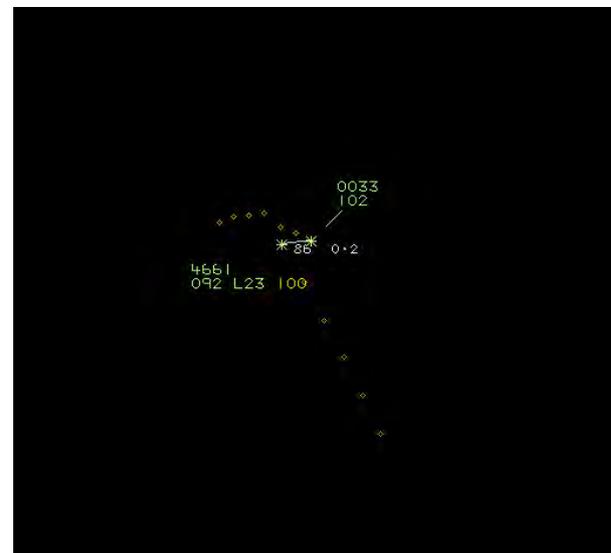
Figure 8 – 0918:50.

The closest point horizontally occurred at 0918:50 (Figure 8), when the aircraft were separated by 0.2nm and 1000ft.
