AIRPROX REPORT No 2018213

Date: 16 Aug 2018 Time: 1434Z Position: 5656N 00039E Location: Aberdeen 106R/98D

PART A: SUMMARY OF INFORMATION REPORTED TO UKAB

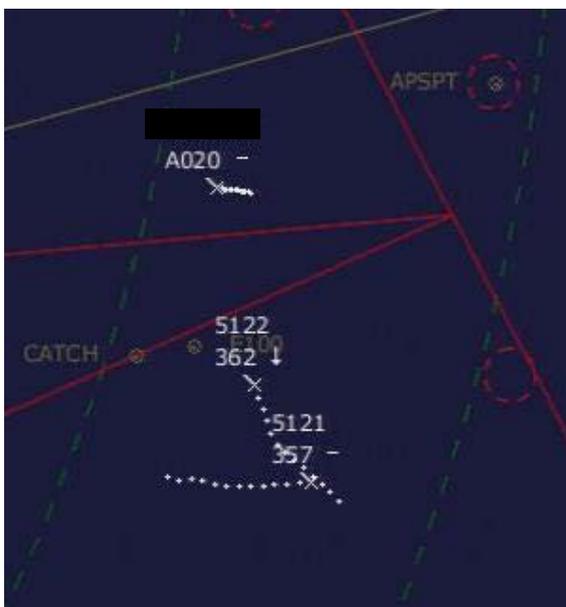
Figure 1 – 1431:55

At 1431:55 (Figure 1), the 5122 squawk can be seen at FL362, about 10nm south of [S92 C/S], tracking north. (For scale, the green dashed range arcs are 20nm apart.)

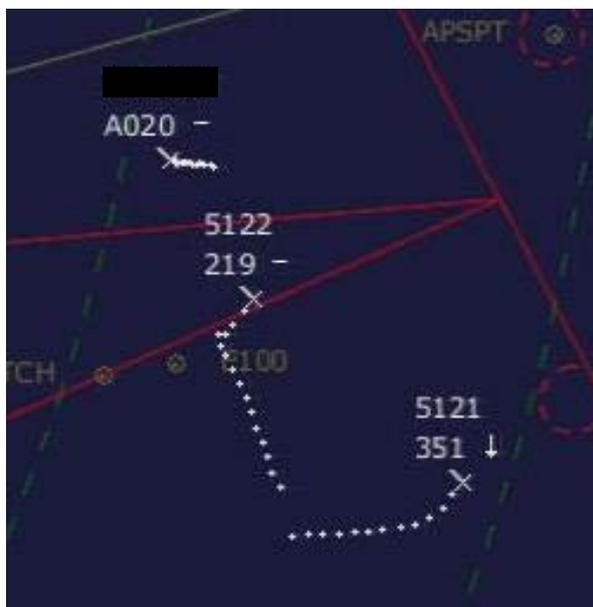
Figure 2 – 1432:28

At 1432:28 (Figure 2), the 5122 squawk was now at FL219 and had turned northeast, now 8nm south east of [S92 C/S]

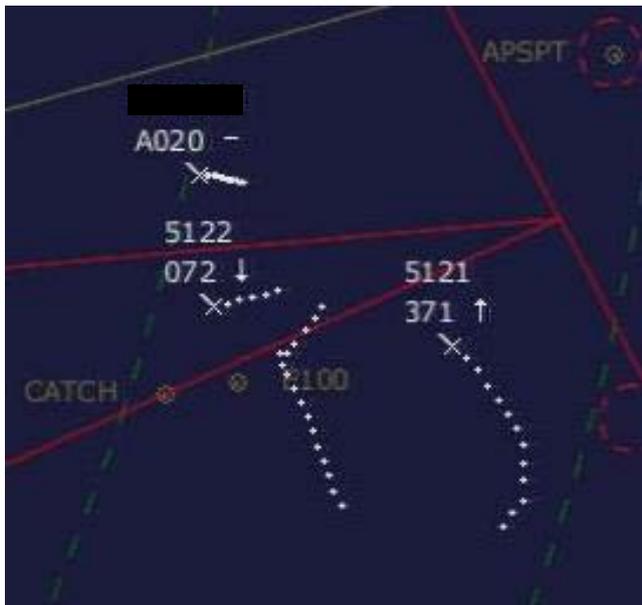
Figure 3 – 1433:07

At 1433:07 (Figure 3), the 5122 squawk was now at FL72 and had made a very abrupt left turn onto west-southwest, tracking almost parallel to [S92 C/S], range 6nm. Average rate of descent had been just under 25,000ft/min but it was still indicating above the coordinated lowest level of 5000ft.

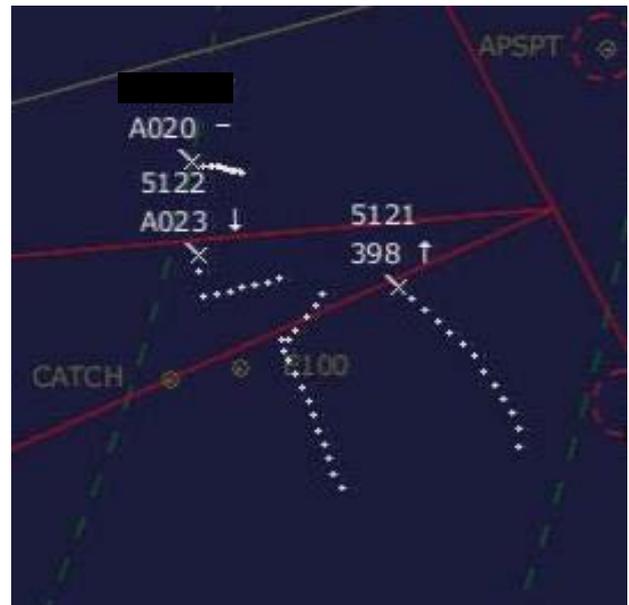
Figure 4 – 1433:25

At 1433:25 (Figure 4), the 5122 squawk made a very abrupt 90° right turn onto north, during which the Mode C was lost. It rolled out tracking directly towards [S92 C/S], range 5nm, and, when the Mode C could be seen again, it briefly indicated 3000ft, then 2300ft and still descending. [S92 C/S] was level at 2000ft. The REBROS controller passed the following traffic information to [S92 C/S]: - "[S92 C/S] Military jet traffic left nine o'clock range two thousand feet tracking north, looks like might pass behind you". [S92 C/S] replied "visual, [S92 C/S]".

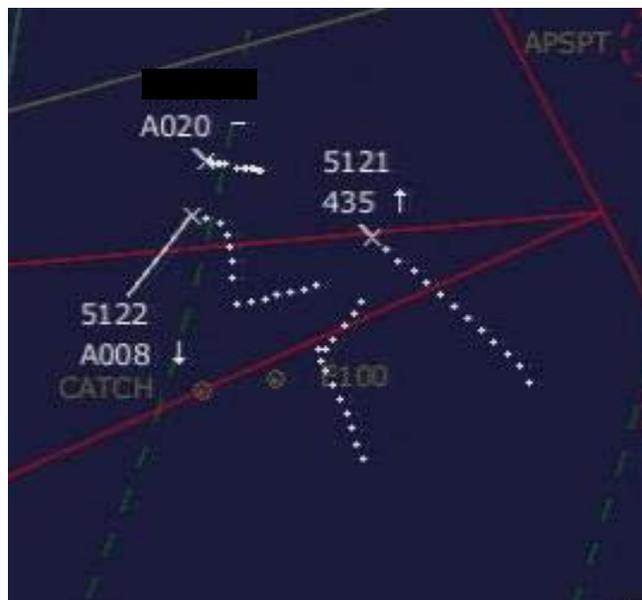
Figure 5 – 1433:45

At 1433:45 (Figure 5), just after descending through the level of [S92 C/S], the 5122 squawk turned west to parallel [S92 C/S], range 2.3nm and descended to 800ft. REBROS called Boulmer and asked to speak to the controller. The 5122 squawk meanwhile levelled at 600ft, and the closest lateral distance from [S92 C/S] was 2.19nm while it was still at 600ft, before it turned left onto a south westerly track and started to climb again.

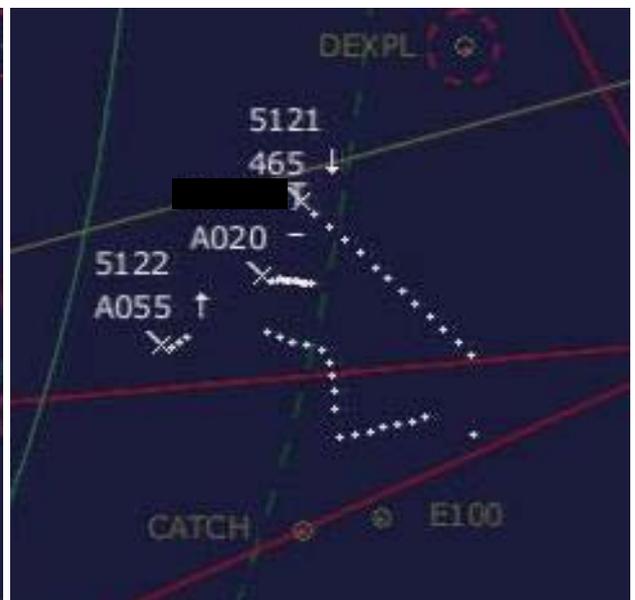
Figure 6 – 1434:38

The Boulmer controller became available on the phone line and REBROS explained that the 5122 squawk had been down to 600ft. The Boulmer controller said that he had been told it would be descending to FL80. The aircraft was now indicating 5500ft and climbing (Figure 6) but REBROS confirmed that it had been sighted by the helicopter crew below their level of 2000ft so there was no doubt that it had been well below the coordinated base of 5000ft. The Boulmer controller said they would file a report. (Distance between the solid and dashed green range arcs is 10nm). The REBROS controller advised [S92 C/S] that they were now clear of the military aircraft and explained what had occurred. The pilot reported that, in addition to being visual with the fast-jet, they had received a TCAS Traffic Alert and stated that while it was not their intention to file an Airprox as such, they would file an ASR on the event.

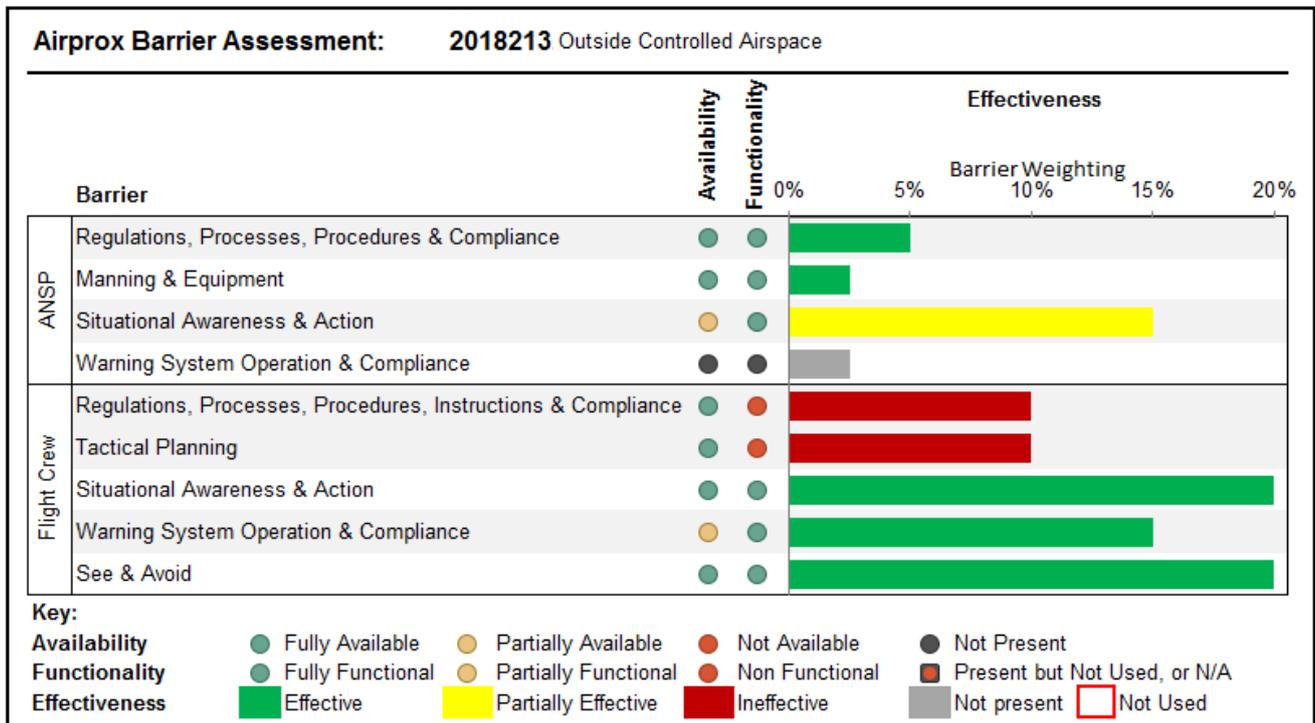
In assessing the effectiveness of the safety barriers associated with this incident, the Board concluded that the key factors had been that:

ANSP:

Situational Awareness and Action were assessed as only **partially available** because, although the Aberdeen controller could see Typhoon No2 descending to low-level on his radar display, this information was not displayed on the Boulmer controller's display.

Flight Crew:

Regulations, Processes, Procedures, Instructions and Compliance were assessed as **ineffective** because the Typhoon No 2 pilot descended below the coordination level.

Tactical Planning was assessed as **ineffective** because the Typhoon No2 pilot did not comply with his known clearance level.

Warning System Operation and Compliance were assessed as **effective** but only **partially available** because only the S92 was equipped with an electronic warning system.
