## AIRPROX REPORT No 2018267

Date: 26 Sep 2018 Time: 1535Z Position: 5053N 00010E Location: Deanland

### PART A: SUMMARY OF INFORMATION REPORTED TO UKAB

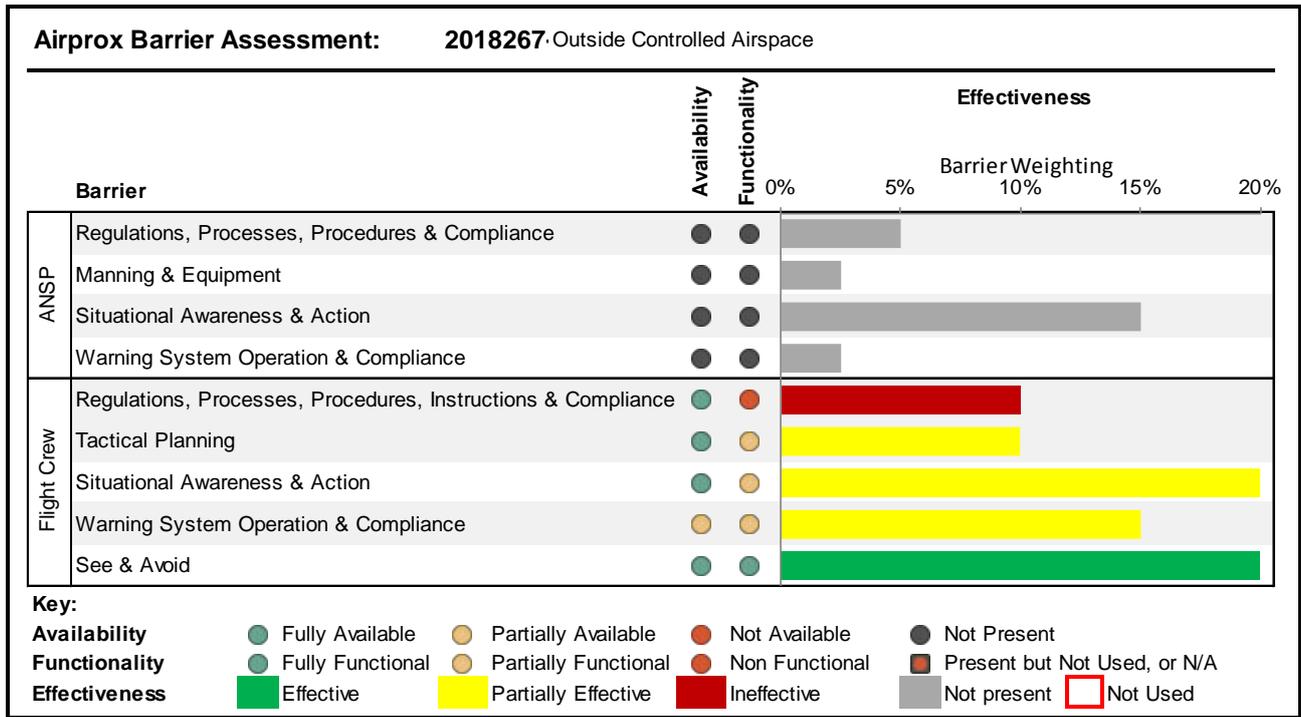
In assessing the effectiveness of the safety barriers associated with this incident, the Board concluded that the key factors had been that:

#### **Flight Crew:**

**Regulations, Processes, Procedures, Instructions and Compliance** were assessed as **ineffective** because the No1 Tornado crew flew through the Deanland pattern of traffic.

**Tactical Planning** was assessed as **partially effective** because although they were aware of its presence, the Tornado crews didn't sufficiently avoid Deanland.

**Situational Awareness and Action** were assessed as **partially effective** because the Tornado crews didn't sufficiently act on the information they had from the TCAS.

**Warning System Operation and Compliance** were assessed as **partially effective** because the Tornado crews had information on the C42 from their TCAS but did not fully resolve the conflict before flying too close to it.
