AIRPROX REPORT No 2018019

Date: 11 Feb 2018 Time: 1112Z Position: 5146N 00149W Location: 8nm W Brize Norton

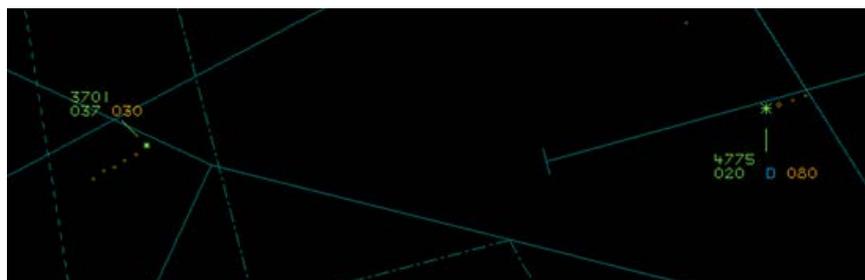
At 11:10:35 (Figure 1), the Brize Controller instructed the C17 pilot to stop climb at 3000ft.

Figure 1: C182 (3701) and C17 (4775) at 11:10:35

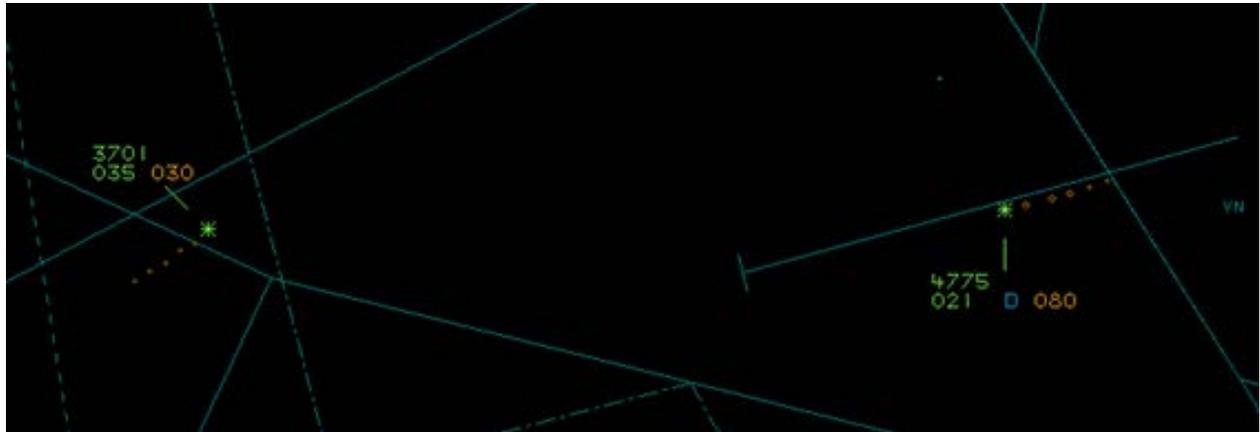
At 11:10:44 (Figure 2), the C182 was inside the Brize CTR at an altitude of 3400ft. After the Brize controller queried his level, the C182 pilot stated that he was descending to 3000ft (Brize QNH 1003) to remain in sight of the ground. The Controller responded 'Roger', and asked the pilot to take up a north-easterly heading so that he could 'climb traffic through your six o'clock'. The C182 pilot responded that he was heading northeast.

Figure 2: C182 (3701) at 11:10:44

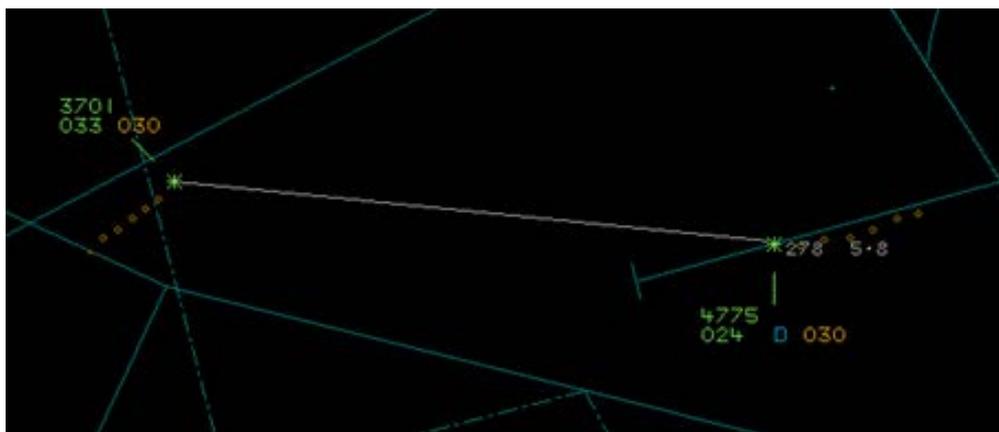
At 11:11:02 (Figure 3), the Brize Controller instructed the C17 pilot to stop climb at 2800ft.

Figure 3: C182 (3701) and C17 (4775) at 11:11:02

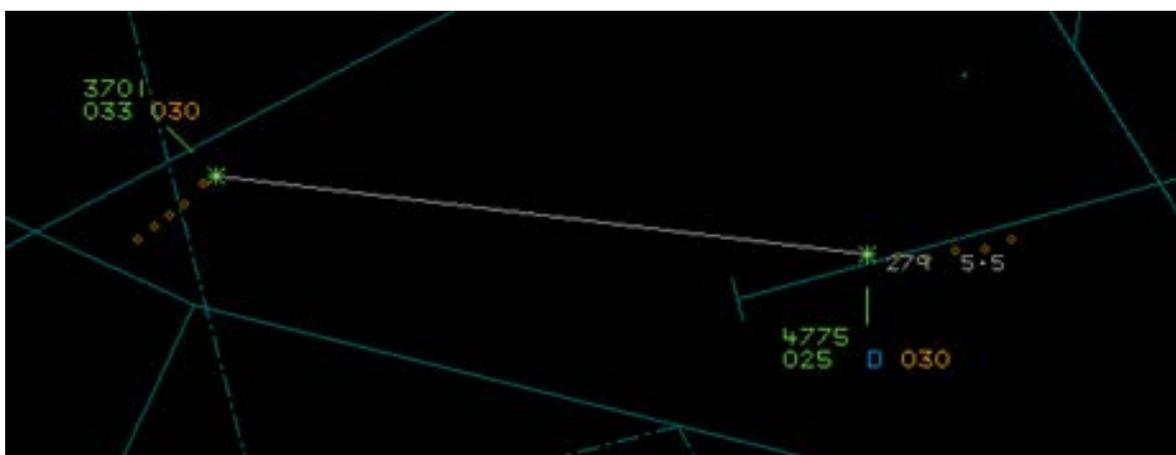
At 11:11:09 (Figure 4), the Brize Controller passed Traffic Information to the C17 pilot on the C182 as 'west of you by 5nm, northeast bound, reported descending to altitude 3000ft'. The C17 pilot acknowledged the Traffic Information.

Figure 4: C182 (3701) and C17 (4775) at 11:11:09

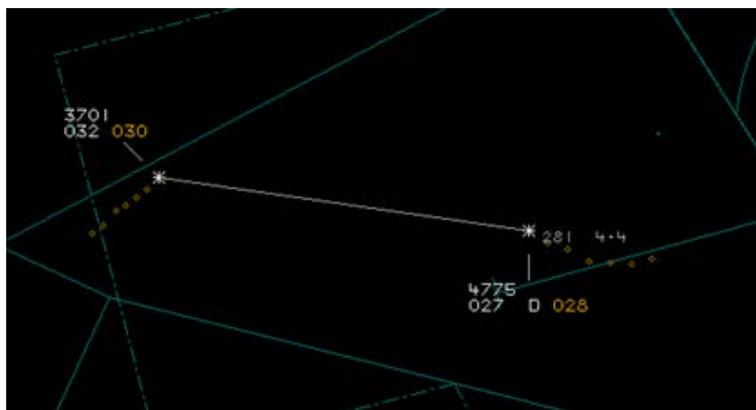
At 11:11:18 (Figure 5), the Brize Controller asked the C182 pilot to remain outside controlled airspace, though the C182 had already entered the Brize CTR shortly before 11:10:44 (Figure 2). The C182 pilot stated that he thought he had been cleared to enter CAS, and that he was visual with the C17.

Figure 5: C182 (3701) and C17 (4775) at 11:11:18

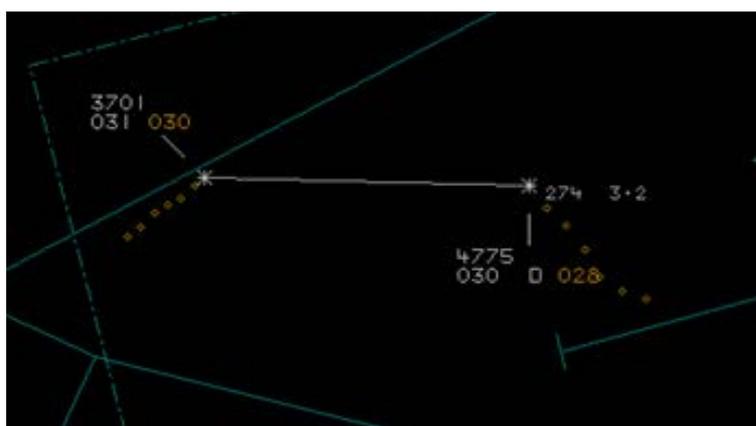
At 11:11:34 (Figure 6), the Brize Controller passed updated Traffic Information to the C17 pilot, describing the C182's position as 'west of you by 2nm, northeast bound, visual with you, 200ft above'.

Figure 6: C182 (3701) and C17 (4775) at 11:11:34

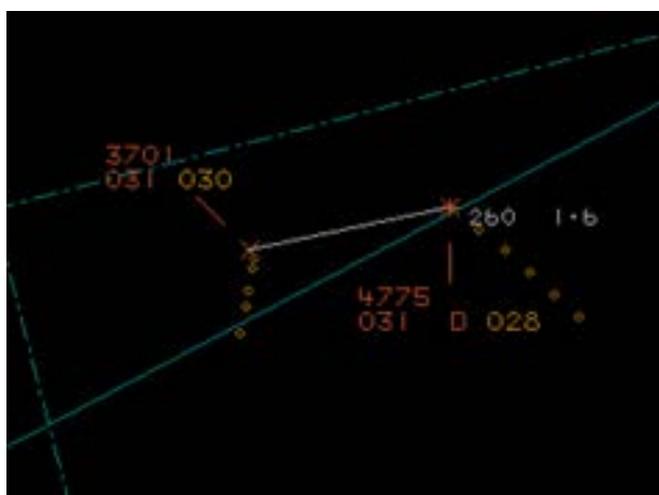
At 11:12:05 (Figure 7), the C182 pilot informed the Brize Controller that he was descending to altitude 2000ft, visual with the C17 in his 3 o'clock.

Figure 7: C182 (3701) and C17 (4775) at 11:12:05

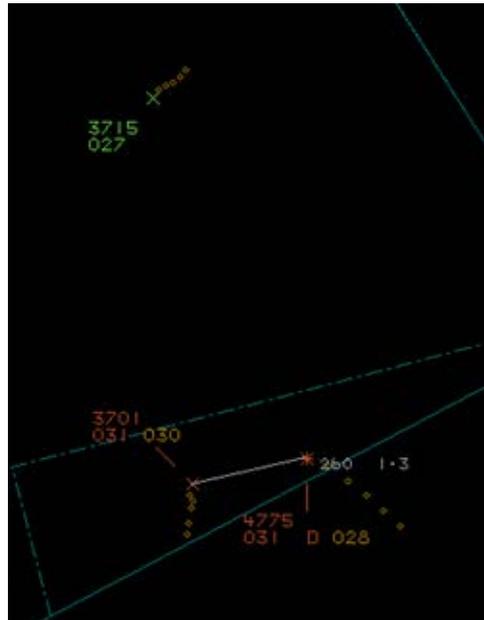
At 11:12:10 (Figure 8), the Brize Controller informed the C17 pilot that the C182 was descending further and advised him to standby for further climb. He passed Traffic Information on further traffic 'north, 4nm, tracking south, indicating 400ft below'.

Figure 8: C182 (3701) and C17 (4775) at 11:12:10

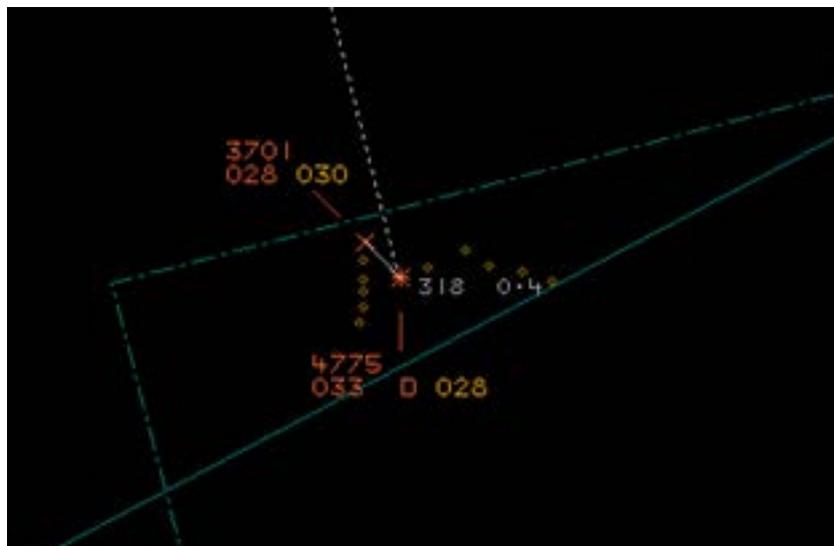
At 11:12:23 (Figure 9), the C17 and C182 were at CPA, with approximately 0.4nm lateral and 500ft vertical separation. The C17 pilot advised the Brize Controller that he had received a TCAS RA and was maintaining visual with the C182.

Figure 9: C182 (3701) and C17 (4775) at 11:12:23

Crews are not currently trained to handle TCAS RA in the turn, nor is guidance contained within Sqn SOPs. We will engage with [another C17 squadron], and request that they investigate and present their findings to Trg Flt for inclusion in the Sqn SOP.
