AIRPROX REPORT No 2018036

Date: 13 Mar 2018 Time: 1031Z Position: 5207N 00226W Location: 5nm SE Bromyard

PART A: SUMMARY OF INFORMATION REPORTED TO UKAB

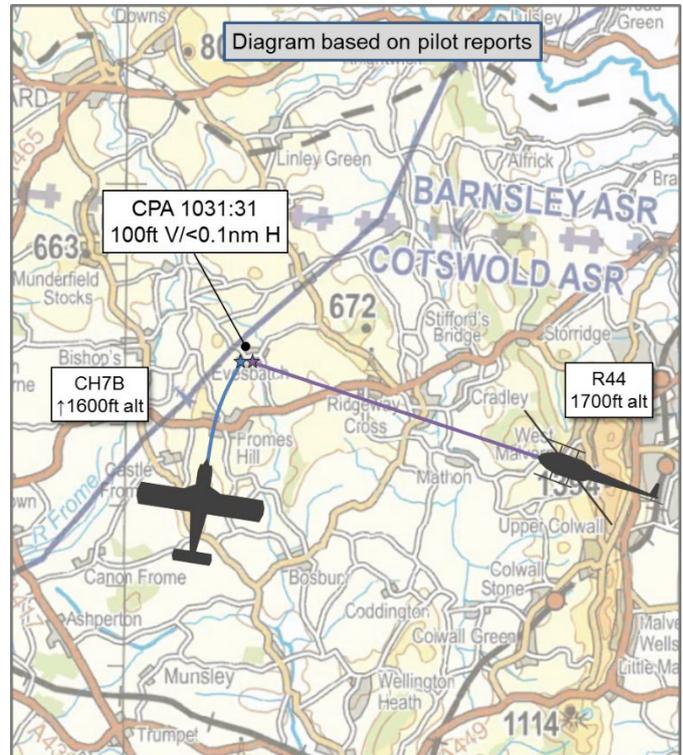
Recorded	Aircraft 1	Aircraft 2
Aircraft	Citabria CH7B	R44
Operator	Civ Pte	Civ Club
Airspace	London FIR	London FIR
Class	G	G
Rules	VFR	VFR
Service	None	None
Altitude/FL	1600ft	1700ft
Transponder	A, C, S	A, C, S
Reported		
Colours	Red, White	Blue
Lighting	Beacon	Nav, Anti-cols
Conditions	VMC	VMC
Visibility	10km	10km
Altitude/FL	1400ft	1600ft
Altimeter	QNH (1007hPa)	QNH (1008hPa)
Heading	015°	300°
Speed	80kt	91kt
ACAS/TAS	Not fitted	Not fitted
Separation		
Reported	<100ft V/50m H	0ft V/15-20m H
Recorded	100ft V/<0.1nm H

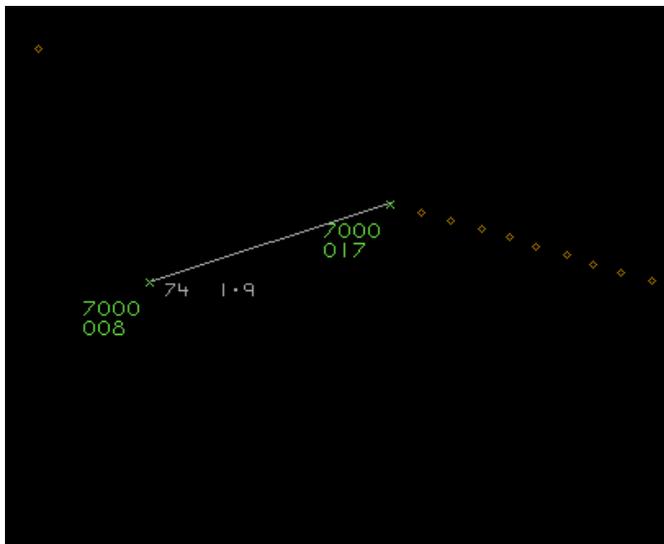
Figure 1: 1030:38

Using the NATS radar recordings, the R44 can be seen transiting at 1700ft squawking 7000 and the CH7B is first be seen at 1030:38 (Figure 1) passing 800ft; at this point the two aircraft are 1.9nm apart. They converge on a constant bearing until CPA at 1031:31 (Figure 3) when they are less than 0.1nm and 100ft apart.

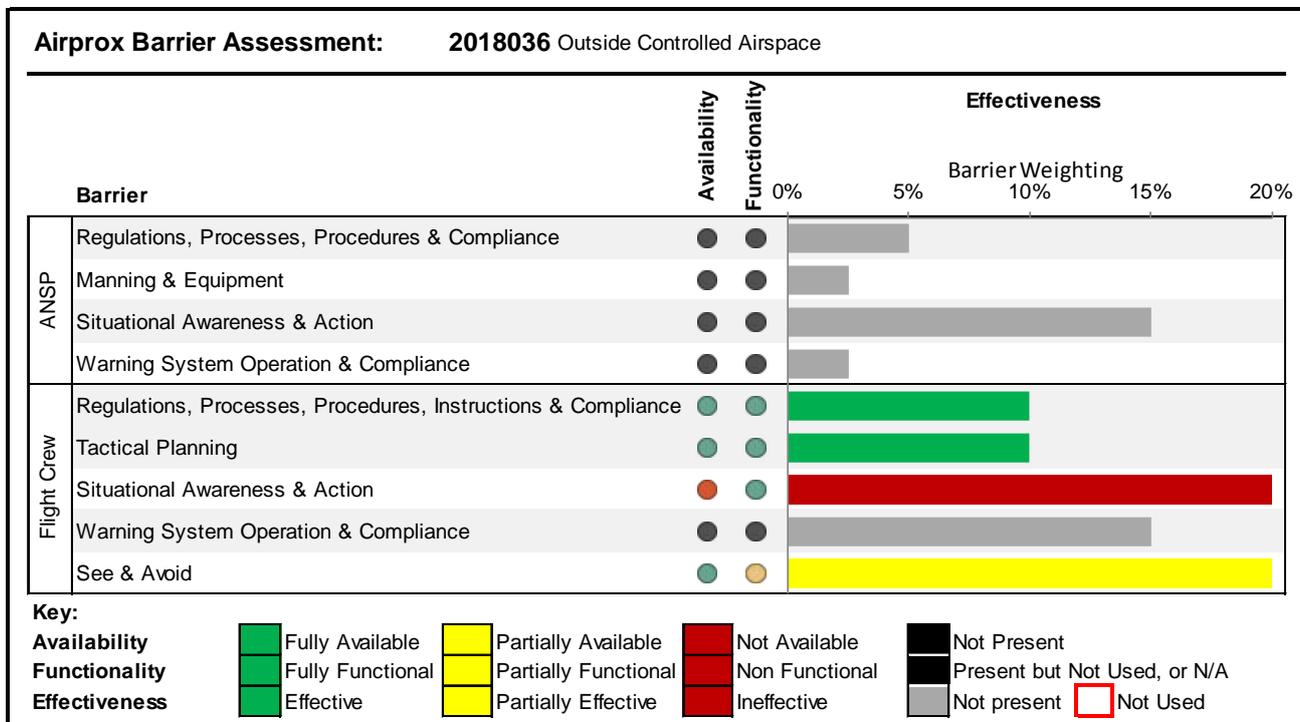
In assessing the effectiveness of the safety barriers associated with this incident, the Board concluded that the key factors had been that:

Situational Awareness and Action were assessed as **ineffective** because neither pilot had any information on the other aircraft.

Warning System Operation and Compliance were assessed as **not present** because neither aircraft was fitted with a CWS.

See and Avoid were assessed as **partially effective** because both pilots only saw each other very late and managed to take only emergency avoiding action that probably did not materially increase separation by much.
