## AIRPROX REPORT No 2018045

Date: 05 Apr 2018 Time: 1451Z Position: 5128N 00058W Location: Reading

### PART A: SUMMARY OF INFORMATION REPORTED TO UKAB

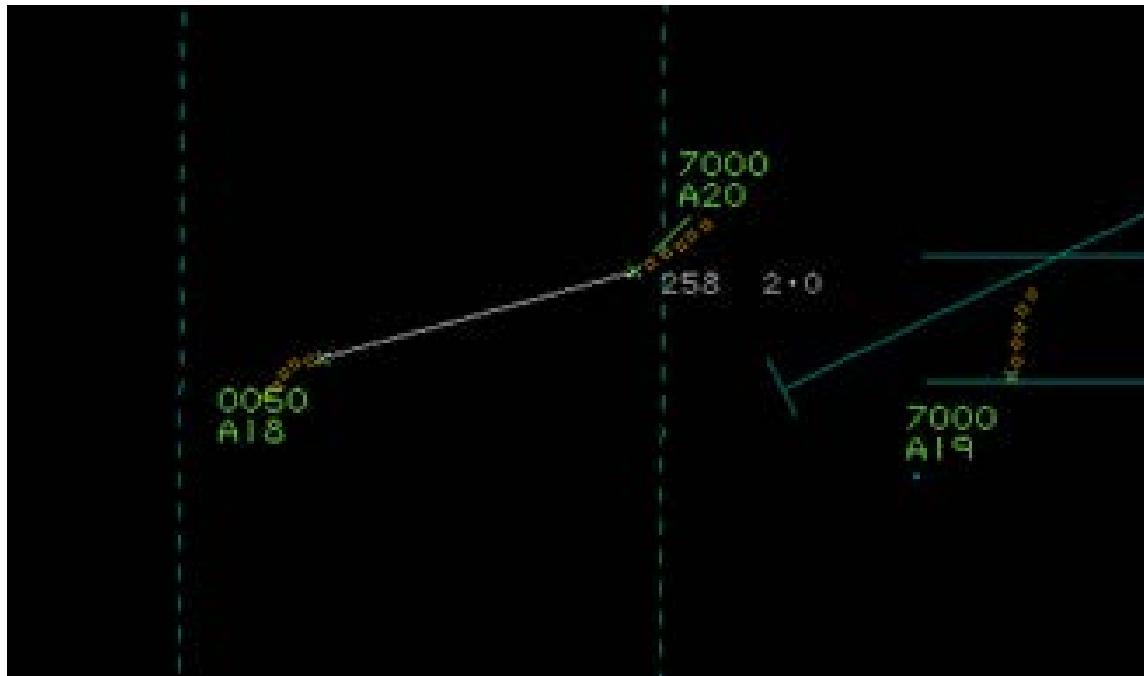
Figure 1: EC135 (0050) and C152 (7000) at 14:48:33

At 14:48:33 (Figure 1), the controller passed Traffic Information to the EC135 pilot on the C152.

Figures 1-4 show the positions of the EC135 and C152 in the lead-up to the Airprox. The pictures are taken from a NATS radar feed, which is not utilised by Benson ATC and therefore does not represent the picture available to the Controller.

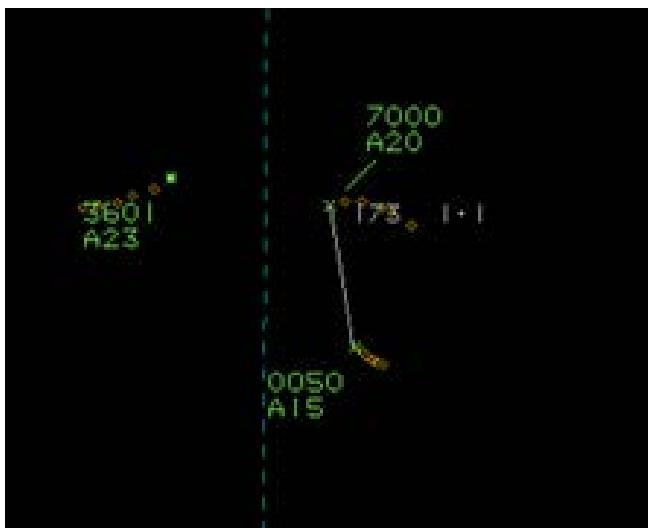
Figure 2: 14:50:13

At 14:50:13 (Figure 2), the controller passed additional Traffic Information to the EC135 pilot on the C152 and the EC135 pilot reported visual with the traffic.

EC135 (0050) and C152 (7000)

The EC135 pilot reported that the C152 appeared to be transiting on an east-west track about 1nm away but then turned south toward the EC135 (fig 2-4 above). The EC135 pilot reported that the C152 then flew directly toward them and did not appear to alter course forcing the EC135 to conduct an avoiding action descent.

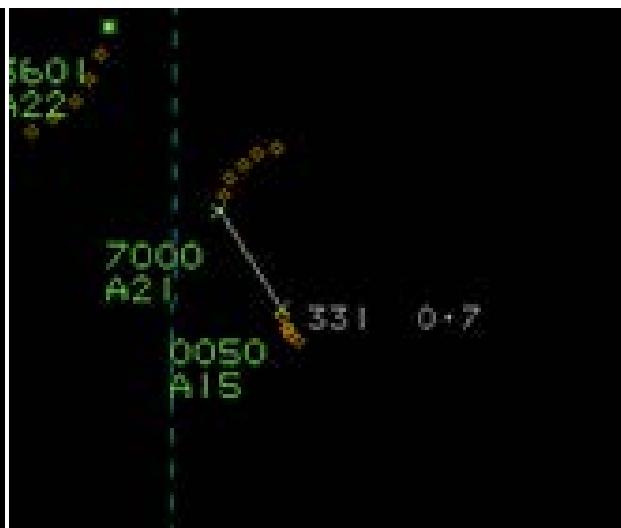
Figure 3: 14:50:33

At 14:50:33 (Figure 3), the C152 is seen to commence a turn to the south toward the EC135.

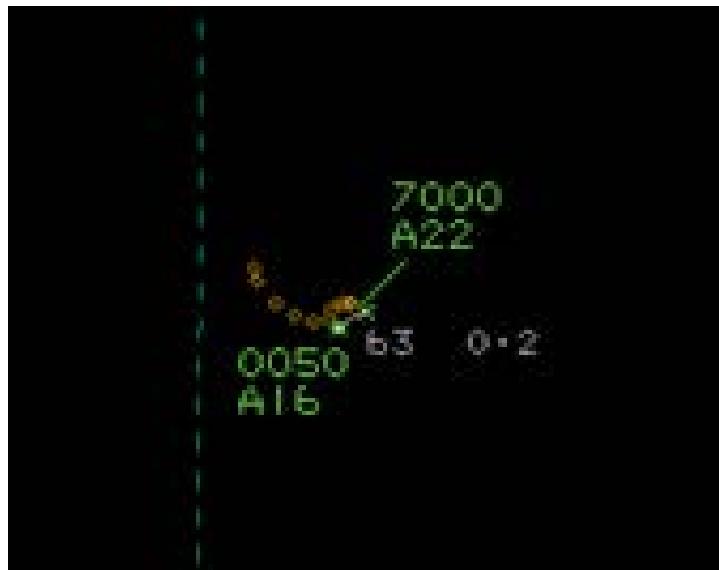
Figure 4: 14:51:08  
EC135 (0050) and C152 (7000)

At 14:51:08 (Figure 4), the controller passed further Traffic Information to the EC135 pilot who again reported visual with the C152.

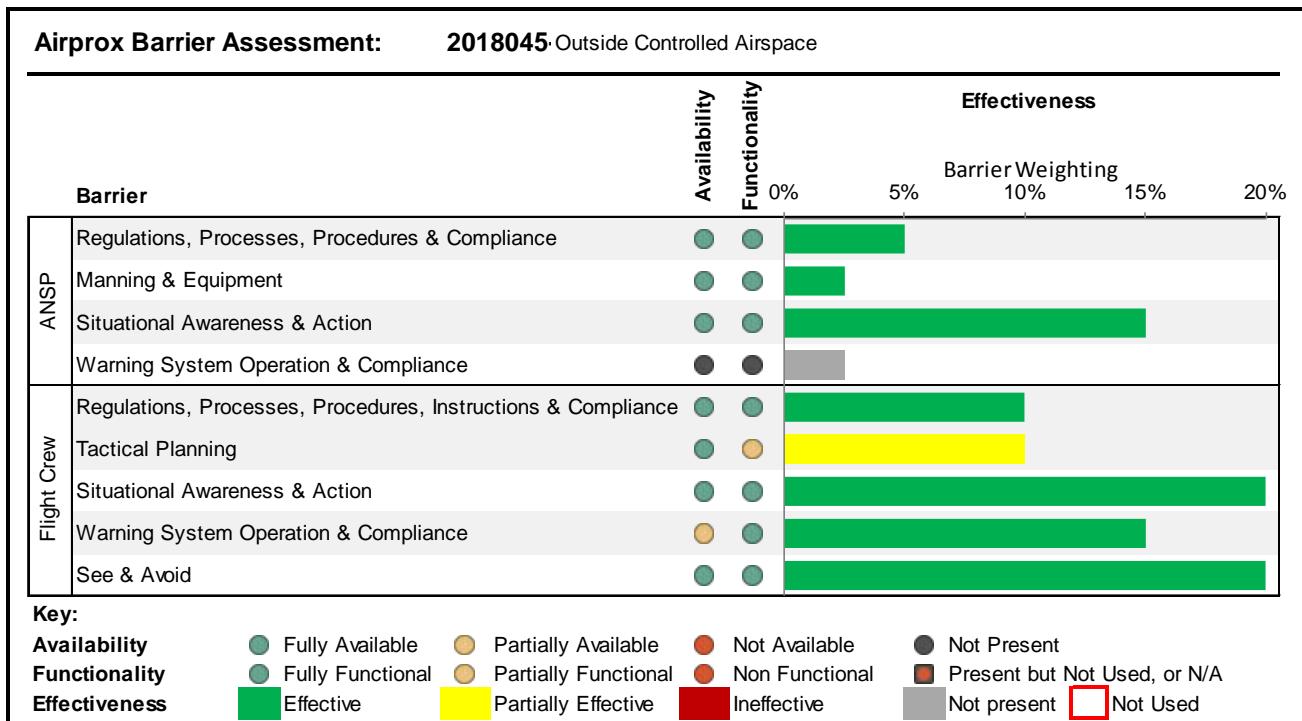
In assessing the effectiveness of the safety barriers associated with this incident, the Board concluded that the key factors had been that:

**Tactical Planning** was assessed as **partially effective** because the EC135 pilot should have requested a Traffic Service if he required Traffic Information on traffic in his vicinity.

**Warning System Operation and Compliance** were assessed as **effective** overall but **partially available** because the C152 was not equipped with a TAS.
