**AIRPROX REPORT No 2018065**

Date: 02 May 2018 Time: 1518Z Position: 5118N 00101W Location: 5nm NW RAF Odiham

**PART A: SUMMARY OF INFORMATION REPORTED TO UKAB**

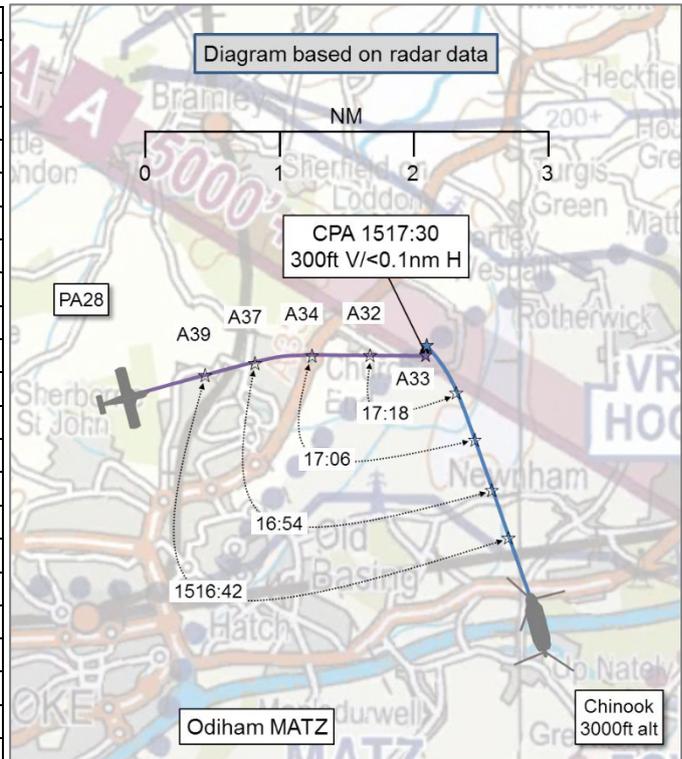
Recorded	Aircraft 1	Aircraft 2
Aircraft	Chinook	PA28
Operator	HQ Air (Ops)	Civ Trg
Airspace	London FIR	London FIR
Class	G	G
Rules	IFR	VFR
Service	Traffic	Information
Provider	Odiham	Blackbushe
Altitude/FL	3000ft	3300ft
Transponder	A, C, S	A, C, S
Reported		
Colours	Green	NK
Lighting	Nav, HISL	NK
Conditions	VMC	VMC
Visibility	30km	50km
Altitude/FL	3000ft	3300ft
Altimeter	QNH (1005hPa)	QNH (NK hPa)
Heading	328°	070°
Speed	120kt	110kt
ACAS/TAS	Not fitted	Not fitted
Alert	Proximity	N/A
Separation		
Reported	150ft V/0m H	200ft V/100m H
Recorded	300ft V/<0.1nm H

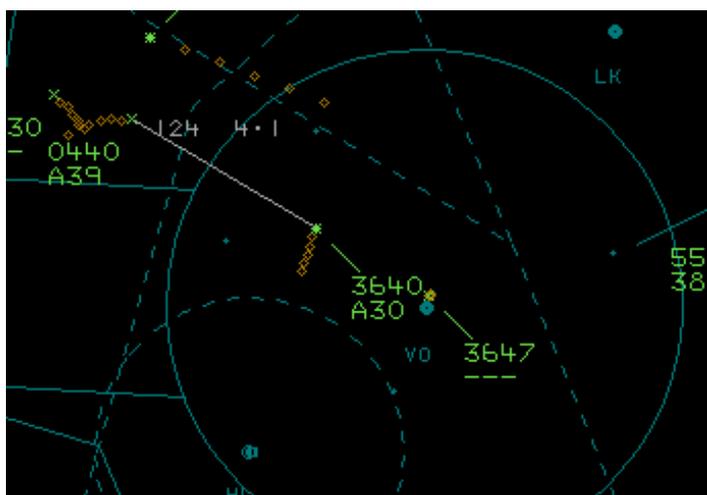
Figure 1

Traffic Information was passed by the Odiham Approach Controller for the first time at 1516:09 at a range of 3½nm (Figure 1). Cardinal headings were used when passing the Traffic Information which, at the request of the Chinook pilot, was updated in clock code format.

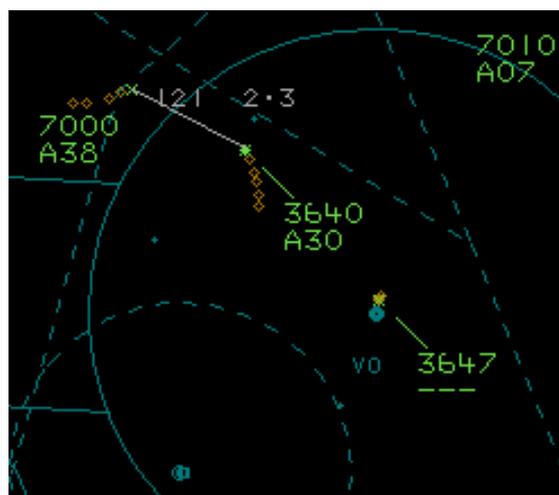
Figure 2

The Traffic Information was updated at 15:16:51 (Figure 2). Note: PA28 squawk changed to 7000 at 1516:23.

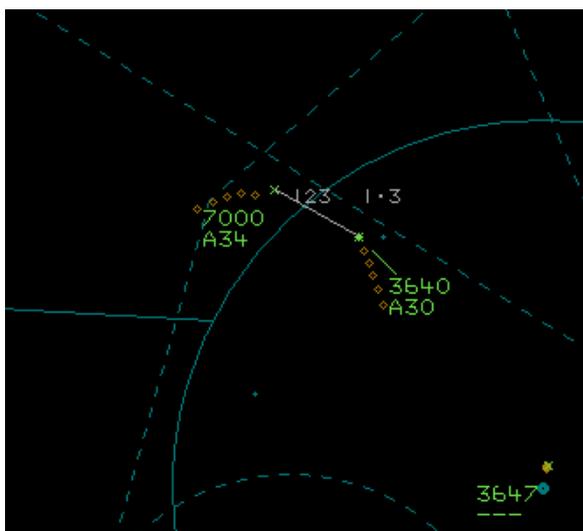
Figure 3

Traffic Information was passed for a final time at 1517:07 (Figure 3). The Chinook pilot reported visual with the PA28 at that time.

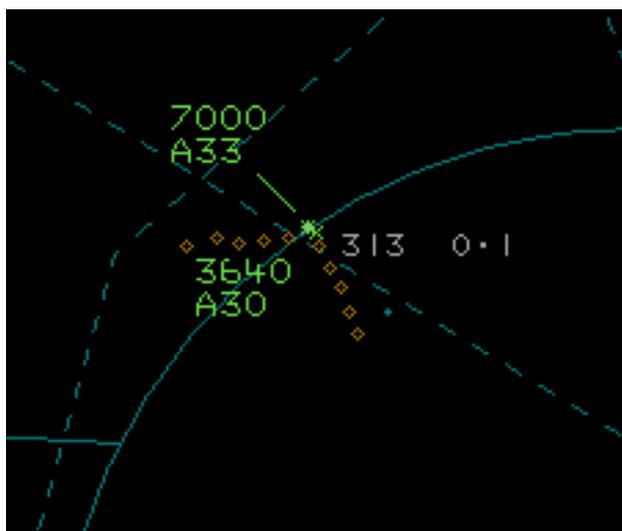
Figure 4

CPA was recorded at 1517:32 (Figure 4) and was measured at 0.1nm and 300ft.

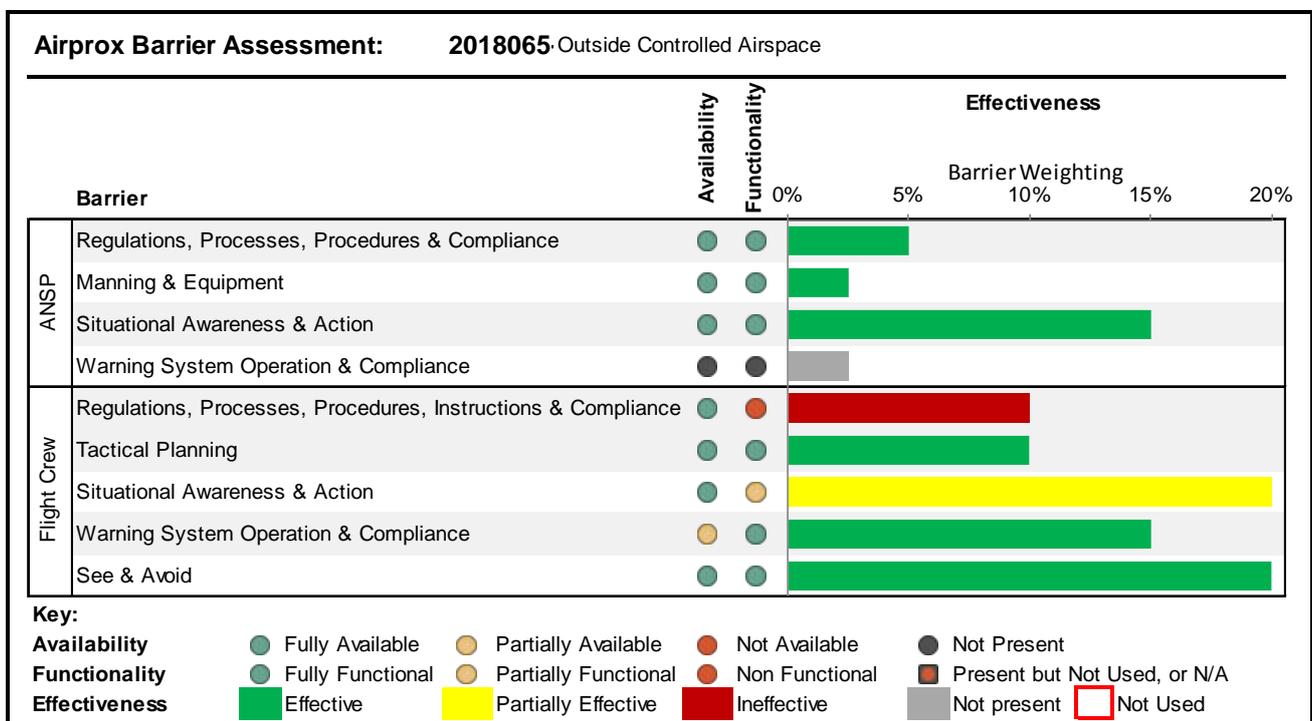
In assessing the effectiveness of the safety barriers associated with this incident, the Board concluded that the key factors had been that:

**Regulations, Processes, Procedures, Instructions and Compliance** were assessed as **ineffective** because in the Board’s opinion, the PA28 pilot did not comply with SERA.3210.

**Situational Awareness and Action** were assessed as **partially effective** because although the PA28 pilot was visual with the Chinook on his right, he continued to descend to within 0.1nm and approximately 300ft of it.

**Warning System Operation and Compliance** were assessed as **partially available** because only the Chinook was equipped with a TAS.
