AIRPROX REPORT No 2018172

Date: 14 Jul 2018 Time: 0925Z Position: 5119N 00050W Location: Blackbushe airfield - elev 325ft

PART A: SUMMARY OF INFORMATION REPORTED TO UKAB

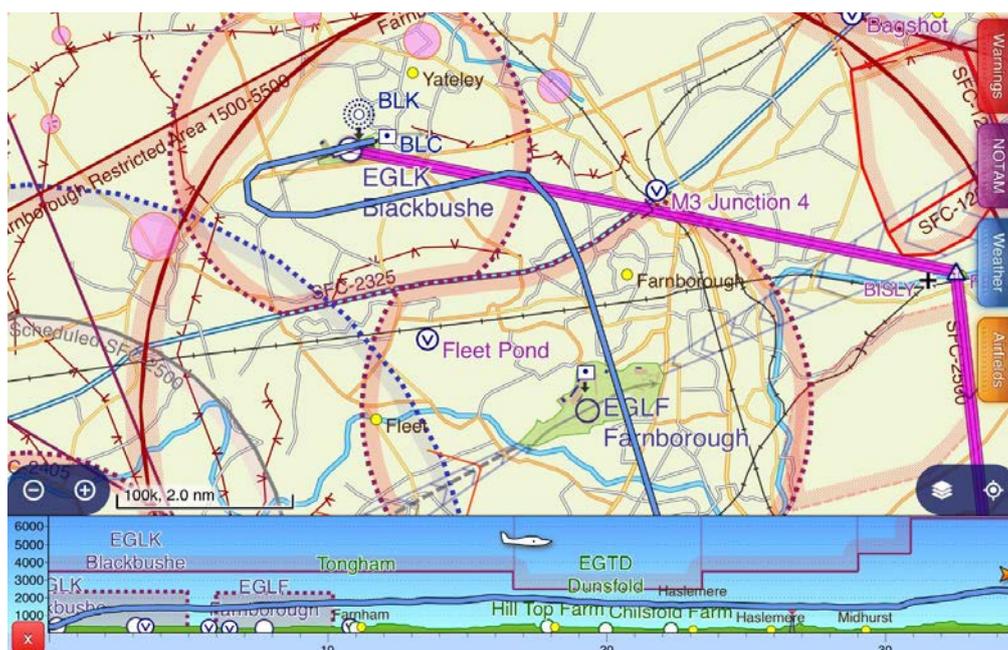
Figure 1 C182 GPS log.

1500ft QNH, if this proved possible. Immediately after this, he telephoned Blackbushe 'ATC' to see how this should be achieved. He was told to conduct the flight as normal and call to change frequency once airborne. On Friday evening he filed a VFR flight plan (via Sky Demon) for the intended route with departure from Blackbushe direct FIMLI. On Saturday it was exceptional weather with CAVOK and no cloud or discernible wind. During start-up, he had to re-set the transponder to get 7000 to display but it seems, from a conversation later with Farnborough, that the Mode C had been not been set correctly and he subsequently had to recycle to 'ALT'. When he called Blackbushe for taxi clearance (not passing full details because they had his flight plan), he specifically asked whether he needed to contact Farnborough whilst still on the ground or in the air. He was told to 'call when airborne below 1500ft QNH'. The airfield was very quiet and he was cleared to depart at 0920 on RW25 as usual with 'nothing known to affect'. The C182 climbs very fast so he was conscious of the special procedures including overhead joins at 800ft QFE (1125ft QNH) so he was alert to possible other joining traffic. When airborne, not far from the upwind end of RW25 (at approximately 800ft QNH), he turned crosswind and continued to climb towards 1500ft (QNH) and then turned downwind. Mindful of the Blackbushe special procedures he kept a close circuit on a normal standard downwind track and distance. The only traffic of which he was aware was a PA28 [actually the PS28] which took off before him and whose radioed intentions he did not understand. Whilst climbing on crosswind leg he saw a slow-moving, low-wing single-engine aircraft on a heading west-to-east at similar altitude to his climb altitude, but it was so far in the distance (2+nm?) that he could not identify the type and thought it might be the PA28 or other Farnborough traffic. In any case he considered it too distant, too slow and on a different course to be a factor to circuit traffic. At 09:22 he reported to Blackbushe that he wanted to change to Farnborough's frequency and was told 'Roger, [frequency] and have a good flight'. Continuing downwind, he was travelling at approximately 125kt, at 1500ft QNH (i.e. 1125 QFE well above the 800 QFE circuit), on the reciprocal runway heading (070°), intending to pick-up his planned route heading (100°) to FIMLI if he did not get transit clearance from Farnborough. In the event, as he was leaving the Blackbushe ATZ, he was given clearance by Farnborough to 'transit overhead, direct MID, not above 1500ft QNH, with a Basic Service. He checked under the wing for traffic on his inside at the same height (and his passenger did also) and saw nothing, so he turned. If he recalled correctly this was instructed as an 'immediate right turn' because of other Farnborough traffic. It was at this point that he was alerted by Farnborough to the Mode C not transponding altitude, so he reset to 'ALT' which was then acknowledged as being seen. He did not believe that there was any issue because at all times he was aware of the potential for other traffic but actively saw none even likely to conflict. Also, the height separation above circuit traffic was sufficient to avoid any conflict.

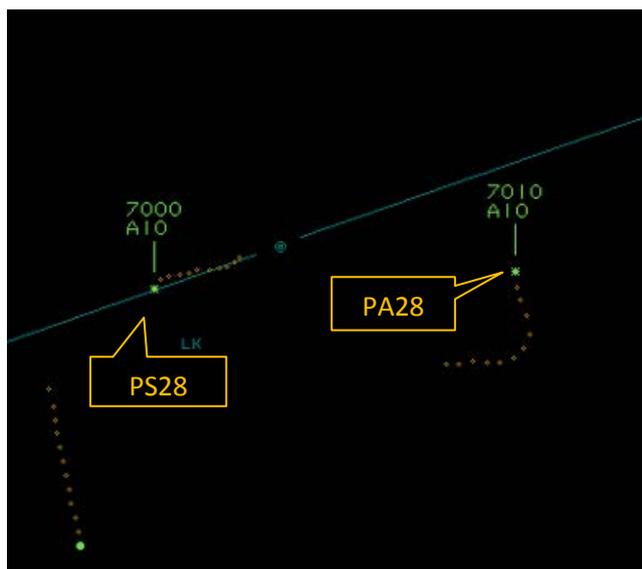
Figure 2 - 0921:18.

At 0920:30 the C182 pilot, having taxied out for departure, asked the Blackbushe AFISO if they, (the pilot), should check with Farnborough about transit of the RA(T), (established for the airshow), before or after getting airborne. The AFISO confirmed that they should wait until airborne, and before reaching 1500ft. The C182 pilot then confirmed that they were ready for departure and were given discretion to take-off at 0921:10. At 0921:18, the PS28 pilot, having completed their touch and go, advised that they were carrying out a (practice) fan-stop, and were asked by the AFISO to report climbing westbound. (Figure 2). At 0921:43, the PS28 pilot reported climbing away, observed on the radar replay at 0921:51. (Figure 3.)

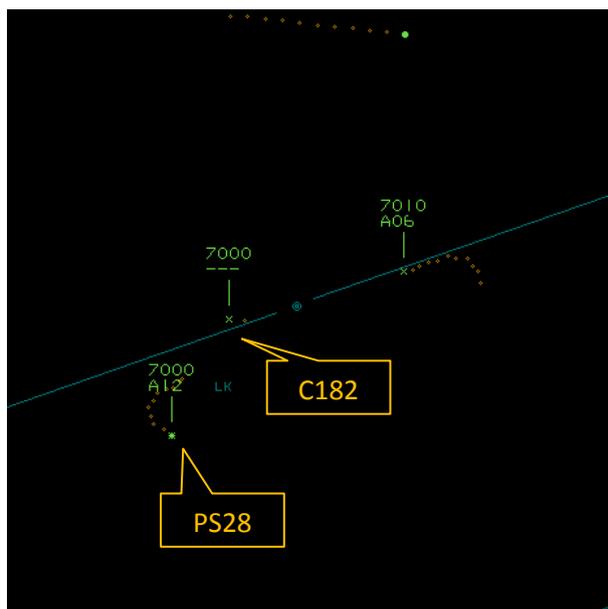
Figure 4 – 0922:19.

The C182 became visible on the radar replay at 0922:19. (Figure 4).

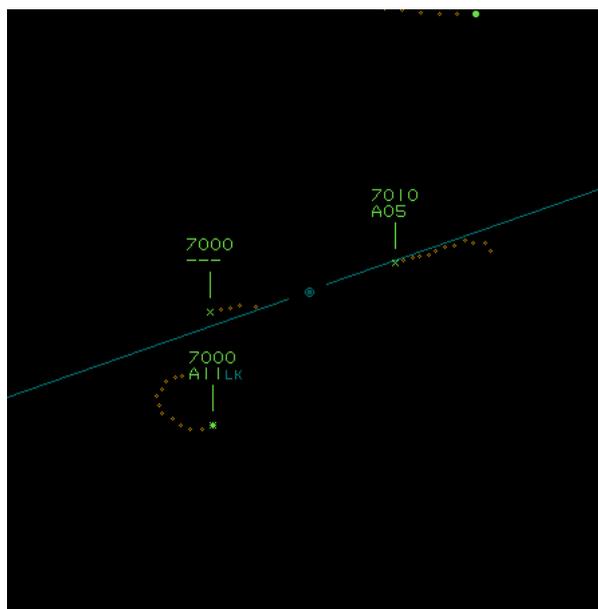
Figure 5 – 0922:28.

At 0922:28, the C182 pilot reported crosswind and ready to change to Farnborough Radar which was acknowledged by the AFISO. (Figure 5).

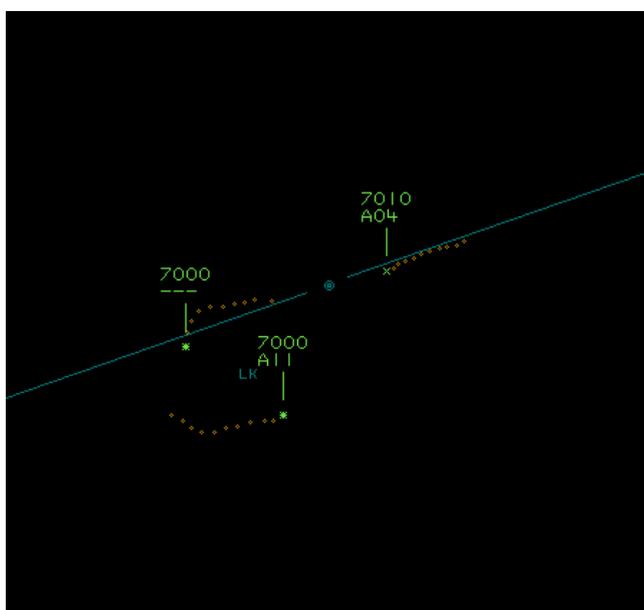
Figure 6 – 0922:53.

At 0922:53, the PS28 pilot reported downwind with Blackbushe. (Figure 6).

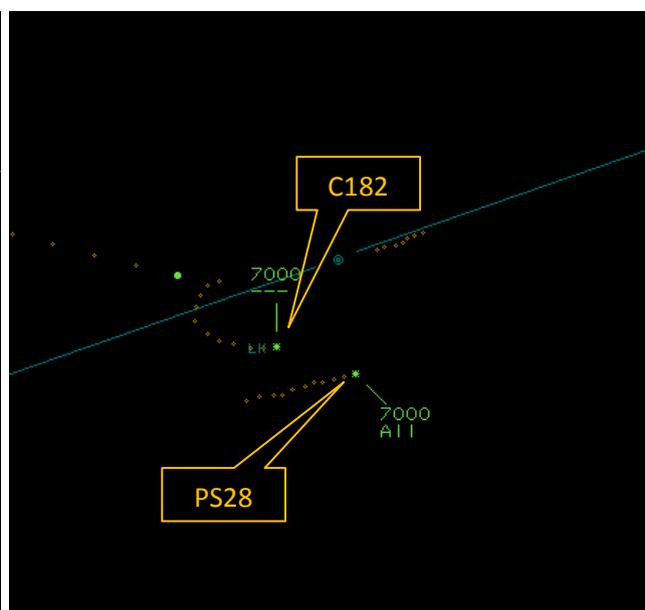
Figure 7 – 0923:15.

At 0923:15 (Figure 7), the C182 pilot contacted Farnborough. After initially telling the controller twice that they were airborne from Farnborough, the pilot subsequently corrected themselves, reported being at 1400ft, and requesting a routing via Frimley to Midhurst, which was acknowledged by the controller.

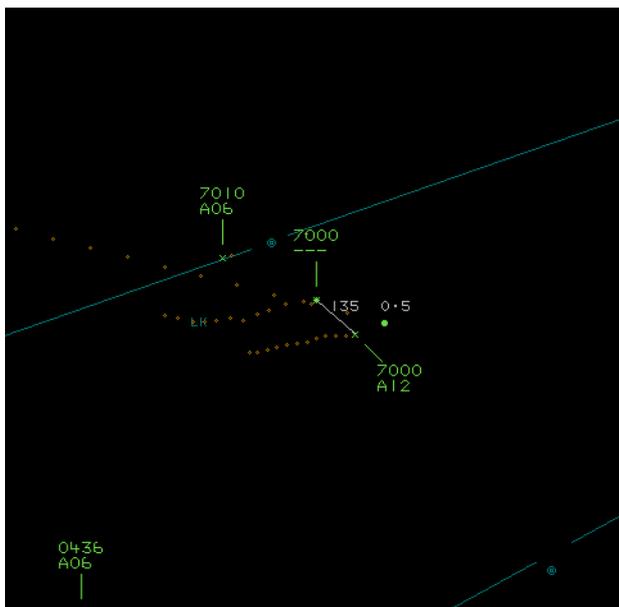
Figure 8 – 0923:42.

Meanwhile, at 0923:42, the Blackbushe AFISO cautioned the pilot of the PS28 that another aircraft, (the C182), was also downwind, but that it was speaking to Farnborough. This was acknowledged by the pilot who reported visual with that aircraft. (Figure 8).

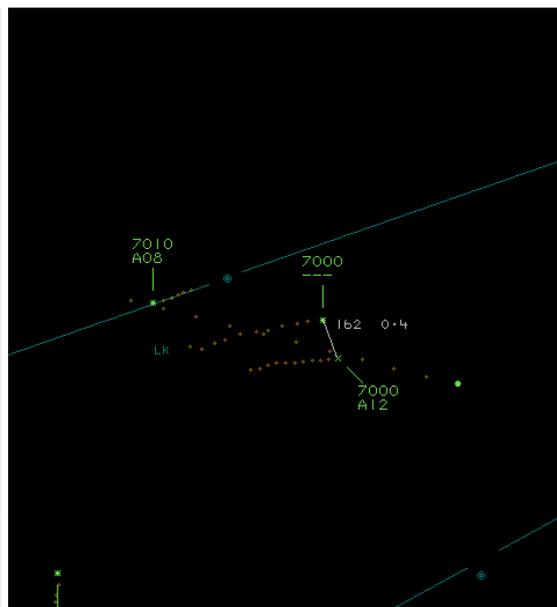
Figure 9 – 0924:00.

Having acknowledged the information passed by the pilot of the C182, at 0924:00, the Farnborough controller passed the Farnborough QNH, a transponder code 0463, and advised that it was a Basic Service. They then cleared the C182 pilot to transit the ATZ, but asked the pilot if they could route to the east of the airfield due to departing traffic, advising that they would then be able to route direct to Midhurst. (Figure 9).

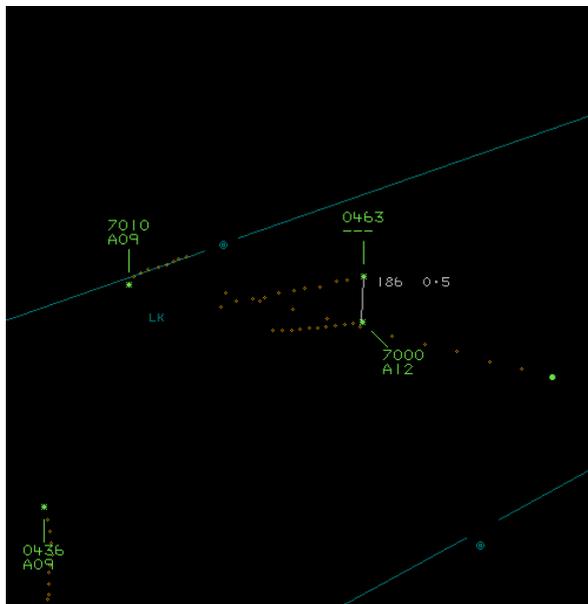
Figure 10 – 0924:12.

Receiving no response from the pilot, the controller then repeated the request, at 0924:12, to which the pilot agreed. (Figure 10).

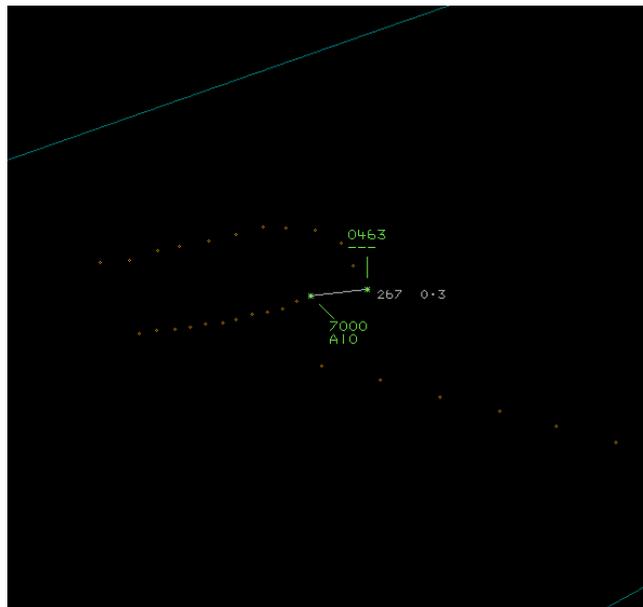
Figure 12 – 0924:38.

CPA took place at 0924:38 with the aircraft separated by 0.3nm laterally. Vertical separation could not be determined as the C182 was not transponding Mode C at the time. (Figure 12).
