AIRPROX REPORT No 2018237

Date: 02 Sep 2018 Time: 0903Z Position: 5218N 00047W Location: Sywell ATZ

PART A: SUMMARY OF INFORMATION REPORTED TO UKAB

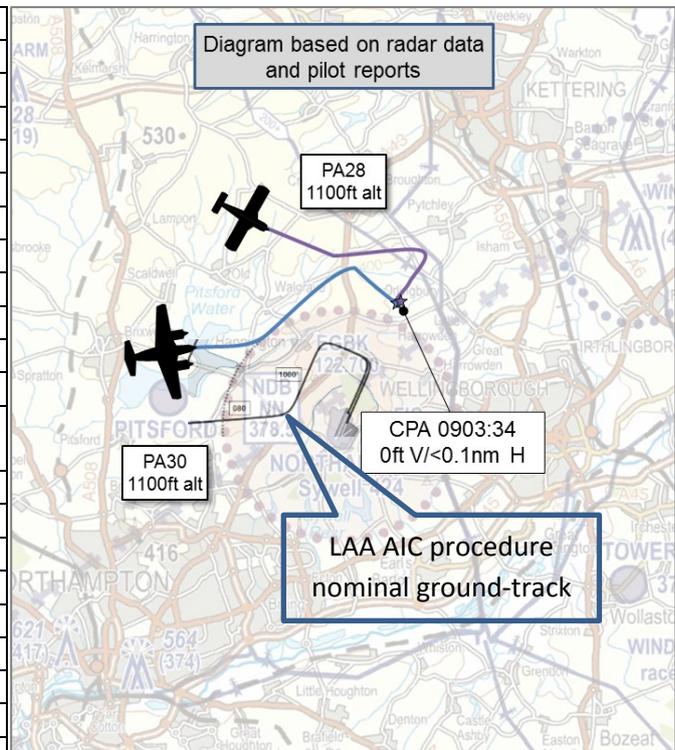
Both aircraft join from the same hold area, although the PA28 leaves the hold much further north than the procedure stipulates and therefore not where the PA30 pilot was probably expecting him. The PA28 (and PA30) then proceed to fly a much larger than intended ground track compared to the published procedure (see diagram on Page 1).

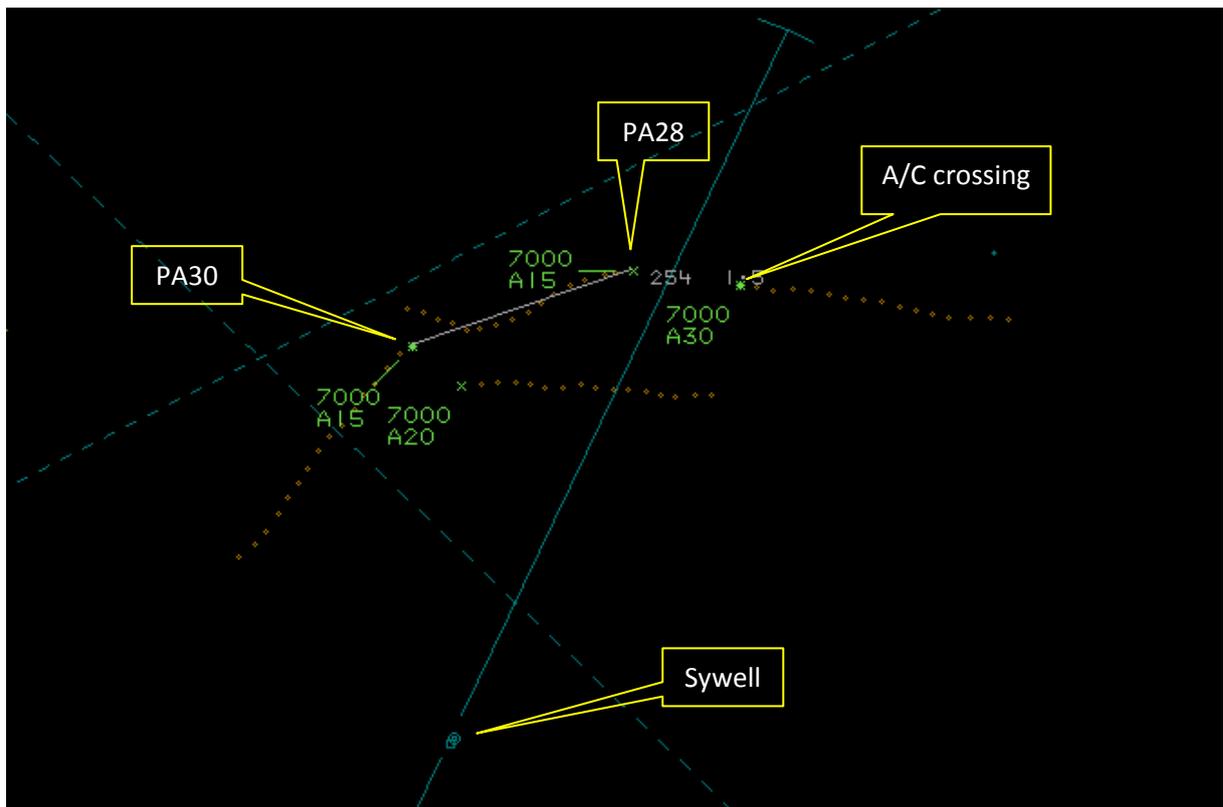
Figure 1 shows the subsequent geometry just before the PA28 pilot turns long final, with the crossing aircraft that the PA28 pilot mentions visible. Prior to this, an aircraft primary-only return (possibly a Jodel that landed ahead of the PA28) appears to be joining from the north-east ahead of the PA28, this subsequently disappears from radar at about 2nm.

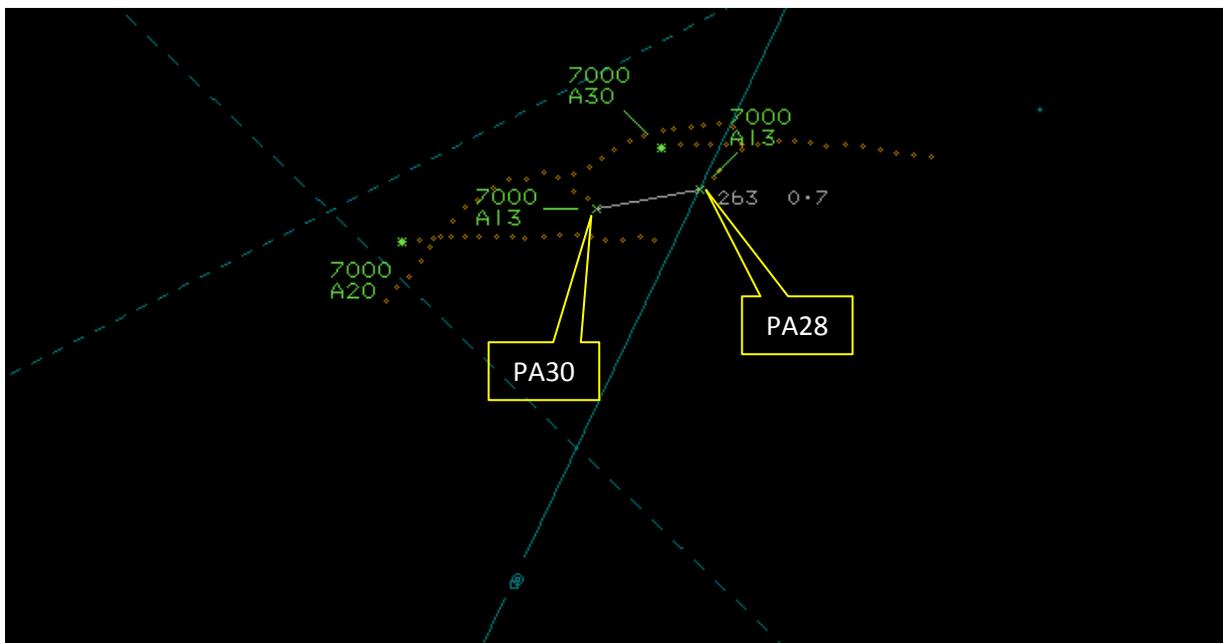
Figure 2

At Figure 2, the PA28 is ahead and has turned onto final at about 3nm. The PA30 is on an extended 'base-leg' and subsequently turns in for final at about 2nm.

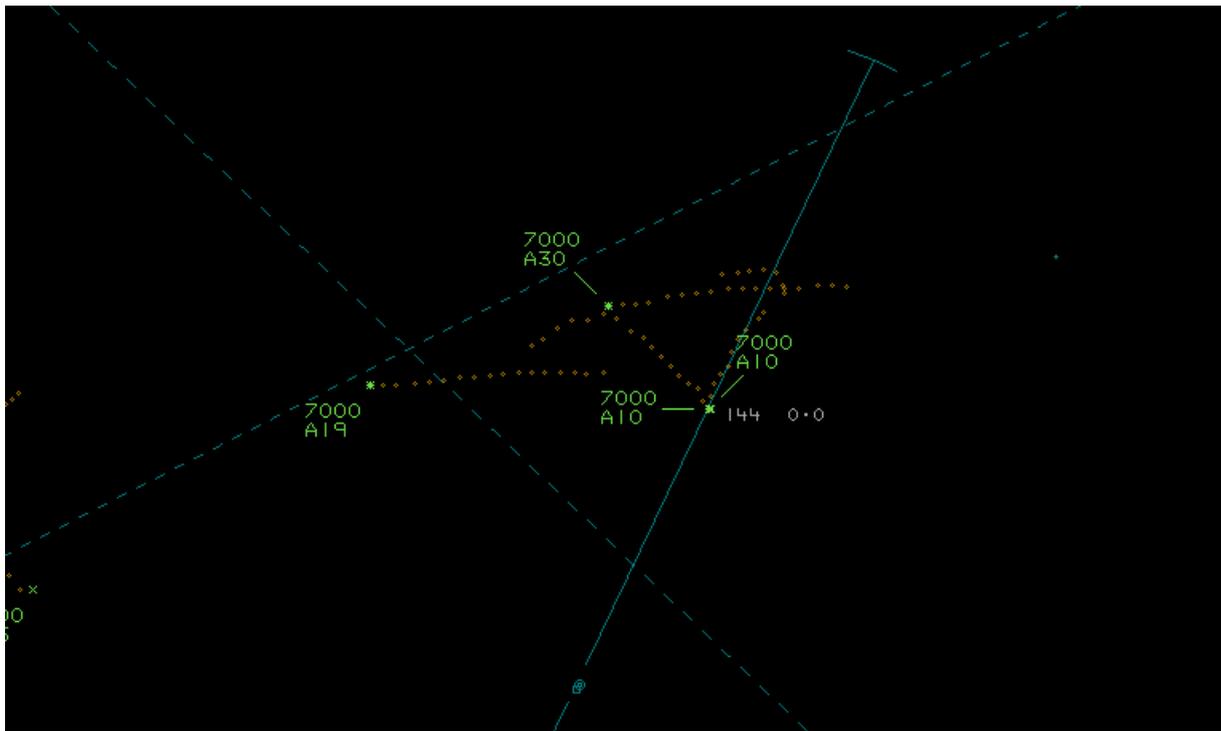
Figure 3

Initial CPA occurs when the aircraft tracks cross on final approach just after the PA30 turns final. Both aircraft are indicating the same level (Figure 3).

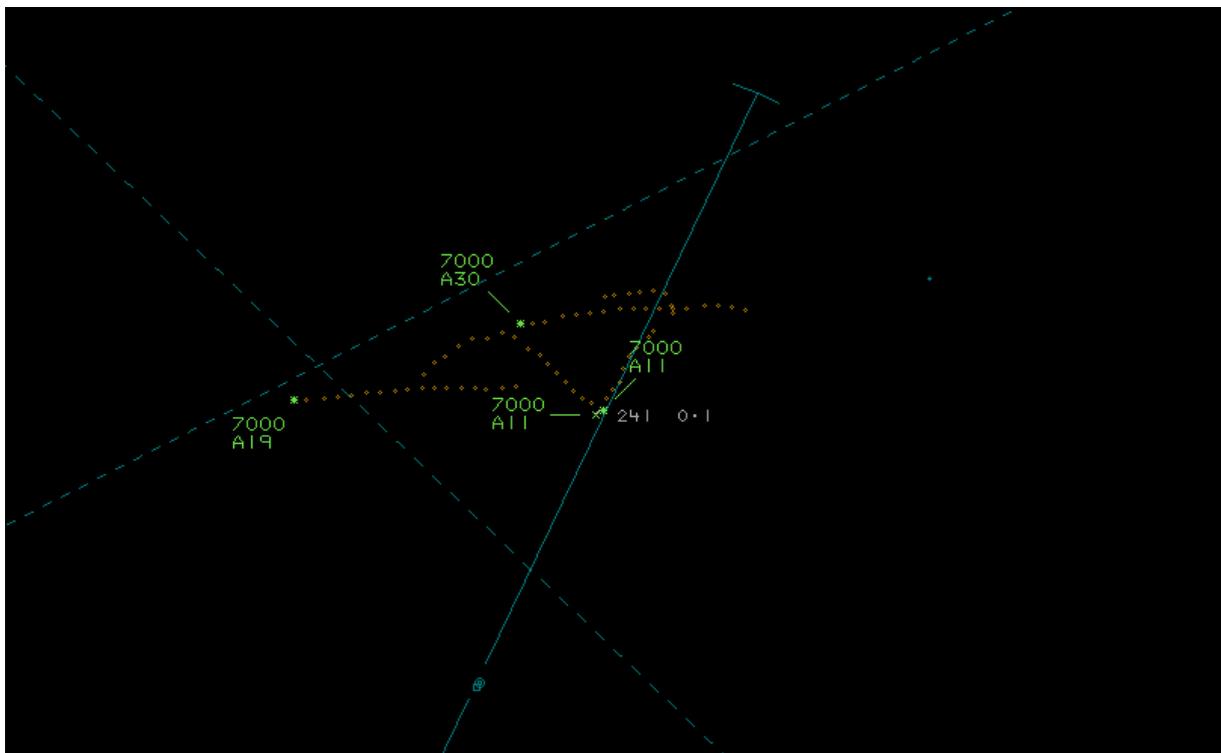
Figure 4

Figures 4, 5, and 6 show the aircraft at similar heights and position as they track down the final approach. From the PA30 pilots report, it is probably at Figure 5 that he saw the PA28 overtaking him and continuing to land as he goes around as indicated at Figure 6.

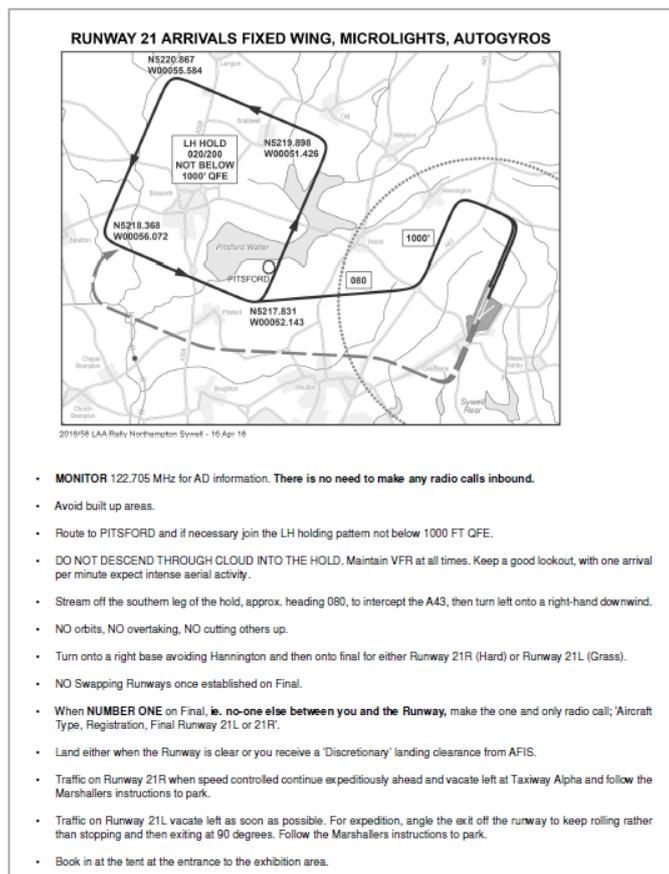
Figure 7: LAA Rally fixed wing arrivals procedure for RW21

The Board began by first looking at the actions of the PA30 pilot. He had left the hold at Pitsford Reservoir in accordance with the AIC, but it appeared from the radar replay that he had turned onto the downwind leg wider than the intended track shown in the AIC; it was subsequently disclosed by the PA30 pilot that his extended track was due to him positioning behind the slower Jodel. It was clear that he had heard the PA28 pilot in the hold, and the additional information from the PA30 pilot indicated that at this point he thought the PA28 was joining behind him. Having himself flown a wider than normal and extended ground track to maintain separation with the Jodel ahead, the PA30 pilot then turned onto final just outside the ATZ. When the PA30 pilot looked up the approach path before turning final, because he was not expecting to see anything beyond his own wider-than-normal track, it was likely therefore that his lookout scan did not acquire the PA28 which he thought was behind him.

The Board then turned to the actions of the PA28 pilot. It was clear that although he had flown to the area of the hold, he had not departed the hold at the specified point (south of Pitsford Reservoir, heading 080°). Thereafter, albeit he was trying to establish the location of aircraft joining ahead and crossing above, his route further deviated from the desired pattern such that he was now well off track and lining up for final well beyond the ATZ boundary. The Board felt that these large-scale deviations from the procedure was contributory to the PA30 pilot not visually detecting the PA28. Seeing no other aircraft ahead, the PA28 pilot had then called 'final' at long range, and GA members felt that although this was likely technically in compliance with the AIC (assuming there were no other aircraft ahead), to do so at such long range invited confusion for other pilots who would be expecting a call much closer to the airfield. Members debated whether the Sywell AIC could usefully include a maximum range (or ground position) for making the 'final' call but the Board eventually decided against making such a recommendation because this might compromise flexibility in the procedure. Notwithstanding, Sywell may wish to consider such an inclusion in the AIC.

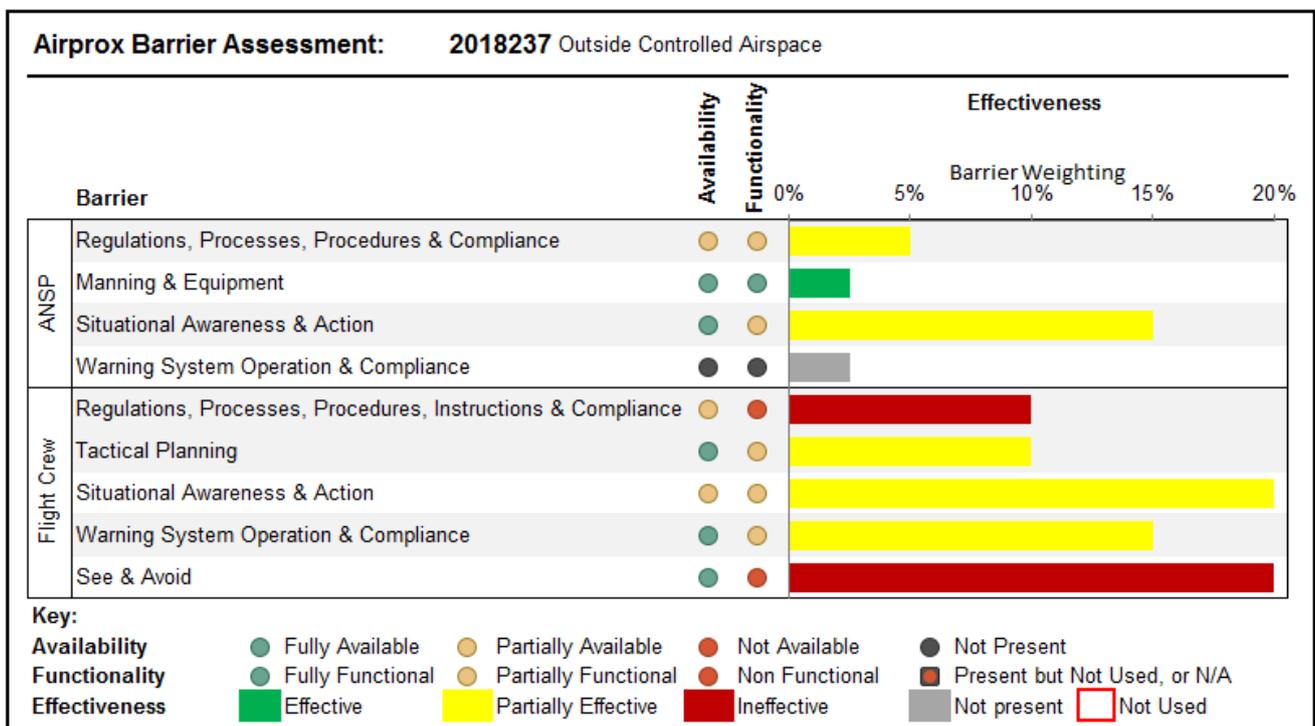
In assessing the effectiveness of the safety barriers associated with this incident, the Board concluded that the key factors had been that:

Regulations, Processes, Procedures and Compliance were assessed as **partially effective** because the procedure did not robustly identify a method that ensures situational awareness if pilots depart from the procedure (e.g. a maximum range to call final), and the AIC did not specifically prohibit parallel approaches.

Situational Awareness and Action were assessed as **partially effective** because the AFISO did not identify the conflict and there were no procedures to determine the point at which an AFISO might intervene if aircraft were in conflict in such circumstances.

Regulations, Processes, Procedures, Instructions and Compliance were assessed as **ineffective** because the PA28 pilot deviated to such an extent that he did not follow the joining procedure.

Tactical Planning was assessed as **partially effective** because the PA28 pilot did not fully follow the AIC instructions when leaving the hold.

Situational Awareness and Action were assessed as **partially effective** because the pilots had only generic awareness of each other prior to coming into proximity.

Warning System Operation and Compliance were assessed as **partially effective** because the installed TAS in the PA28 alerted but the pilot did not act upon it because he was visual with the PA30. The PilotAware in the PA30 either did not alert, or if it did, the alert was not reported or acted upon.

See and Avoid were assessed as **ineffective** because the PA28 pilot was visual with the PA30 as it turned in on final but, by continuing, he did not act sufficiently to avoid the conflict or increase the separation. For his part, the PA30 pilot did not see the PA28 already established on long-final as he himself turned final.
