**AIRPROX REPORT No 2018271**

Date: 30 Sep 2018 Time: 1438Z Position: 5212N 00010E Location: Cambridge ATZ

**PART A: SUMMARY OF INFORMATION REPORTED TO UKAB**

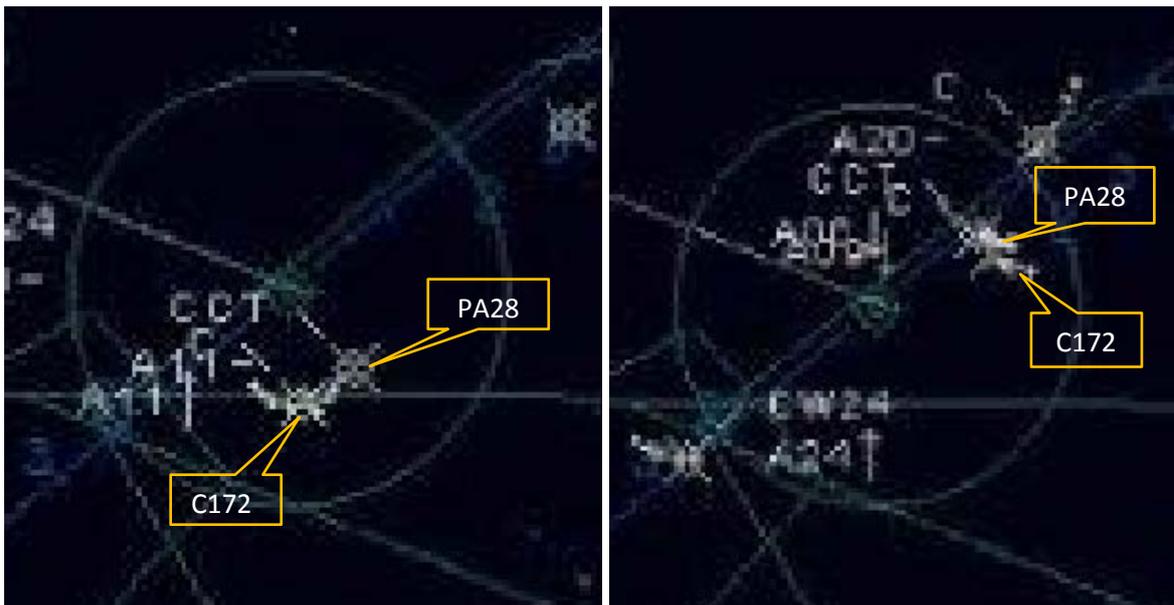
Figure 1 - 1435:00

At **1435:00** (Figure 1), the PA28 had turned downwind left-hand ahead of the C172.
