AIRPROX REPORT No 2019032

Date: 22 Feb 2019 Time: 1443Z Position: 5445N 00123W Location: Peterlee Airfield

PART A: SUMMARY OF INFORMATION REPORTED TO UKAB

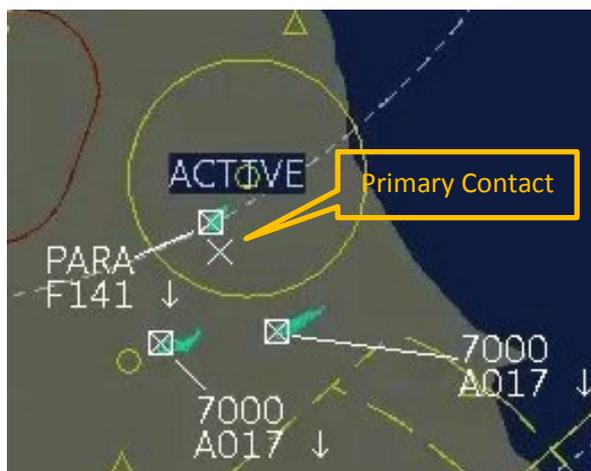
Figure 1

Although the Tiger Moth could not be seen on the NATS radars, Newcastle reviewed their radar and were able to provide screenshots. A primary only contact, thought to be the Tiger Moth, could first be seen on the Newcastle radar at 1442:49 (Figure 1), when a primary only contact can be seen just south of the Caravan (code callsign converted as 'PARA' on the Newcastle radar). At 1444:43 the non-squawking aircraft can be seen to the north of the airfield, having flown overhead. The parachute centre called Newcastle at this time to report that a bi-plane had just flown underneath some parachutes (Figure 2).
