**AIRPROX REPORT No 2019062**

Date: 16 Apr 2019 Time: 0944Z Position: 5851N 00315W Location: 12nm SW Kirkwall

**PART A: SUMMARY OF INFORMATION REPORTED TO UKAB**

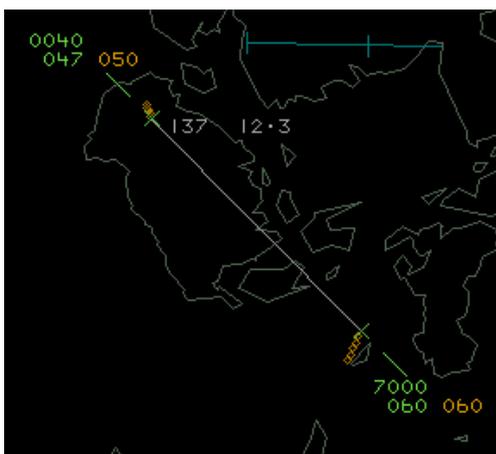
Figure 3 - 0942:50

At 0942:50 (Figure 3), the Saab340 pilot reported commencing their left turn on the arc for RW09. The controller instructed the pilot to descend now, with the procedure, QNH 1024hPa, and to report localiser established. The pilot responded with a full and accurate readback.

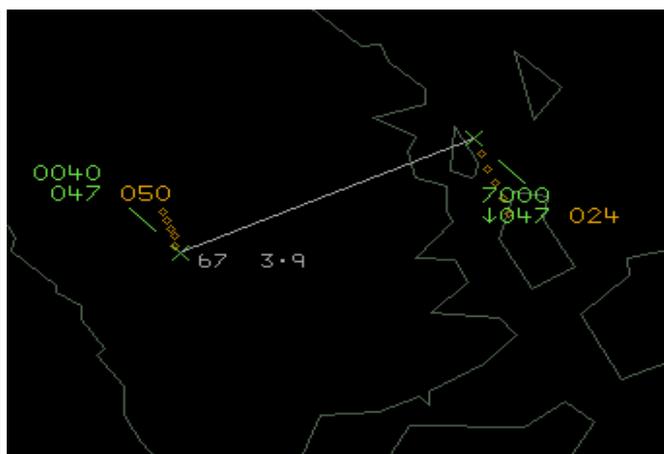
Figure 4 - 0944:50 (CPA)

At 0944:50 (Figure 4), the controller then asked the Saab340 pilot to report their passing radial on the arc and their altitude. CPA occurred at this time, with the aircraft separated by 3.9nm laterally and zero feet vertically.

The Board then turned to the risk and members quickly agreed that with the separation between the S92 and the Saab340 being no closer than 3.9nm when their levels crossed, normal safety standards and parameters had pertained, risk Category E. Notwithstanding, the Board also agreed that the Saab340 pilot had been right to express his concerns through the Airprox reporting system given that the incident had highlighted important considerations regarding the operation of his commercial air transport aircraft under a Procedural Service in Class G airspace.
