**AIRPROX REPORT No 2019087**

Date: 02 May 2019 Time: 1123Z Position: 5303N 00056W Location: Syerston – elev 231ft

**PART A: SUMMARY OF INFORMATION REPORTED TO UKAB**

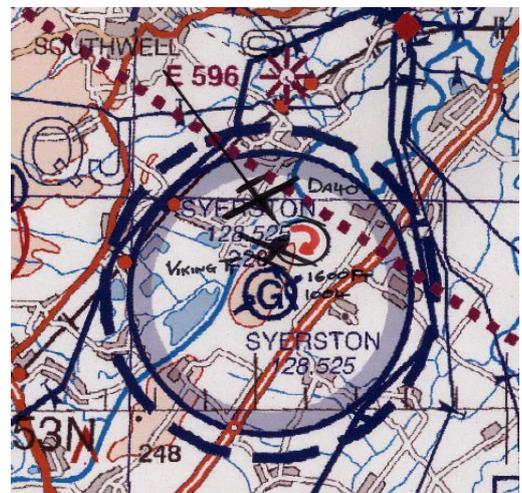
Figure 1  
Viking Pilot's Sketch of the Incident

**THE VIKING PILOT** reports recovering to RAF Syerston during the descent from a soaring trip. They began a right-hand orbit adjacent to the high-key circuit point for RW29. They began their descent from 2100ft on the Syerston QFE and, when passing 1800ft, broke off the right-hand orbit and continued on a heading of 330° for around 1nm. At that point they carried out a 'pre-lookout' scan and entered another right-hand descending turn to re-join for RW29. At that point the pilot contacted Syerston Radio with a re-join call. After completing approximately 300° of an intended 360° orbit, a GA aircraft was spotted on a collision track in the 12 o'clock position at the same height and at a range of 400ft. To avoid a mid-air collision, the pilot increased AoB to around 60-70° and pitched the nose down. At this point he estimated the light-aircraft passed directly over the top of his aircraft by about 150-200ft. He continued the turn to the right to see an aircraft continuing on a southerly heading, approximately 170°. It was evident that the light-aircraft pilot took no apparent action to avoid a collision and therefore he assumed the pilot of the GA aircraft had not seen his aircraft. After taking avoiding-action, he noted the altimeter was indicated 1600ft on the Syerston QFE 1004. He called Syerston Radio and informed them of the near-miss. The pilot noted that he believed from his position and the proximity of RAF Syerston ATZ that the GA aircraft in question also infringed the RAF Syerston ATZ by an estimated 1nm laterally and 100ft vertically (using Syerston QFE 1004 and East Midlands QNH 1014). The Barnsley RPS at the time of incident was recorded as 1008. The Viking pilot provided a sketch of the incident as he perceived it (Figure 1).

He assessed the risk of collision as 'Very High'.
