**AIRPROX REPORT No 2019107**

Date: 18 May 2019 Time: 1631Z Position: 5222N 00107W Location: 4nm NW Rugby

**PART A: SUMMARY OF INFORMATION REPORTED TO UKAB**

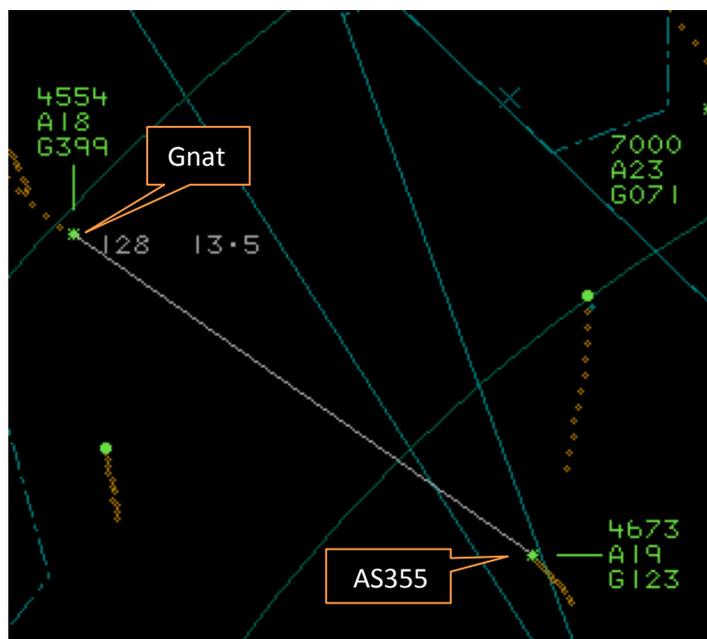
Figure 1- 16:28.39

At 16:28.39 (Figure 1), the Gnat was 13.5nm northwest of the AS355 and displaying a groundspeed of 399kt. The AS355 was displaying a groundspeed of 123kt.

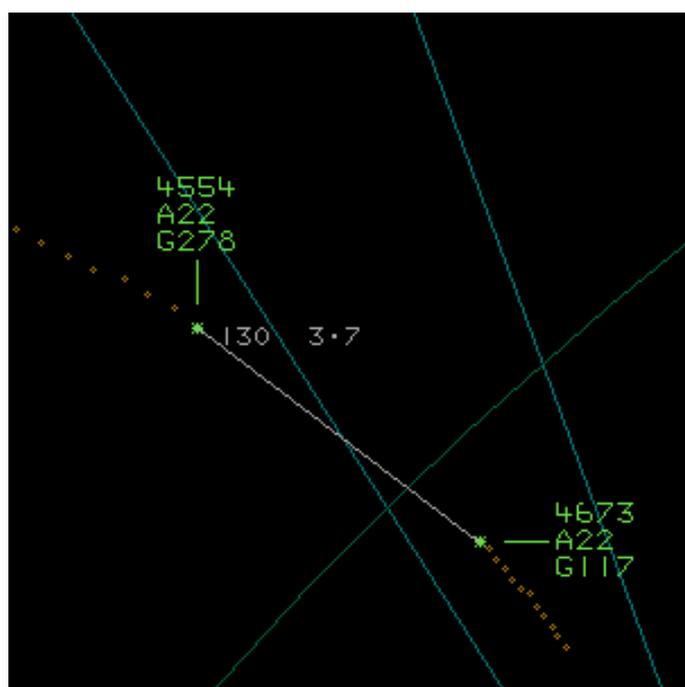
Figure 2 - 16:30.07

At 16:30.07 (Figure 2), the Gnat was 3.7nm northwest of the AS355, with both aircraft indicating altitude 2200ft. The Gnat was displaying a groundspeed of 278kt at this point and the AS355 was displaying a ground speed of 117kt. The controller made it clear to the AS355 pilot that he was still under a Basic Service but that he had traffic in the 12 o'clock, range 3 miles, opposite direction, indicating the same level. The AS355 pilot advised the controller that he would climb to altitude 2500ft and, once clear of the traffic, they would 'QSY' to East Midlands.

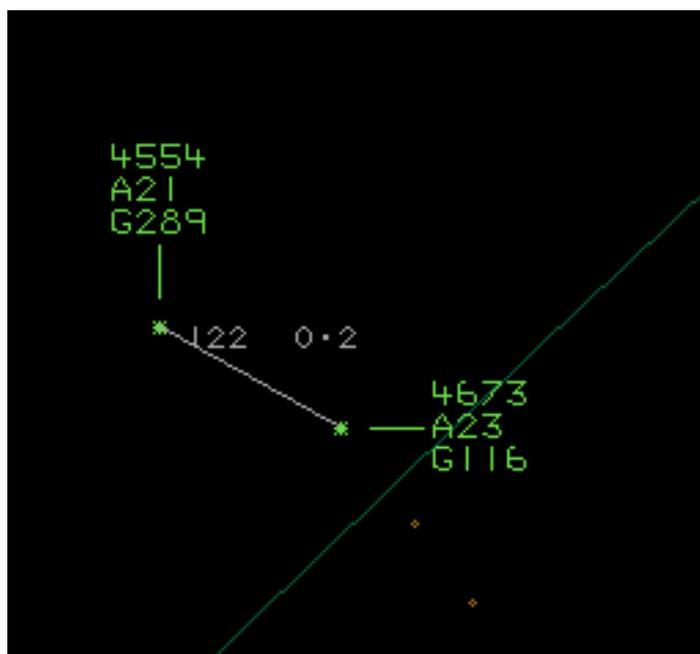
Figure 3-16:30.39 CPA

CPA occurred at 16:30.39 (Figure 3), with the aircraft separated by 0.2nm laterally and 200ft vertically. The displayed ground speed of the Gnat at CPA was 289kt and the displayed ground speed of the AS355 116kt.

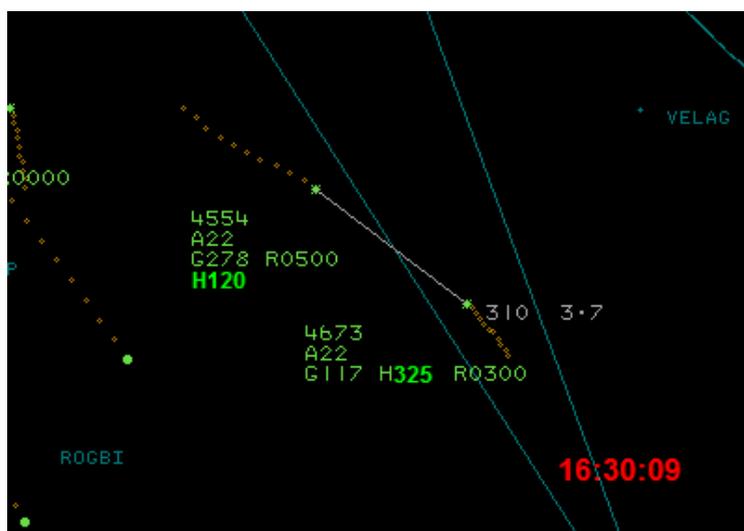
Figure 4

At 16:30:09 (Figure 4), the GW INT U/T informed the pilot of [AS355 C/S] "is still a basic service, but there is traffic in your twelve o'clock, range three miles, opposite direction, same level."

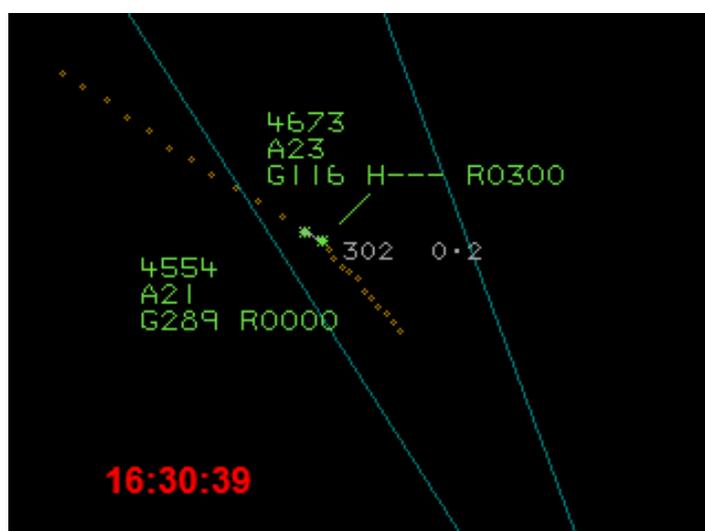
Figure 5

CPA occurred at 16:30:39 and was recorded on the LTCC Multi-Track Radar as 0.2nm and 200 feet, see Figure 5.

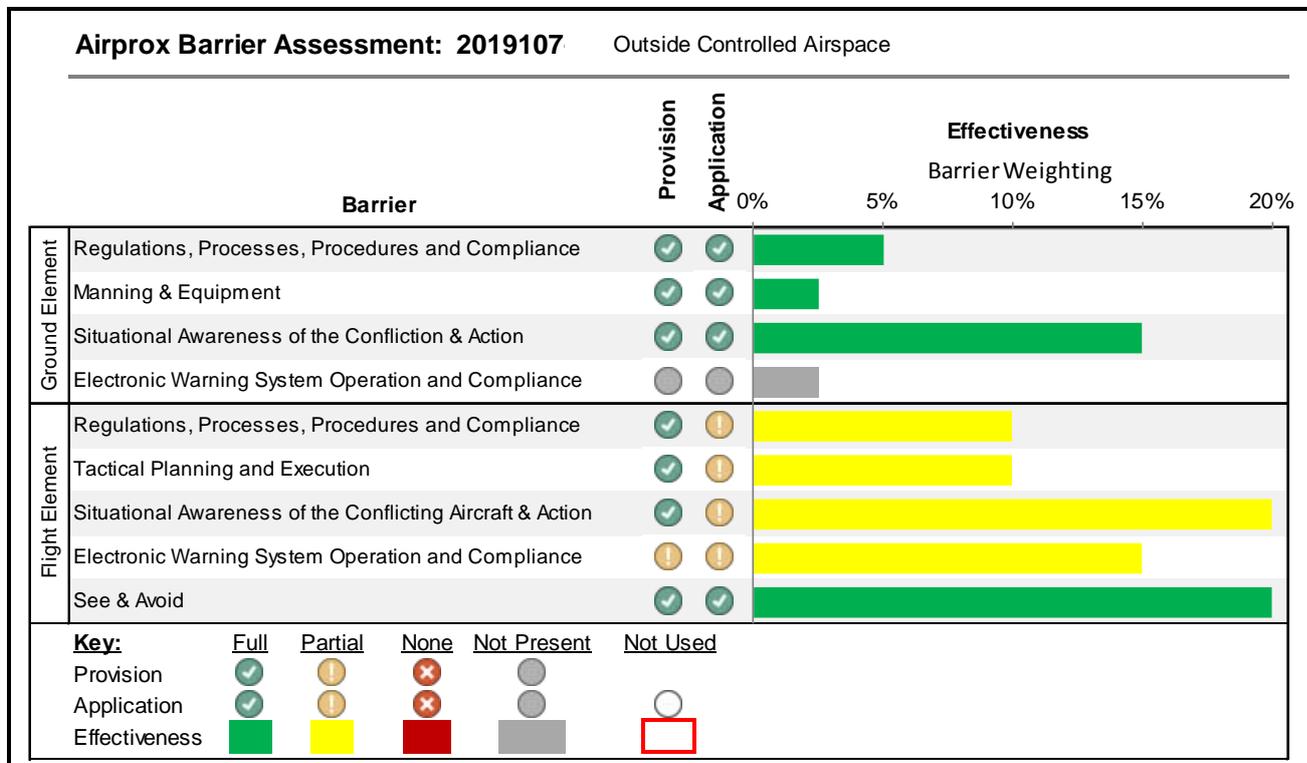
**Regulations, Processes, Procedures and Compliance** were assessed as **partially effective** because the Gnat pilot was flying slightly faster than an indicated airspeed of 250kt without being in receipt of a surveillance based Air Traffic Service.

**Tactical Planning and Execution** was assessed as **partially effective** because in his display planning the Gnat pilot had not ensured the prompt availability of a surveillance based Air Traffic Service for his return transit to base.

**Situational Awareness of the Conflicting Aircraft and Action** were assessed as **partially effective** because the Gnat pilot was not aware of the approaching AS355 but the AS355 pilot had been given Traffic Information on the Gnat, and it was displayed on his TAS, such that he was able to manoeuvre to reduce the risk of collision, albeit later than desirable due to their closure speed.

**Electronic Warning System Operation and Compliance** were assessed as **partially effective** because the Gnat did not have a TAS but the AS355 did.
