AIRPROX REPORT No 2019119

Date: 12 May 2019 Time: 1057Z Position: 5320N 00242W Location: 5NM E Liverpool airport

PART A: SUMMARY OF INFORMATION REPORTED TO UKAB

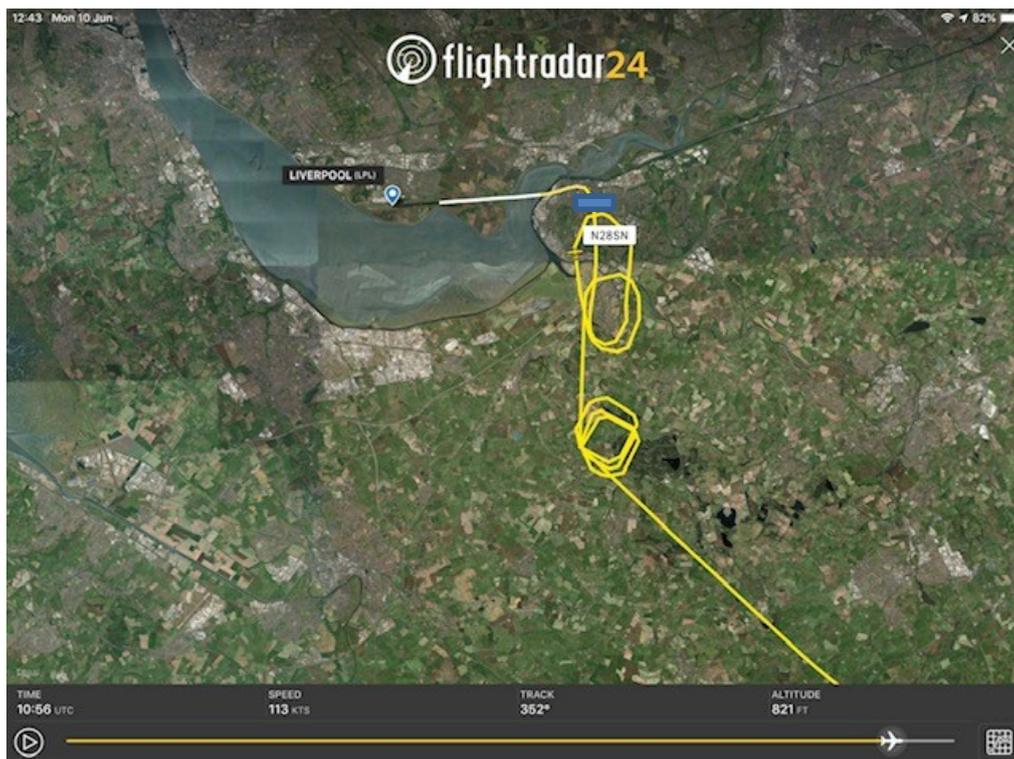
Figure 1. SR22's inbound track.

THE CIRRUS SR22 PILOT reports that he was asked to hold 2nm past the Oulton VRP and did 3 circuits in that location. He was then asked to move in 2nm and hold. He was approximately over Frodsham Visual Reference Point (VRP). The controller told him at this point to remain south of the M56 and he did this, although on the first turn at this VRP he drifted slightly over the M56 (a few 100m), this was as a result of a misjudgement. He carried out one circuit and then was told to follow base leg for RW27. He was then asked to 'change plans' and to move 1nm in and then do an orbit to hold again. He was about to start the turn for this hold when the controller asked him to take avoiding action and to do an immediate 180° turn. This he did, heading out to Frodsham VRP to hold again. At this point the controller made a comment that he had been asked to keep south of the M56. He decided to ignore this because with the 'change of plans' request he had asked him to come in on base 1nm which would, by definition, take him past the M56. He did see the aircraft on final but was following the ATC instructions as he understood them, to move 1nm further in on base and then take up an orbit. He did think it was close to IFR traffic but because he was on radar he thought this was what ATC wanted. He did not think it was a collision risk because he was about to turn for the orbit and he merely thought that ATC were getting him close in to the final approach path so that he would not hold up traffic when turning onto final following the landing IFR traffic. In his view there was little risk of collision because he was about to take up the orbit as requested and he had the aircraft in sight (also on TCAS). The controller asked him to orbit earlier than the 1nm requested, which he did. He commented that he flies into the airport frequently and mostly under IFR. It is often busy and he thought ATC were trying to keep him tight to traffic. The pilot provided a screenshot from Flightradar24 that showed his track (Figure 1).

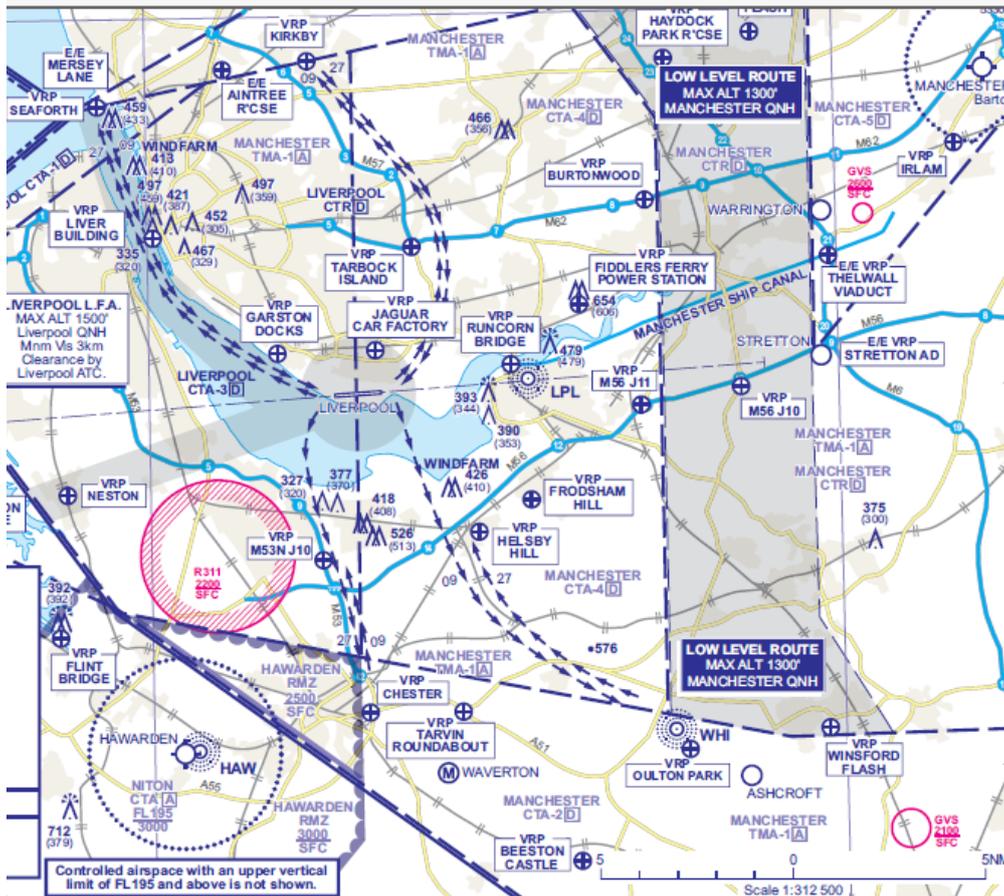
Figure 2. UK AIP AD 2-EGGP-4-1.

Figure 2 shows the relevant Liverpool AIP entry which denotes the various VRPs and visual inbound/outbound routes.

The Board was aware that both the Aerodrome and Radar controllers were very busy, with almost constant R/T loading. After clearing the SR22 pilot to enter the CTR, he was told to 'hold' at Delamere Forest. This was a position unknown to the SR22 pilot and which does not appear in Figure 2 (UK AIP AD 2-EGGP-4-1); the Board agreed that, as a result, the SR22 pilot could not be expected to know where Delamere Forest was. Having informed the controller of this, the controller then instructed the SR22 pilot to 'hold' in his current position and then to 'just orbit'. However, the Board felt that the initial use of the word 'hold' could have been misconstrued to mean 'adopt a racetrack pattern' and, noting that the pilot had remarked to the Radar controller that he would 'just hold here' and that his hold was '1min outbound', GA members opined that the SR22 pilot had likely used his navigation equipment to set up an automatic holding pattern rather than an orbit. This was compounded by him being further instructed to 'continue holding' and to contact the Tower frequency. In the SR22 pilot's mind, he was to continue flying racetrack 'hold' patterns and members opined that this was probably why he ended up routing further north and south of the controller's intended 'orbit' position.

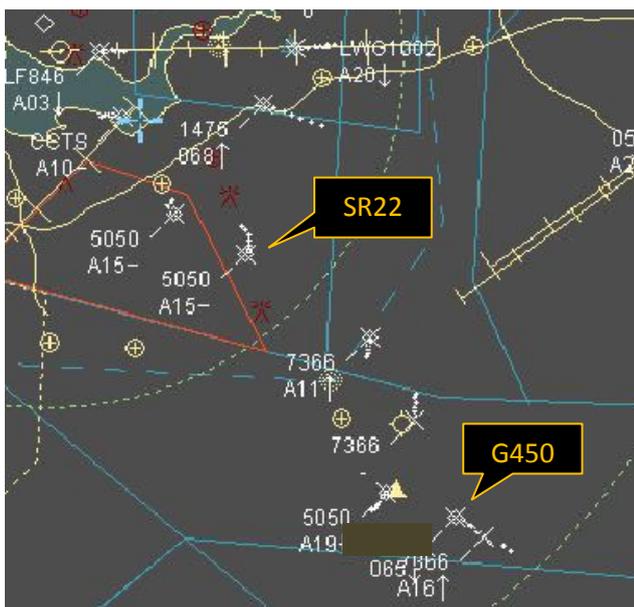
Figure 3 – 1047:20

At 1047:20 (Figure 3), the SR22 pilot checked in with the Aerodrome controller and advised that they were holding on base leg at 1500ft. The controller instructed the pilot to continue in the hold and asked the pilot if they were visual with the PA38 just to the north of them. The pilot responded that they did not have it visual but had it on TCAS.

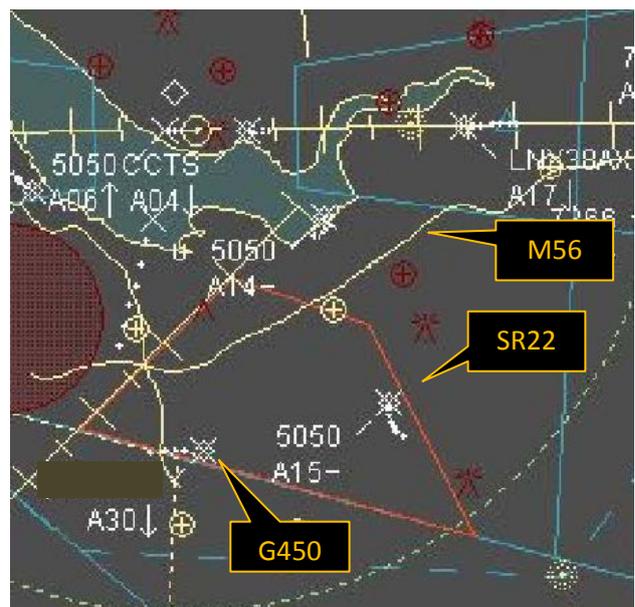
Figure 4 – 1052:10

When the SR22 pilot made their initial left-base call, the aircraft was approximately 7-8nm south of the airport. At this distance the aircraft was too far away for the controller to easily integrate it with IFR arriving aircraft on final approach so, at 1050:20 (Figure 4), the Aerodrome controller instructed the SR22 pilot to route *‘further north now, no further north than the M56’*. This was readback correctly by the pilot.

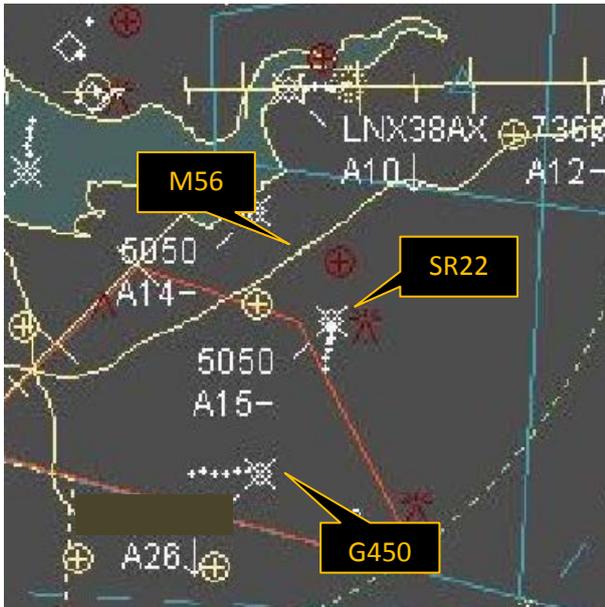
Figure 5 - 10:53.00

At 1053:00 (Figure 5), the Radar controller instructed the G450 pilot to descend to altitude 2500ft and passed Traffic Information to the pilot on the SR22, described as left 11 o'clock, range 4nm, maintaining at least 1000ft below. The pilot responded with, *‘OK descending to 2500 feet’*. The pilot was then instructed to turn left heading 080° and descend to altitude 2000ft.

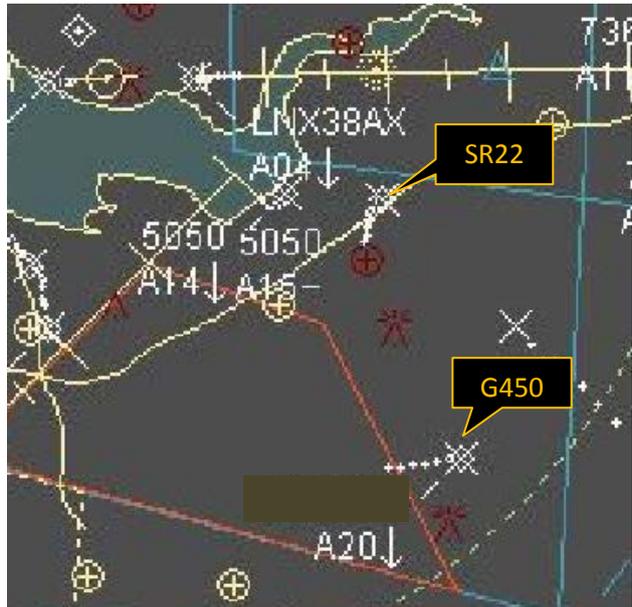
Figure 6 - 10:54.00

At 1054:00 the SR22 pilot had tracked north of the M56 and appeared to be continuing toward the final approach track so the Aerodrome controller asked the SR22 pilot if they could just stay south of the M56. The pilot responded with “yes OK I’ll stay south” (Figure 6).

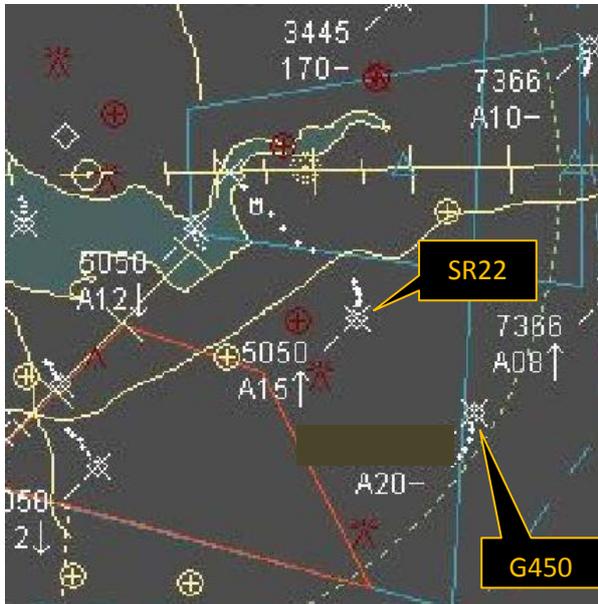
Figure 7 – 1054:53

At 1054:53 (Figure 7), the Radar controller instructed the G450 pilot to turn left heading 360° base leg and passed Traffic Information on an unrelated aircraft followed by Traffic Information on the SR22, described as in their left 10 o’clock, range 3nm, holding with the Tower, indicating 1500ft. The pilot responded that they were looking.

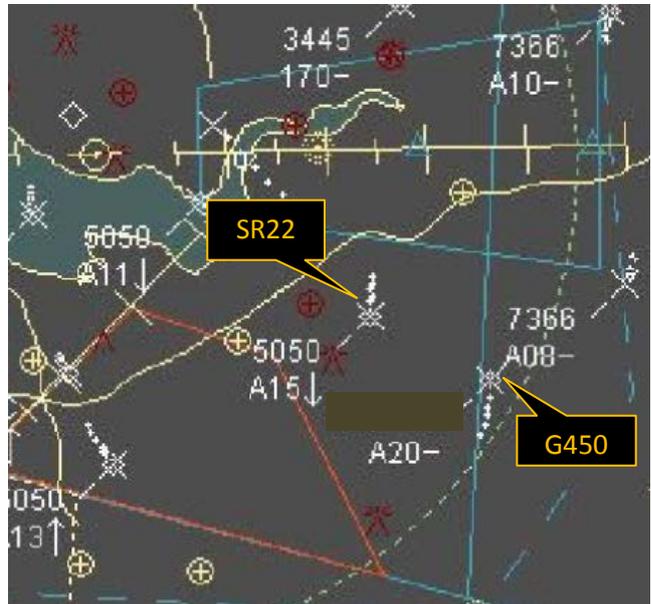
Figure 8 – 1055:00

At 1055:00 (Figure 8), the SR22 was again 6nm southeast of the Aerodrome, tracking south, with the G450 displayed as 9nm southeast of the airport. The Aerodrome controller instructed the SR22 pilot to report final and advised that they were No2 following a PA38 just coming up to the lighthouse now. The pilot provided a full and accurate readback.

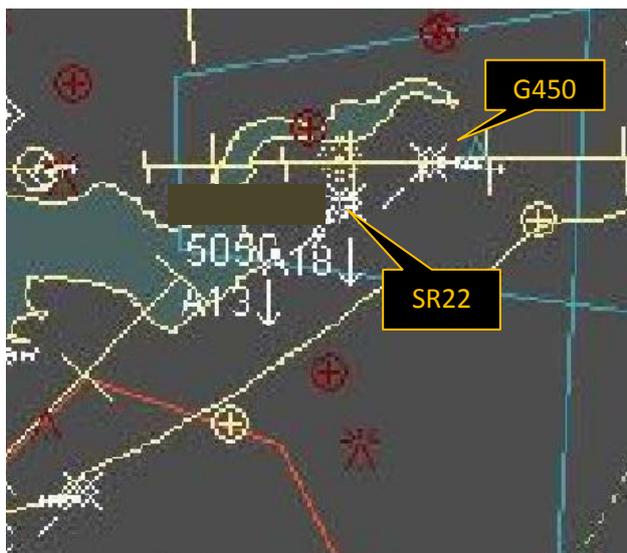
Figure 9 – 1057:20

At 1057:20 (Figure 9), the Aerodrome controller issued avoiding action to the SR22 pilot, *“Avoiding action turn right now heading 180 degrees, turn right now heading 180 degrees, Avoiding action.”* The pilot responded *180 degrees [C/S]”*. The controller repeated *“heading 180 degrees now please, 180 degrees”*. The pilot responded with their callsign.

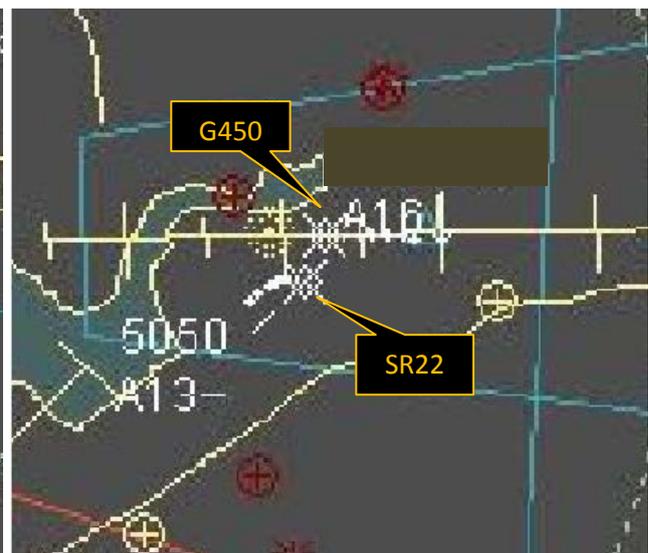
Figure 10 – 1057:35

CPA could not be measured using the Liverpool Radar recording but the Radar Analysis Cell synopsis using NATS radars stated that CPA occurred at 1057:35 (Figure 10), with the aircraft separated by 0.6nm laterally and 300ft vertically.
