AIRPROX REPORT No 2019326

Date: 03 Dec 2019 Time: 1439Z Position: 5332N 00041W Location: North Moor airfield

PART A: SUMMARY OF INFORMATION REPORTED TO UKAB

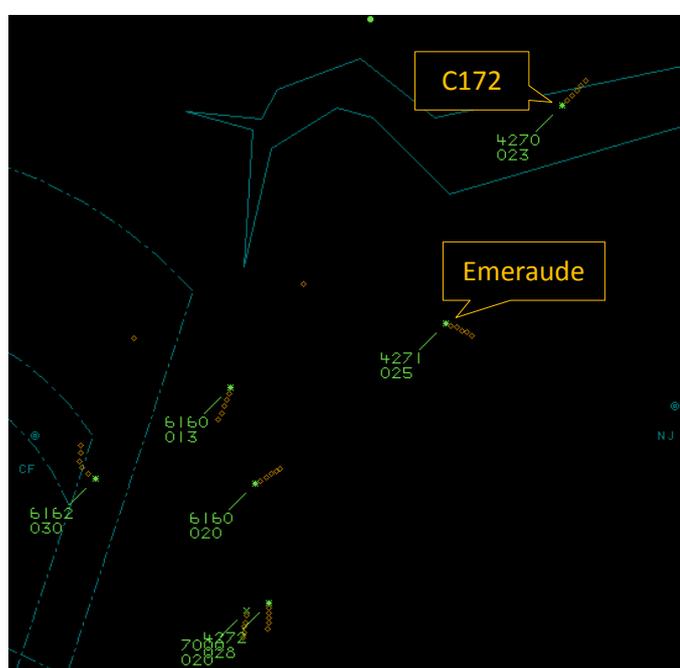
Figure 1 – 1429:50

At 1429:50 the Emeraude pilot, who had been receiving a Basic Service from Humberside Radar since 1415:56, advised the Humberside controller that they were returning to North Moor, remaining to the north and west of Scunthorpe, which the controller acknowledged (Figure 1).

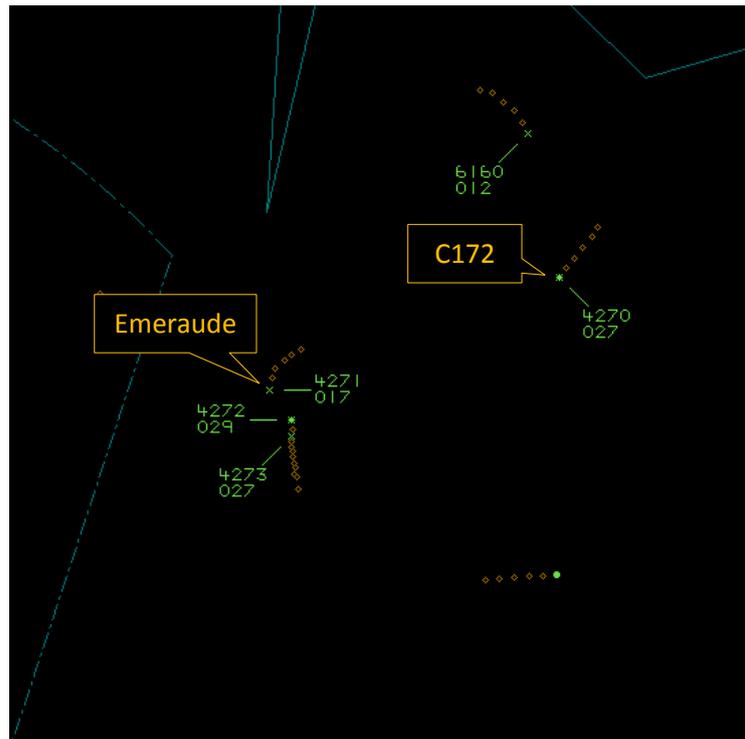
Figure 2 – 1434:58

At 1434:58 the Emeraude pilot advised the Humberside controller that they were visual with North Moor, were changing frequency and would squawk 7000 which the controller acknowledged (Figure 2).

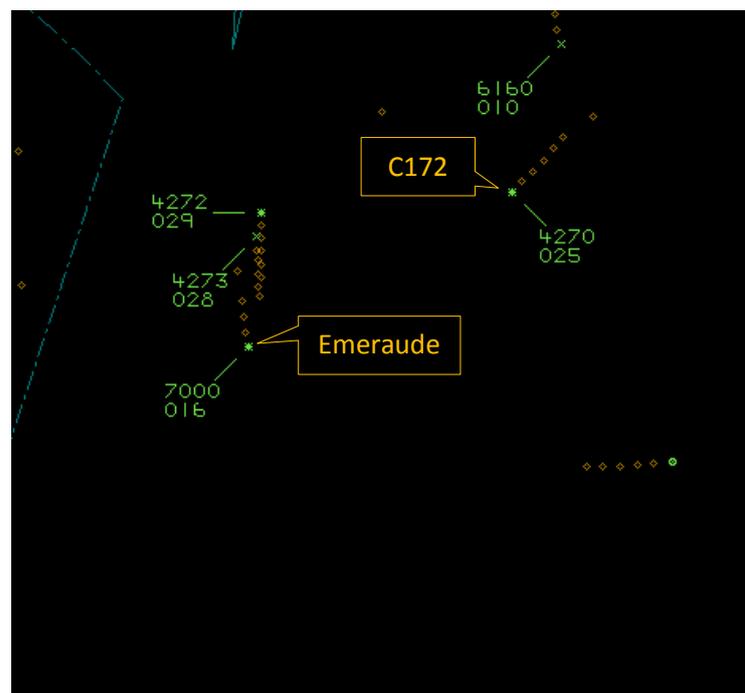
Figure 3 – 1435:45

At 1435:45 (Figure 3), the C172, flown by a student pilot who was completing a solo navigational training exercise, and who had also been with Humberside Radar for some time, reported being overhead Scunthorpe and requested a frequency change to Doncaster which was approved by the Humberside controller.

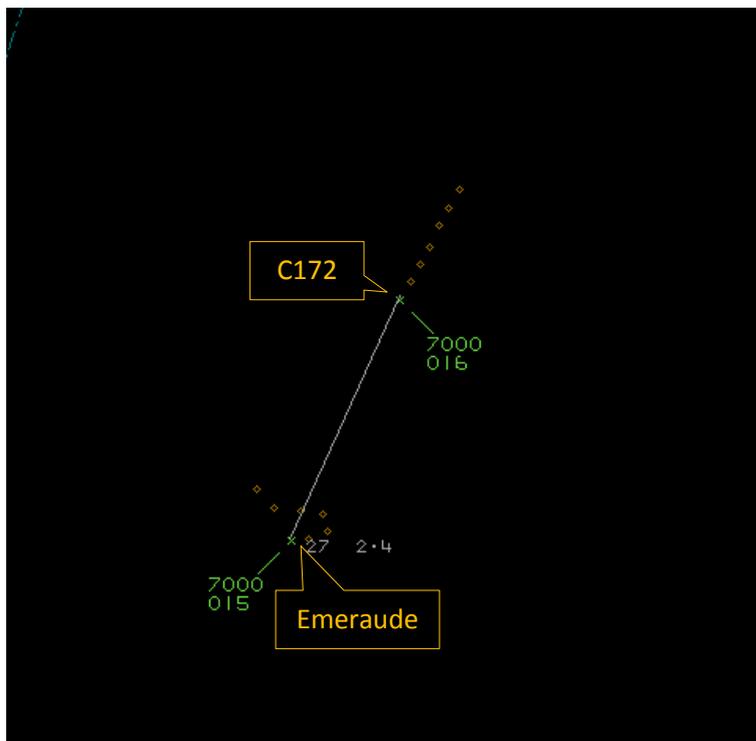
Figure 4 – 1438:00

At 1438:00 the C172 made their initial call to Doncaster Radar (Figure 4).

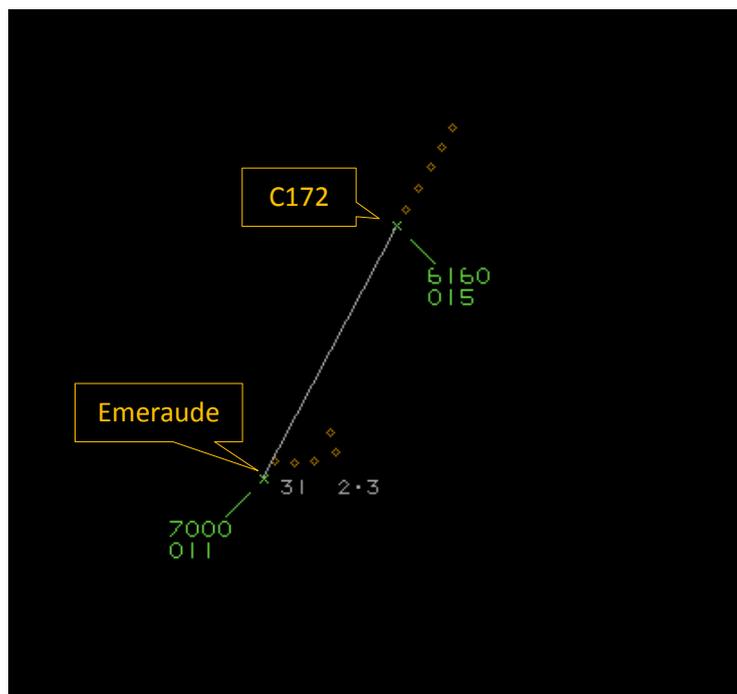
Figure 5 – 1438:20

The Doncaster radar controller allocated a squawk, confirmed that they would provide a Basic Service and asked the C172 to pass their message. The C172 read back the squawk and service and reported being at Scunthorpe. They requested a re-join via Haxey, a VRP to the east of Doncaster-Sheffield. The controller acknowledged this and immediately, at 1438:20, advised the C172 that “*there is traffic at North Moor indicating 1400ft*”. They then issued the C172 pilot a joining clearance via Haxey, not above 2000ft VFR. The C172 pilot read back the clearance but did not acknowledge the Traffic Information passed by the controller (Figure 5).

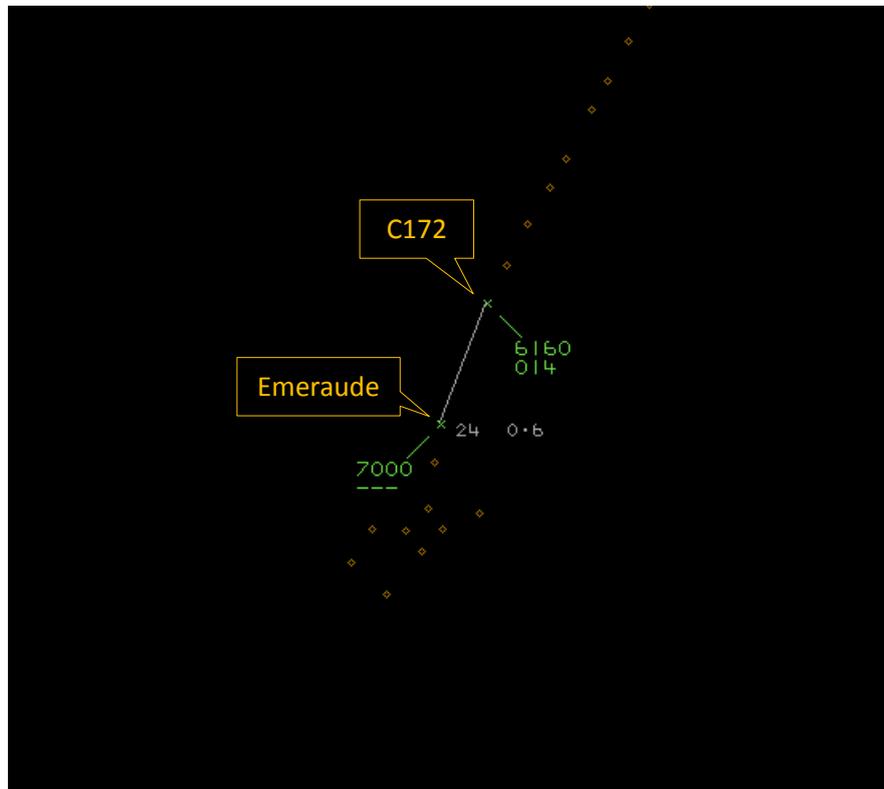
Figure 6 – 1438:58

The C172 then continued a south-westerly track, (Figures 6), with CPA estimated, (due to the slow sweep-rate of area radar), to occur at 1439:15 (Figure 7).

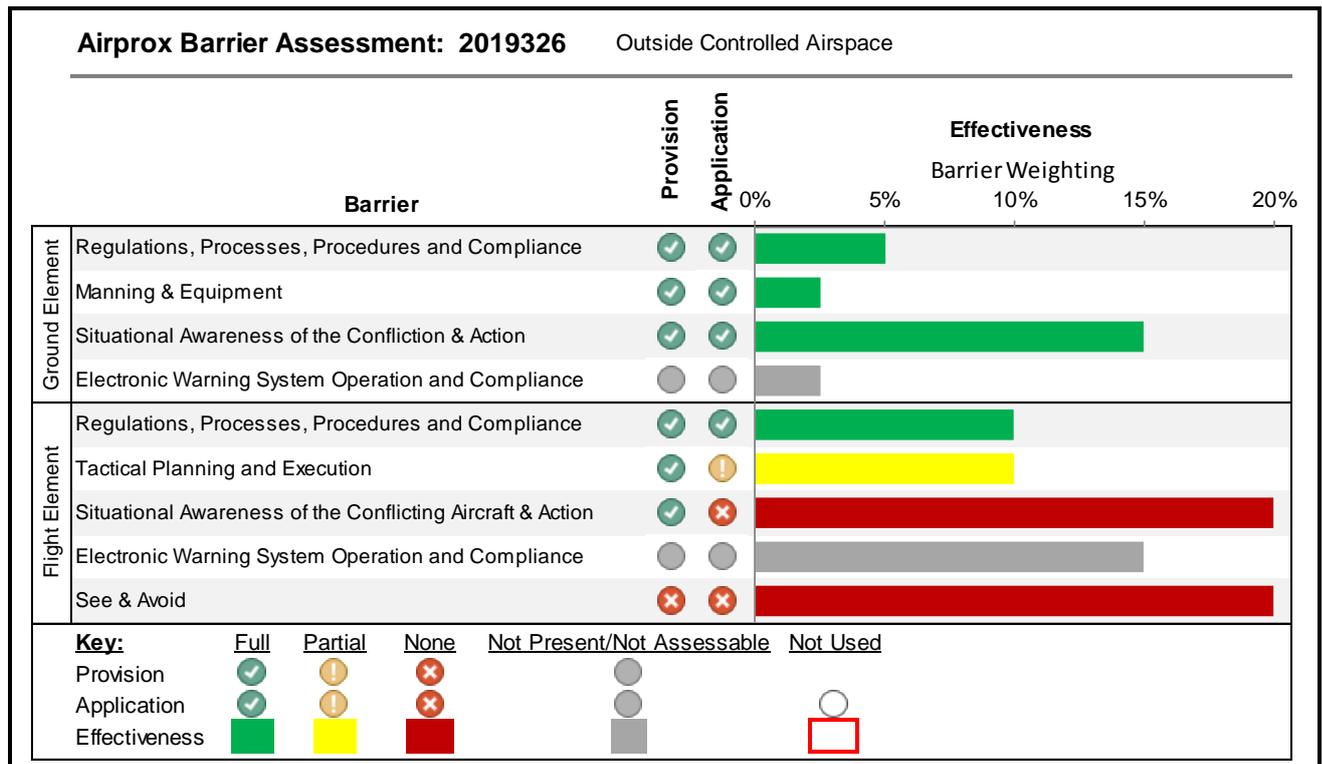
See and Avoid were assessed as **ineffective** because the C172 pilot did not see the Emeraude and the Emeraude pilot saw the C172 at such a late stage that he could not increase separation at CPA, effectively a non-sighting.
