AIRPROX REPORT No 2019184

Date: 05 Jul 2019 Time: 1605Z Position: 5114N 00040W Location: 2nm W Guildford

PART A: SUMMARY OF INFORMATION REPORTED TO UKAB

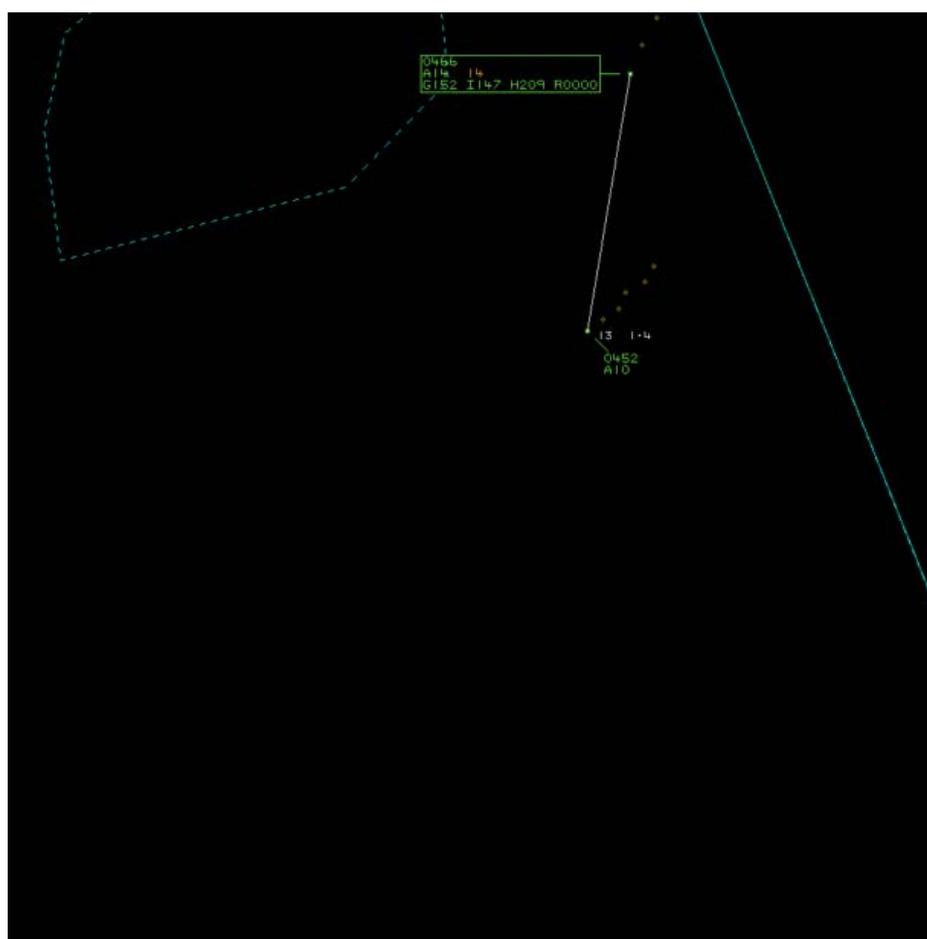
Figure 1 1604:15. SR22 0466; C152 0452.

The following screen-shots were taken from the NATS radar recording of the incident.

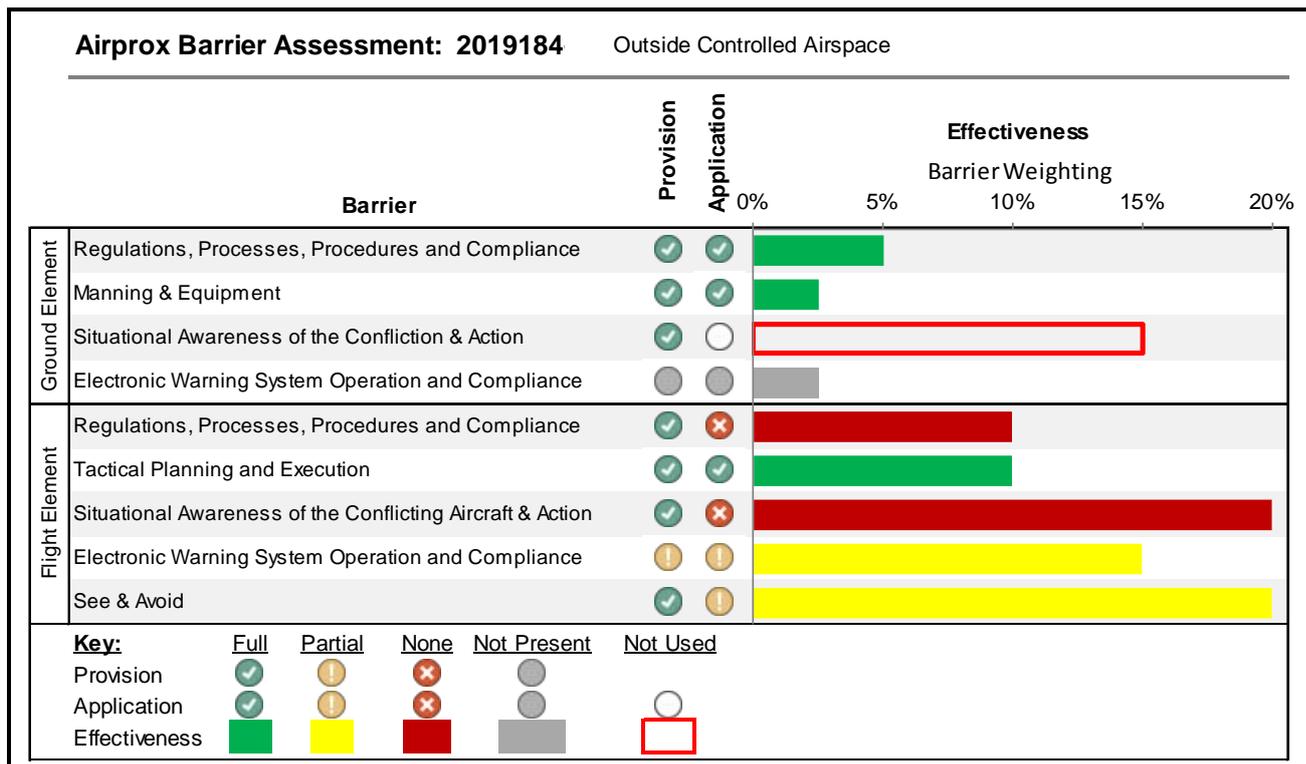
Electronic Warning System Operation and Compliance were assessed as partially available because only the SR22 was equipped with an electronic warning system. They were only **partially effective** because, although the SR22 pilot had received a TAS alert at 2nm and was therefore aware of the C152, he still passed close to the C152 whilst overtaking.

See and Avoid were assessed as **partially effective** because although the SR22 pilot saw the C152 in good time, he still flew into close proximity whilst overtaking.
