**AIRPROX REPORT No 2020038**

Date: 20 May 2020 Time: 1603Z Position: 5206N 00053E Location: 3NM SW Wattisham

**PART A: SUMMARY OF INFORMATION REPORTED TO UKAB**

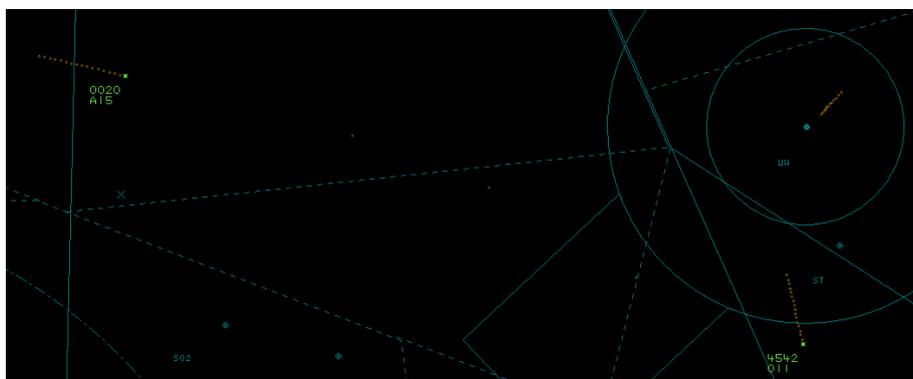
1: 1555:30 – EC145 (0020) MATZ penetration approved

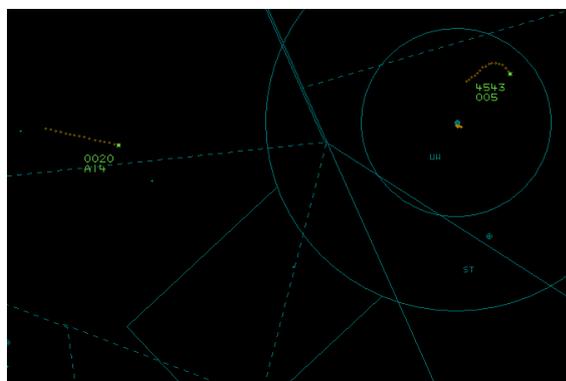
2: 1559:47 – Apache cleared for T/O

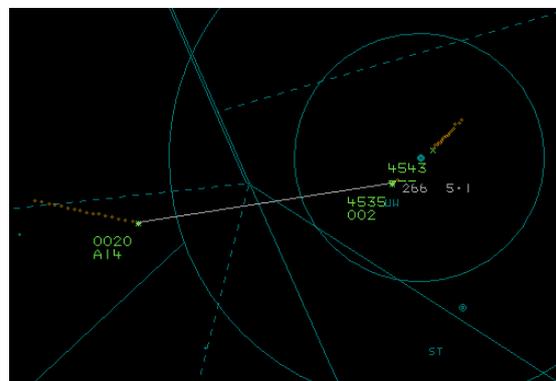
3: 1601:26 – TI on EC145 passed to Apache (4535) (TI on Apache passed to EC145 at 1602:00)

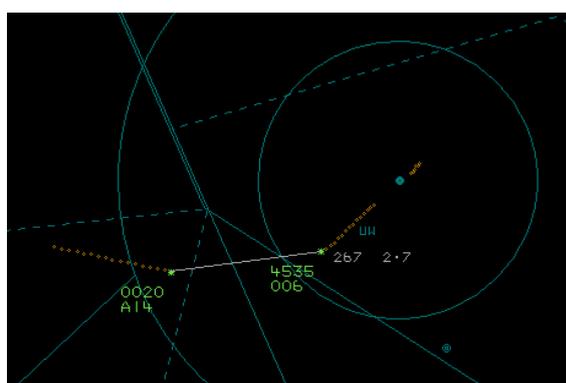
4: 1602:14 – Apache pilot reports EC145 in sight

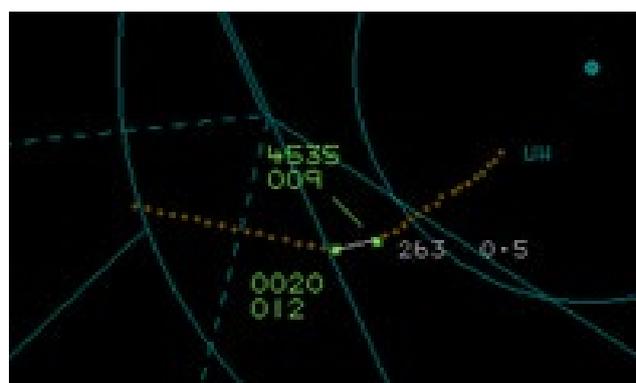
5: 1602:55 – Apache pilot reports EC145 in sight, maintaining 800ft with the 'Helimed above'
