AIRPROX REPORT No 2020137

Date: 29 Sep 2020 Time: 1220Z Position: 5214N 00108W Location: Newnham

PART A: SUMMARY OF INFORMATION REPORTED TO UKAB

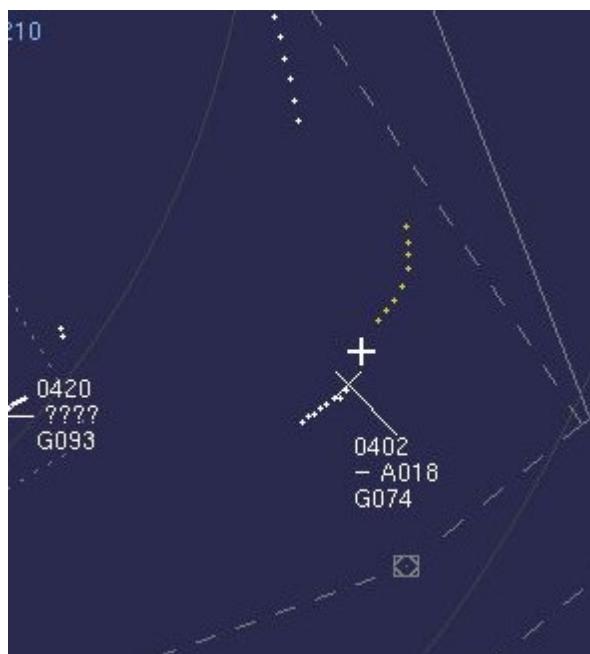
Figure 1

The Cabri G2 was receiving a Basic Service with Birmingham radar. The Cabri G2 pilot stated that they wished to report an Airprox. Figures 1 and 2 show the Cabri G2 (squawk 0402) passing a contact with no transponder information available. The controller took the Airprox details and informed the Cabri G2 pilot that they will file a report and that the pilot will need to file an Airprox report when they land. The second aircraft was believed to be a Vampire aircraft.

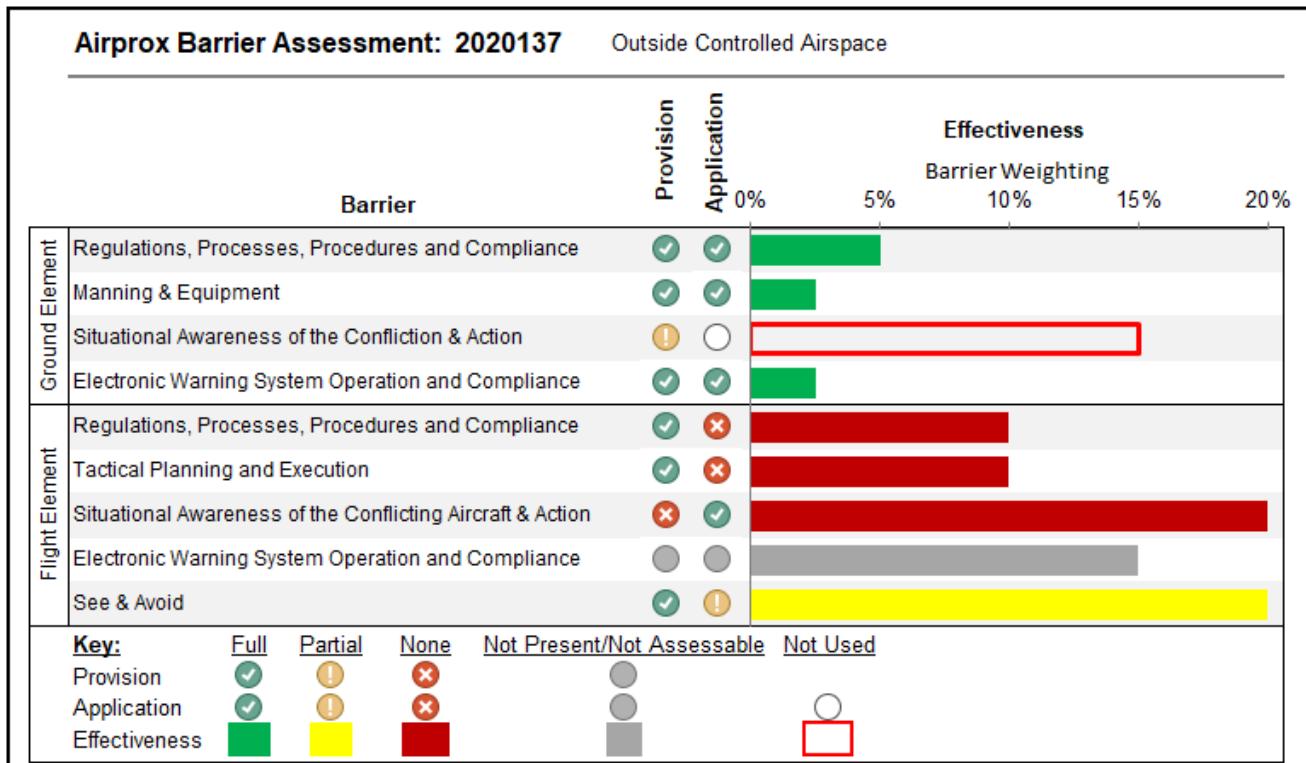
Situational Awareness of the Conflicting Aircraft and Action were assessed as **ineffective** because neither pilot had any information regarding the other aircraft.

See and Avoid were assessed as **partially effective** because the Vampire pilot reported seeing the Cabri G2 at 5NM but flew within 0.1NM of the Cabri G2. The Cabri G2 pilot saw the Vampire late due to the aircraft's colour scheme and the cloud cover.
