AIRPROX REPORT No 2020120

Date: 10 Sep 2020 Time: 1431Z Position: 5201N 00109W Location: Hinton-in-the-Hedges

PART A: SUMMARY OF INFORMATION REPORTED TO UKAB

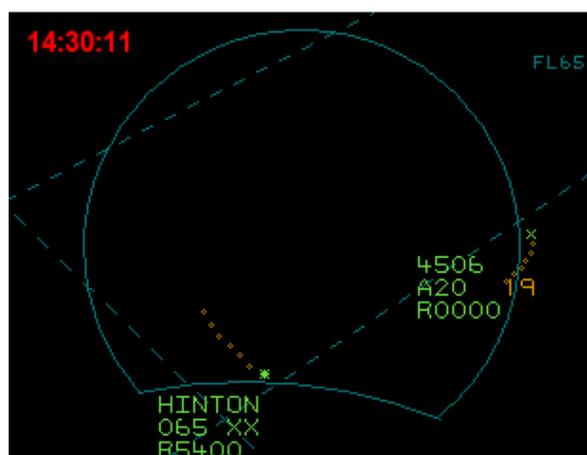
Figure 1

Having released the paradroppers, the P750 left CAS by descent at 1430:11 (Figure 1). At 1430:12 the pilot reported, "[P750 C/S], *descending,*" to which the TC Midlands controller responded, "[C/S]*thanks, speak to you later.*"

The pilot of [P68 C/S] reported that the event took place to the West of the Hinton Paradropping area, however this occurred to the south east of the 1.5NM area as defined within the UK AIP. The boundary marked within Figures 1 and 2 above related to an extended 3NM area used within TC Midlands procedures. The pilot of the P750 submitted a corresponding Airprox report, which noted that they did not see the conflicting traffic and so were unaware of the close proximity to the P68. Upon leaving CAS, the TC Midlands controller did not advise the pilot of the P750 that their radar service was terminated, however given that the P750 pilot was asked to report leaving CAS and reported within one second of leaving, the pilot was aware of the change of class of airspace. Given the nature of the Hinton Paradropping activity and the regularity of such flights, the pilot was aware of the see-and-avoid nature of the airspace they were frequently operating in. Notwithstanding the above, the requirement to advise the pilot that radar services were terminated has been brought to the attention of the watch Competency and Proficiency Coordinator. This event occurred in Class G airspace with both pilots being aware of the requirements of Class G airspace with regards to separation.

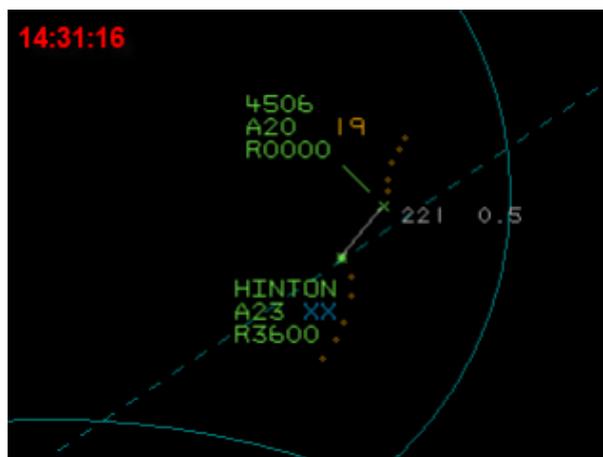
Figure 2

A P68, was operating a survey flight and the pilot was in communication with Oxford ATC, displaying Mode A 4506. The pilot submitted an Airprox report to the UK Airprox Board. The closest point of approach between the P750 and the P68 occurred at 1431:16 and was measured on the LTC Multi-Track Radar as 0.5NM and 300ft (Figure 2).

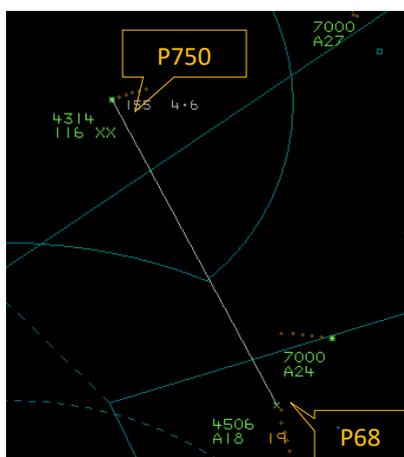
Figure 3 – 1427:30

At 1427:30 the controller passed Traffic Information: *“traffic 12 o’clock, 4 miles, at Flight Level 110, believed to be the paradropping aircraft from Hinton-in-the-Hedges.”* The pilot responded that they would be looking out.

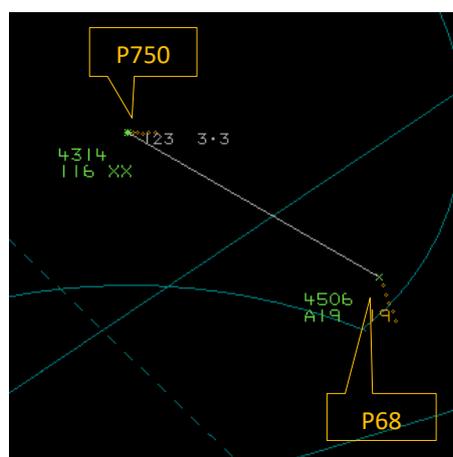
Figure 4 – 14:28.54

At 1428:54 the controller passed further Traffic Information, *“the paradropping aircraft, left 10 o’clock, 3 miles, now descending, believed with the Para droppers underneath it.”* The pilot responded, *“looking out.”*

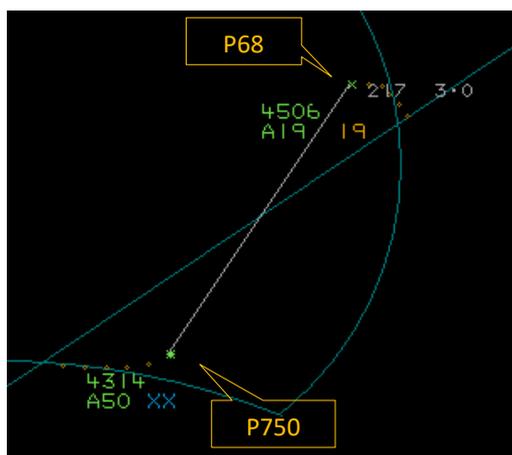
Figure 5 – 1430:40

At 1430:40 the controller passed further Traffic Information, *“paradropping aircraft southwest, 2 miles, in a wide left turn back towards north easterly, at 4900ft descending.”* The pilot responded, *“copied that and I have the parachute jumpers in sight as well.”* (Figure 5).

The pilot responded to the last set of Traffic Information at 1430:41 with the words “*copied that and I have the parachute jumpers in sight as well.*” The words “*as well*” used at the end of the pilot’s response may have been interpreted by the controller as the pilot having the parachutists in sight as well as the para dropping aircraft when the aircraft were still 3NM apart. However, the P68 pilot confirmed in their report that they had the para jumpers in sight at this point but that they did not gain sight of the para dropping aircraft until there was an estimated 500 or 600m between them, and that the late sighting may have been as a result of the P750 being in a steep descent above them.

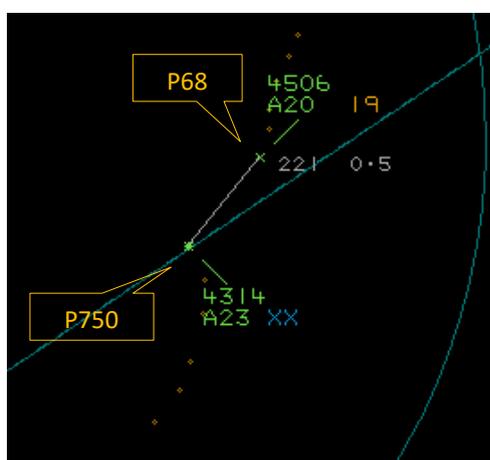
Figure 6 – 1431:16 CPA

At 1431:16 CPA occurred, with the aircraft separated by 0.5NM laterally and 300ft vertically (Figure 6).

In determining the risk, members quickly agreed that the separation was such that there had been no risk of collision. Some members thought that safety had been degraded because neither pilot had seen the other aircraft in time to take avoiding action. However, others thought that the separation, at 0.5NM, meant that normal safety procedures pertained. A discussion followed, but in the end the latter view prevailed; Risk Category E.
