AIRPROX REPORT No 2020164

Date: 19 Nov 2020 Time: 1213Z Position: 5556N 00343W Location: 4NM S of Falkirk

PART A: SUMMARY OF INFORMATION REPORTED TO UKAB

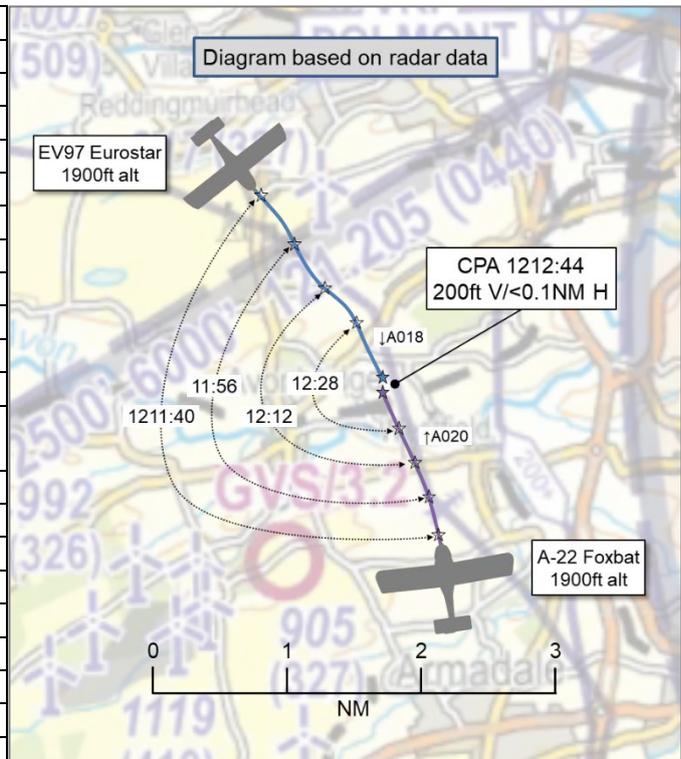
Recorded	Aircraft 1	Aircraft 2
Aircraft	EV97 Eurostar	A-22 Foxbat
Operator	Civ FW	Civ FW
Airspace	Scottish FIR	Scottish FIR
Class	G	G
Rules	VFR	VFR
Service	None ¹	Basic ²
Provider	Edinburgh App	Edinburgh App
Altitude/FL	FL014	FL016
Transponder	A, C, S	A, C, S
Reported		
Colours	Blue/silver	Orange
Lighting	Wingtip strobes	Strobes, nav, landing light
Conditions	VMC	VMC
Visibility	40NM	NR
Altitude/FL	1800ft	1900ft
Altimeter	QNH (1027hPa)	NK
Heading	155°	340°
Speed	82kt	85kt
ACAS/TAS	Not fitted	Unknown
Separation		
Reported	200ft V/200m H	400ft V/1NM H
Recorded	200ft V/<0.1NM H

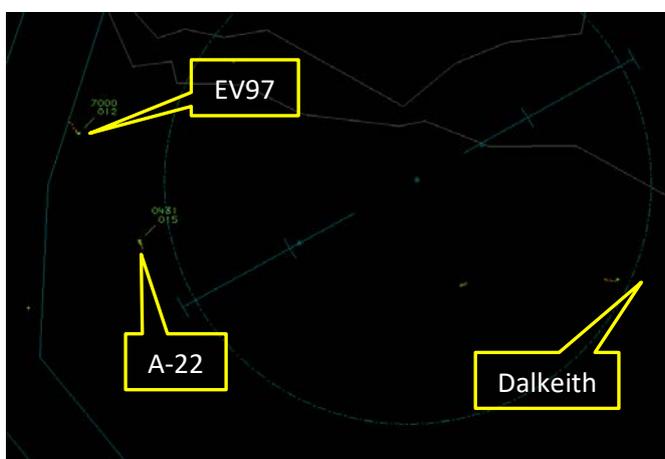
Figure 1 – 1210:55

The EV97 initially appeared as a primary-only contact on the area radar replay used for this investigation. The Edinburgh unit investigation report provided a snapshot of their radar showing the EV97 with a Scottish Information transponder code at **1204:08**, passing to the west of Stirling, tracking southeast at an altitude of 2800ft, coincidental with the airborne call from the second aircraft out of [the local airfield]. The pilot of the second [local airfield] aircraft reported leaving controlled airspace at Dalkeith at **1210:55** which was acknowledged by the controller. The EV97 was 5NM northwest of the A-22 at this time (Figure 1). At **1212:11** the EV97 pilot called the controller (Figure 2).

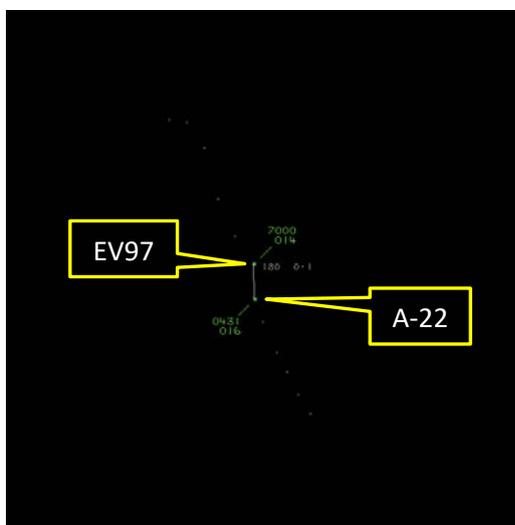
Figure 3 – 1212:45 – CPA

The EV97 pilot continued; “we’re a Eurostar EV97, current position three miles southwest of Polmont (VRP) and...”. The transmission stopped at **1212:29**. There was a gap in transmissions before the Edinburgh controller replied at **1212:45** (Figure 3), advising that they would provide a Basic Service and passed the Edinburgh QNH, during which CPA occurred. The EV97 was observed to have initiated a descent and passed below (200ft) and to the east (0.1NM) of the A-22 (Figure 4).

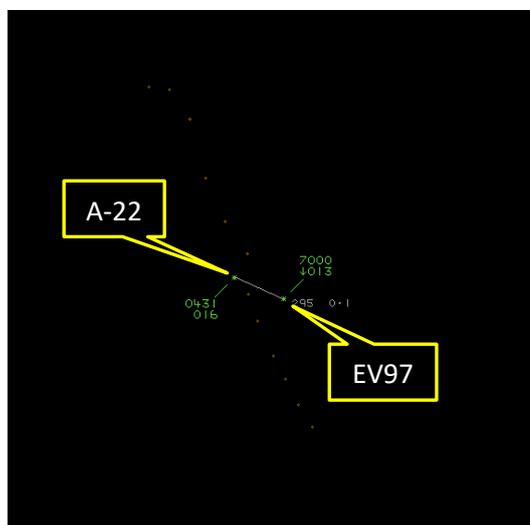
Figure 4 – 1212:48

The pilot of the EV97 then reported to Edinburgh “*sorry, we just had to take avoiding action for an oncoming aircraft*”.
