AIRPROX REPORT No 2021016

Date: 14 Mar 2021 Time: 1139Z Position: 5124N 00021E Location: 8NM NE Biggin Hill

PART A: SUMMARY OF INFORMATION REPORTED TO UKAB

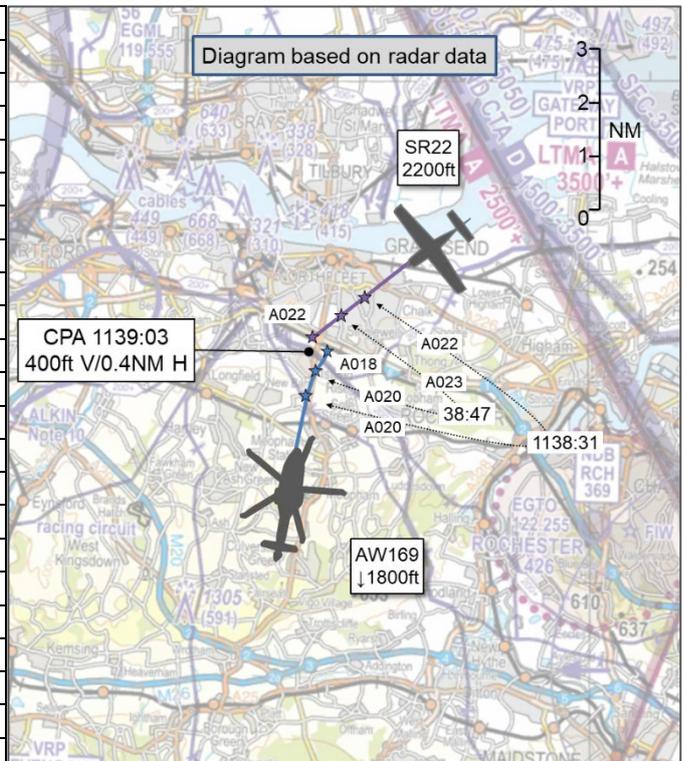
Recorded	Aircraft 1	Aircraft 2
Aircraft	AW169	SR22
Operator	HEMS	Civ FW
Airspace	London FIR	London FIR
Class	G	G
Rules	VFR	VFR
Service	Traffic	Basic
Provider	Thames Radar	Biggin Hill
Altitude/FL	1800ft	2200ft
Transponder	A, C, S	A, C, S
Reported		
Colours	White, Blue	White
Lighting	Strobes, HISLs	Strobes
Conditions	VMC	VMC
Visibility	>10km	>10km
Altitude/FL	2000ft	2096ft
Altimeter	QNH	NK
Heading	360°	270°
Speed	100kt	140kt
ACAS/TAS	TCAS II	TAS
Alert	RA	TA
Separation		
Reported	200ft V/1NM H	1000ft V/1NM H
Recorded	400ft V/0.4NM H

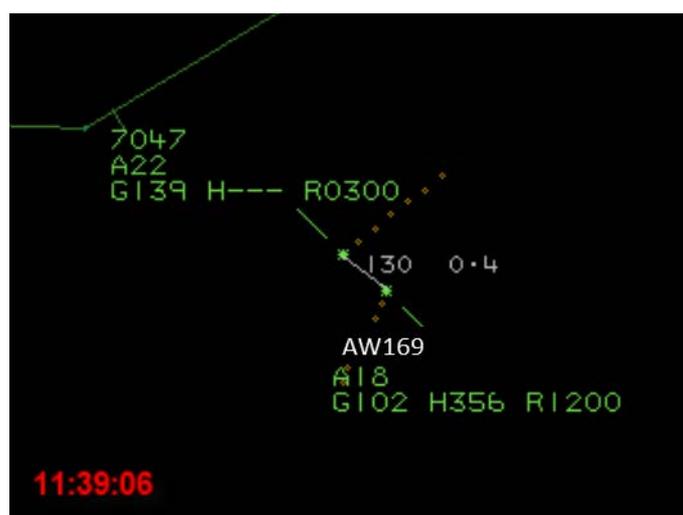
Figure 2

Whilst speaking to the Biggin Hill controller, at 1138:52 the pilot of [AW169 C/S] reported "unable to comply due to TCAS RA, levelling now". There was no response from the Thames Radar controller, indicating that this may not have been heard due to the telephone conversation taking place at the time of the event. The controller's report stated that 'the controller did not give avoiding action as the aircraft were both outside controlled airspace in Class G and in addition the [AW169 C/S] had reported visual with the traffic.' The closest point of approach between [the AW169] and [the SR22] occurred at 1139:06 and was measured on Multi-Track Radar as 0.4NM and 400ft (Figure 2).

There were no separation requirements between the two aircraft. The incident was resolved by the TCAS RA increasing the vertical distance between the two aircraft.
