AIRPROX REPORT No 2021039

Date: 23 Apr 2021 Time: 1440Z Position: 5254N 00102W Location: Nottingham

An Airprox was reported when a Bulldog and an AA5 flew into proximity 3NM southeast of Nottingham at 1440Z on Friday 23rd April 2021. Both pilots were operating under VFR in VMC and both were in receipt of an AGCS from Nottingham.

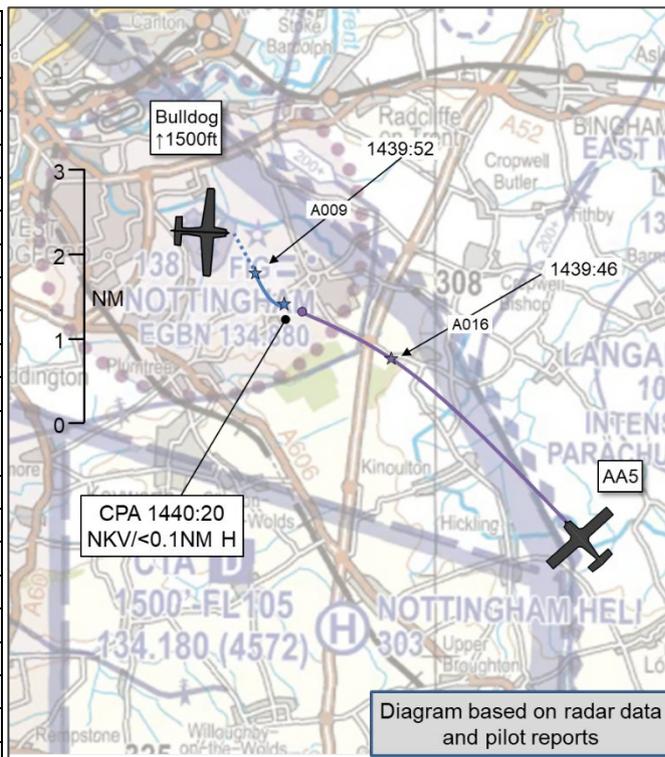
Recorded	Aircraft 1	Aircraft 2
Aircraft	Bulldog	AA5
Operator	Civ FW	Civ FW
Airspace	Nottingham ATZ	Nottingham ATZ
Class	G	G
Rules	VFR	VFR
Service	AGCS	AGCS
Provider	Nottingham	Nottingham
Altitude/FL	1400ft	NK
Transponder	A, C	A, C, S
Reported		
Colours	Silver, Blue	White, Red
Lighting	Taxi, Landing	Nav, Beacon, Landing
Conditions	VMC	VMC
Visibility	>10km	>10km
Altitude/FL	1500ft	1500ft
Altimeter	QNH	QFE (1024hPa)
Heading	145°	325°
Speed	115kt	NK
ACAS/TAS	SkyEcho	Not fitted
Alert	None	N/A
Separation		
Reported	2-300ft V/0m H	2-300ft V/0m H
Recorded	NK V/ <0.1NM H

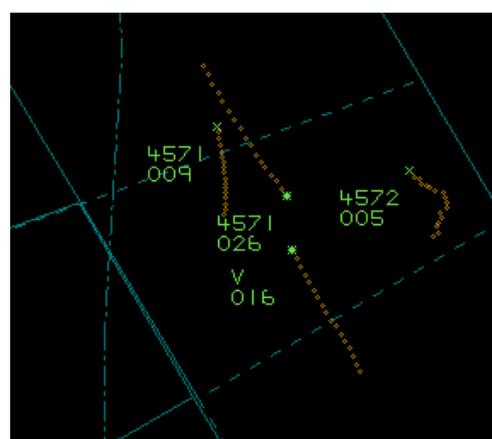
Figure 2: 1435:35

The AA5 squawk changed to 7000, indicating that the pilot had changed to their en-route frequency and descended to 1600ft. The unknown traffic climbed to 2600ft (Figure 2) and the two aircraft crossed shortly afterwards.
