AIRPROX REPORT No 2021058

Date: 26 May 2021 Time: 1156Z Position: 5124N 00125W Location: 3.5NM W Newbury

PART A: SUMMARY OF INFORMATION REPORTED TO UKAB

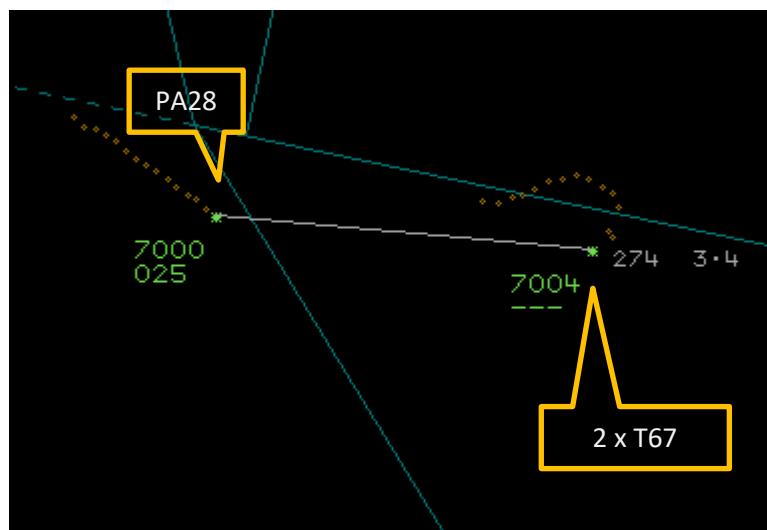
Figure 1:1155:37

Neither pilot was receiving an ATS, however, GPS data provided by the PA28 meant that the aircraft could be identified on the NATS area radars even though none of the aircraft were fitted with Mode S. At 1155:37 (Figure 1) the PA28 was squawking 7000 (the pilot did not change to a Farnborough listening squawk until after the Airprox) and indicated 2500ft. The lead T67 was squawking 7004, but Mode C was not displayed, and did not display for the duration of the Airprox.

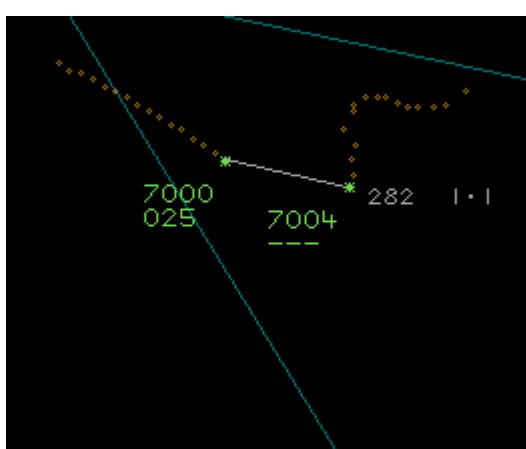
Figure 2: 1156:31

By 1156:31 (Figure 2) the T67 formation had crossed in front of the PA28 at a range of 1NM, before turning onto a westerly heading. Figure 3 was generated using the single source Clee Hill radar and has less ‘smoothing’ of the PA28’s track. The two tracks closed to a separation of 0.1NM (Figure 4) when the T67 formation passed down the right-hand-side of the PA28. Due to the lack of Mode C data from the T67s, the vertical separation could not be ascertained.
