AIRPROX REPORT No 2021191

Date: 21 Sep 2021 Time: 1525Z Position: 5249N 00121E Location: 10NM north Norwich

PART A: SUMMARY OF INFORMATION REPORTED TO UKAB

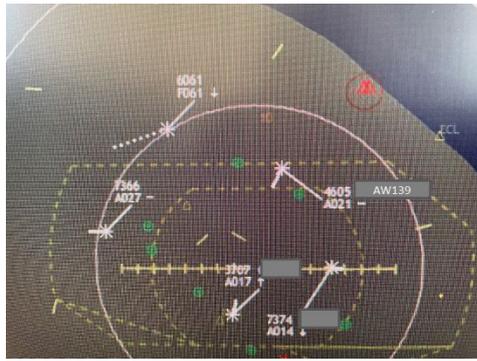
Figure 1:1523:30 – Traffic Information passed

[AW139 C/S] was receiving a Traffic Service in VMC in Class G airspace north of Norwich CAS having departed Norwich Airport en-route to the North Sea, the ATCO gave [AW139 C/S] Traffic Information on a single fast-jet to the north west at 6NM and 4000ft above. The ATCO continued to monitor the fast jet and updated the Traffic Information 45sec later at which point the pilot of [AW139 C/S] elected to descend to 1500ft to avoid the potential confliction. The ATCO then rang RAF(U) Swanwick to establish the fast jet's intentions and was informed that the Typhoon was operating in the block 'surface to 20,000ft' the ATCO asked if it was a singleton; this information was confirmed by RAF(U) Swanwick and passed to the pilot of [AW139 C/S]. The Typhoon transited north of the AW139 and once the AW139 reached the coastline reported to the Norwich ATCO that they would be filing an Airprox.

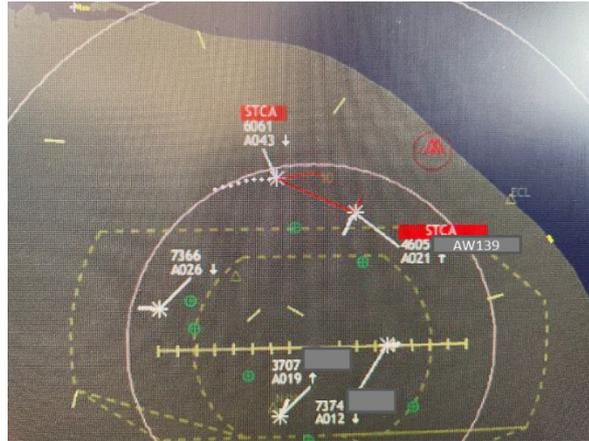
Figure 2: 1524:15 – Traffic Information updated

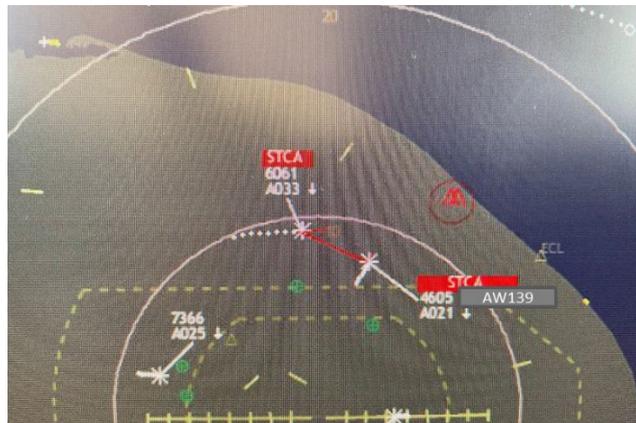
Figure 3: 1524:30 – Call to Swanwick(Mil)

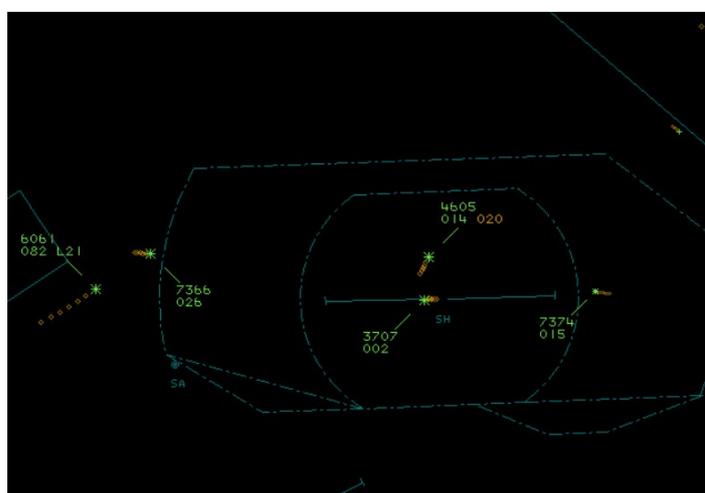
Figure 5

At **1521:30** the AW139 pilot (squawk 4605) called Norwich Radar on departure, passing 1900ft. The Norwich Radar controller instructed them to climb to 2000ft on the Yarmouth RPS and advised that it would be a Traffic Service on leaving controlled airspace which was read back correctly by the pilot. The Typhoon (squawk 6061) was 15NM west of Norwich at this time.

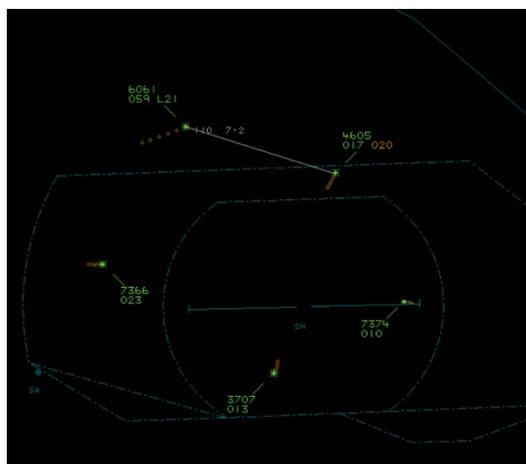
Figure 6

At **1523:37** the Norwich controller passed the following Traffic Information; *“there is traffic er in your, correction, west of you now range of 6 miles, fast moving, believed to be military fast jets crossing left to right, currently they are indicating FL57 but they are descending”*. The pilot replied; *“er roger – looking”*:

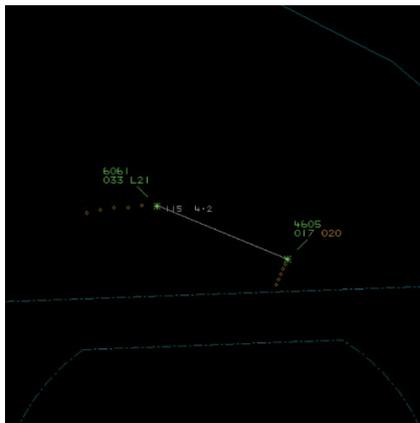
Figure 7

At **1524:12** the Norwich controller passed updated Traffic Information: *“that traffic now in your left, 9 o’clock – 4 miles, crossing left to right, still fast moving, 2000ft above but descending”*. The pilot requested to drop to 1500ft which was approved by the controller:

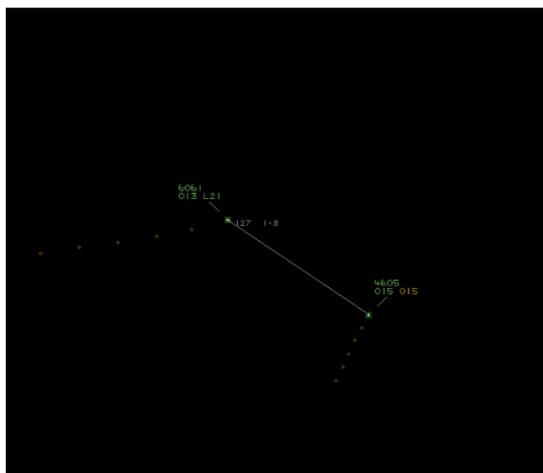
Figure 8

At **1524:30** the controller again updated the Traffic Information: *“that traffic now in your left 10 o’clock 2 miles, manoeuvring (???) currently at a similar level just turning to the north east”*:

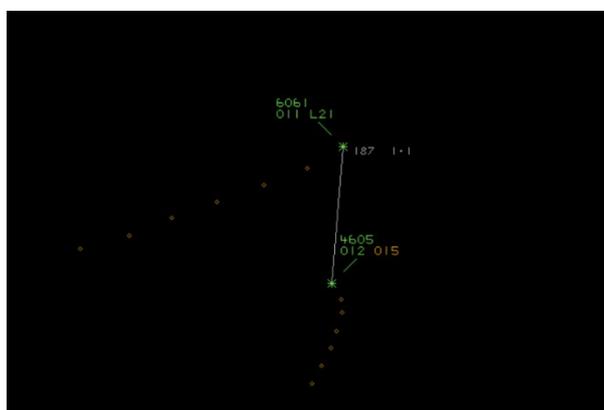
The pilot confirmed that they were visual with one. The controller went on to say that they were checking with Swanwick Mil to determine if it was a single aircraft, to which the pilot replied *“roger, he’s current, er passing the same level just in front of us now”*. The controller then confirmed that it was a single aircraft and the pilot replied *“that’s copied- we’re good visual – he’s right in front of us now”*.

Figure 9 : 1525 CPA

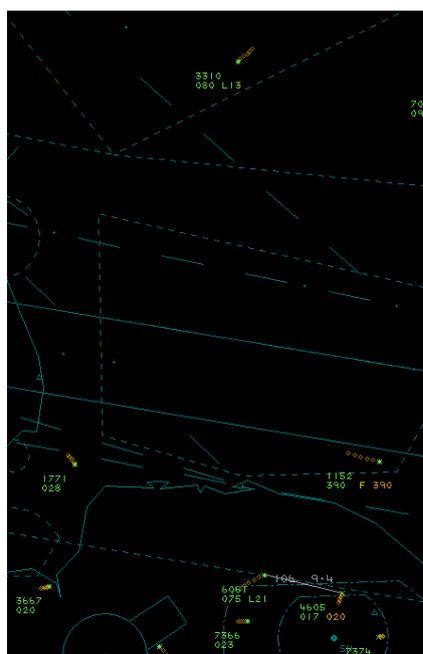
Figure 10: The position of the freecalling Typhoon in MDA 323 squawking 3310.

At 1518:50 the Swanwick Mil controller received a freecall from another Typhoon that reported they would be recovering to base with a technical issue in approximately five minutes time. Separation between the AW139 and Typhoon was measured at 9.4NM and 5800ft.

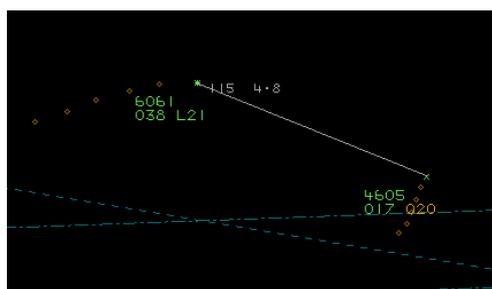
Figure 11:
Separation decreased below 5NM.

By 1524:03 separation had decreased to 4.8NM and 2100ft. During this time the Swanwick Mil controller was passing the local weather to the other Typhoon under their control to allow them to confirm a type of recovery.

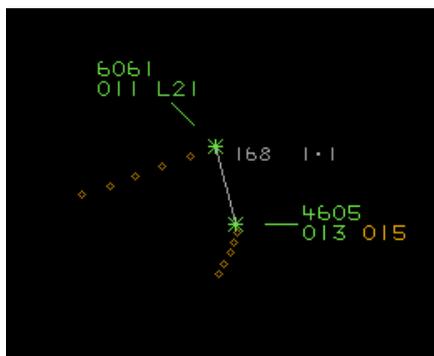
Figure 12: CPA.

At 1524:55 Traffic Information was passed to the Typhoon from the Swanwick Mil controller. CPA was measured at 1.1NM and 200ft.

By the controller's own admission their focus was on the freecalling Typhoon and they did not recognise the developing situation between the AW139 and the Typhoon until after standard separation was lost. It can be understood why priority was given to the freecalling Typhoon considering they had reported that they would be recovering to base with a technical issue. However, the controller should have divided their attention between all the aircraft under their control prioritising control action before administrative transmissions.
