AIRPROX REPORT No 2021255

Date: 31 Aug 2021 Time: 1855Z Position: 5107N 00020W Location: 3NM N of Horsham

PART A: SUMMARY OF INFORMATION REPORTED TO UKAB

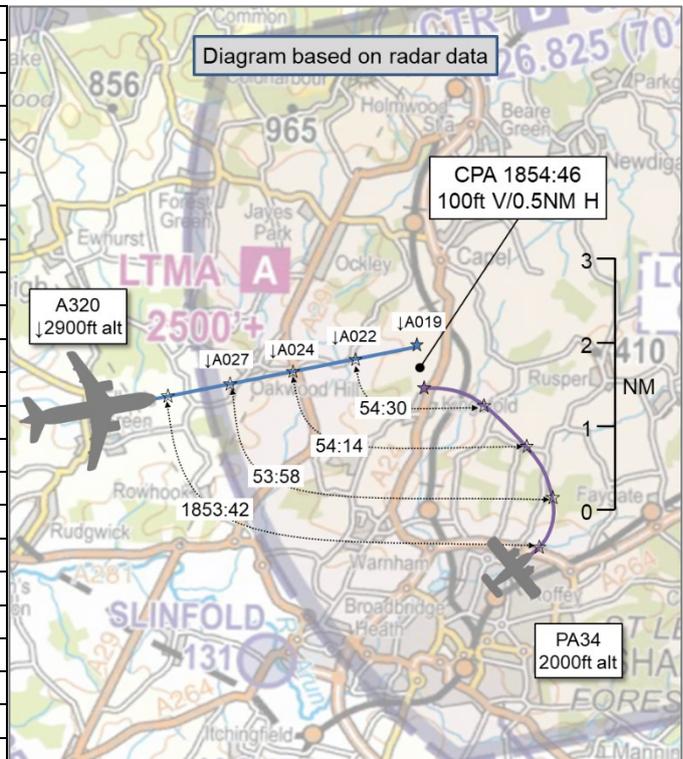
Recorded	Aircraft 1	Aircraft 2
Aircraft	A320	PA34
Operator	CAT	Civ FW
Airspace	Gatwick CTR	Gatwick CTR
Class	D	D
Rules	IFR	VFR
Service	ACS	Radar Control
Provider	Gatwick Tower	Gatwick Int/Fin
Altitude/FL	1800ft	2000ft
Transponder	A, C, S	A, C
Reported		
Colours	Company livery	White, blue
Lighting	NR	Nav, strobes
Conditions	NK	VMC
Visibility	NR	>10km
Altitude/FL	2500ft	2000ft
Altimeter	NK	QNH (NK hPa)
Heading	080°	NK
Speed	180kt	NK
ACAS/TAS	TCAS II	Not fitted
Alert	RA	N/A
Separation at CPA		
Reported	NR V/NR H	NK V/0.5NM H
Recorded	100ft V/0.5NM H

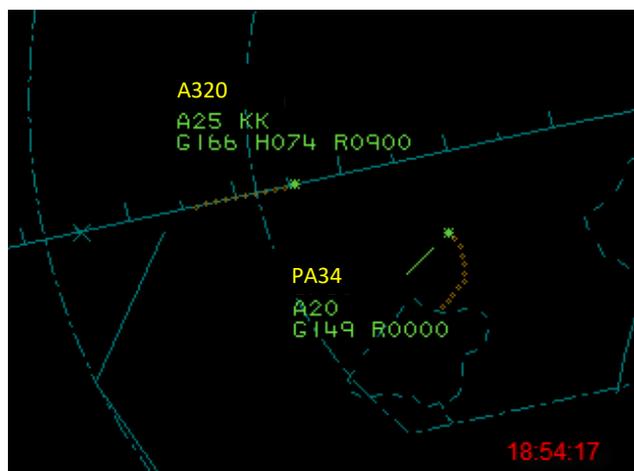
Figure 1 – 1854:17

The KK INT controller then transferred communication with [the A320] to the TWR controller at **1854:17** (see Figure 1). High level Short Term Conflict Alert (STCA) activated at **1854:26** and was shortly followed by the KK INT controller transmitting “[PA34 c/s] *just confirm you’re passing behind that A three twenty?*”, to which the pilot responded “*affirm [PA34 c/s]*”. The closest point of approach between [the A320] and [the PA34] occurred at **1854:46** and was recorded using the multi-track radar system as 0.5NM and 100ft (see Figure 2).

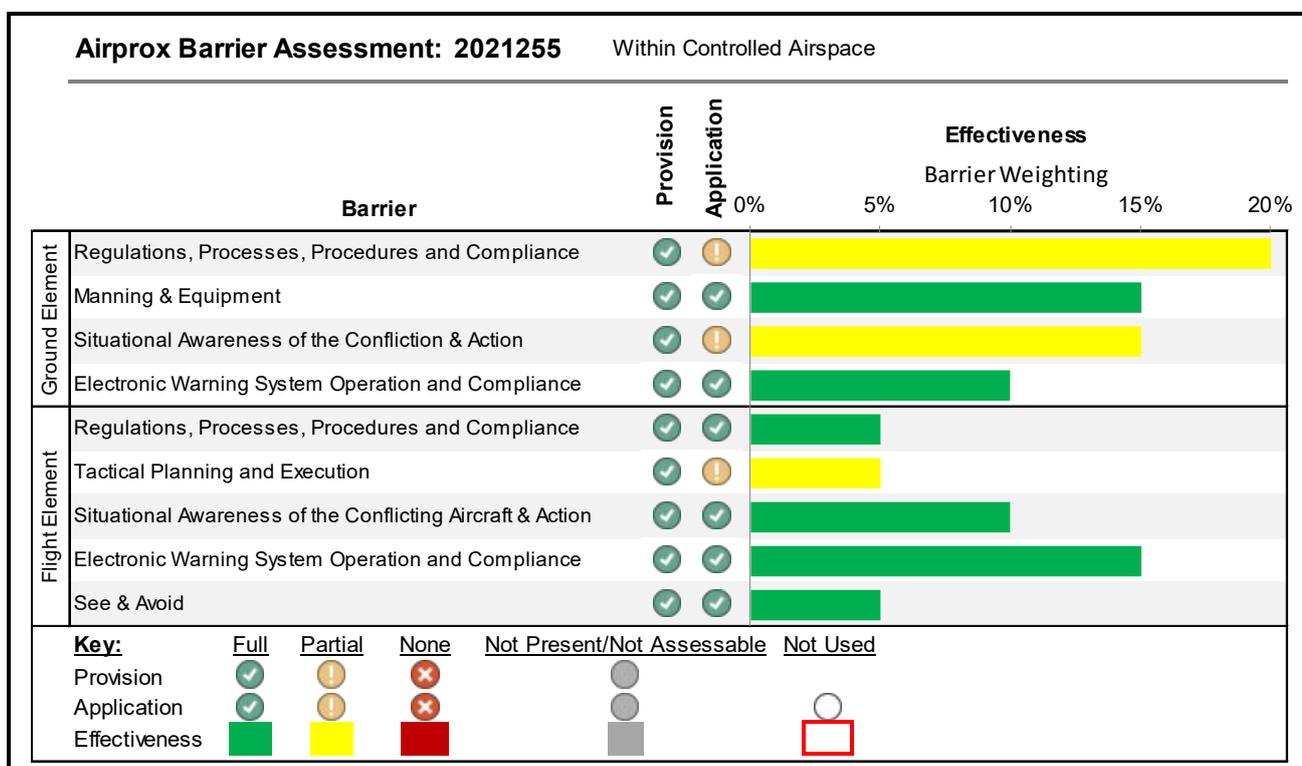
Safety Barrier Assessment⁵

In assessing the effectiveness of the safety barriers associated with this incident, the Board concluded that the key factors had been that:

Regulations, Processes, Procedures and Compliance were assessed as **partially effective** because the Gatwick INT/FIN controller did not issue instructions to the PA34 pilot regarding their routing to minimise the likelihood of a TCAS RA (as per the LTC MATS Pt 2 GEN 2.2.5).

Situational Awareness of the Confliction and Action were assessed as **partially effective** because the Gatwick Tower controller was under the impression that the PA34 would be conducting a right-hand orbit to deconflict from the approach path of the A320.

Tactical Planning and Execution was assessed as **partially effective** because the PA34 pilot, whilst achieving VFR separation from the A320, flew close enough to the A320 to trigger a TCAS RA.
