AIRPROX REPORT No 2022116

Date: 26 Jun 2022 Time: 1535Z Position: 5104N 00059W Location: 3NM NW Liss, Hampshire

PART A: SUMMARY OF INFORMATION REPORTED TO UKAB

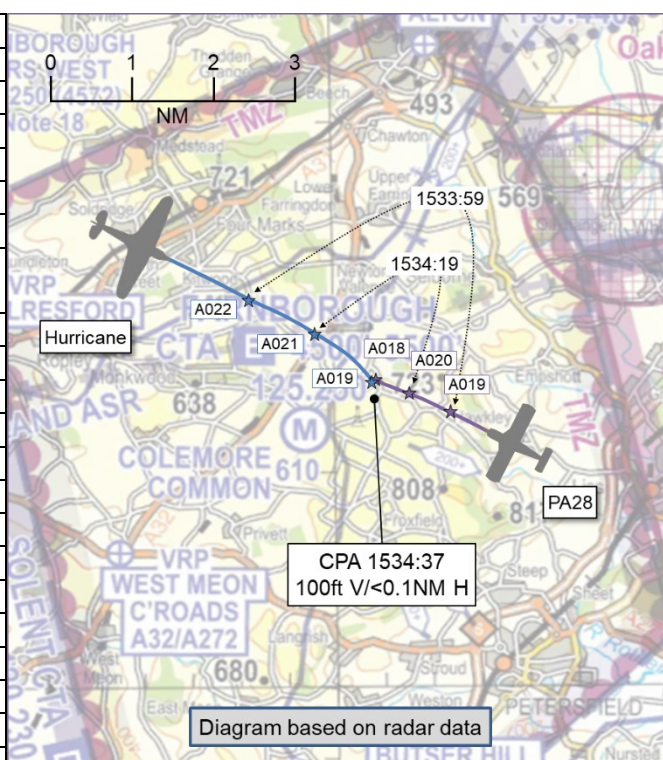
Recorded	Aircraft 1	Aircraft 2
Aircraft	Hurricane	PA28
Operator	HQ Air (Ops)	Civ FW
Airspace	London FIR	London FIR
Class	G	G
Rules	VFR	VFR
Service	Listening Out	Basic
Provider	Farnborough LARS West	Farnborough LARS West
Altitude/FL	2000ft	1900ft
Transponder	A, C, S	A, C, S+ ¹
Reported		
Colours	WWII camouflage	Red, white
Lighting	Nil	Beacon
Conditions	VMC	VMC
Visibility	>10km	>10km
Altitude/FL	2000ft	2000ft
Altimeter	QNH (NR hPa)	QNH (1012hPa)
Heading	122°	275°
Speed	165kt	100kt
ACAS/TAS	PowerFLARM	Not fitted
Alert	None	N/A
Separation at CPA		
Reported	0ft V/300m H	NR V/NR H
Recorded	100ft V/<0.1NM H

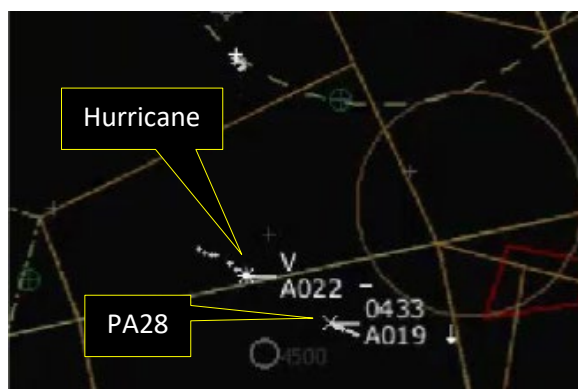
LARS West was operating as a solo function. The LARS West frequency was moderately busy with seven aircraft on frequency according to the initial unit investigation. A handover of position had just taken place at 1531. [The PA28] was operating on a Basic Service, identified on a 0433 squawk. At 1534:11 [the PA28] could be seen indicating A019 Mode C with opposite direction traffic [the Hurricane] on a 7000 squawk (converted to a 'V') ahead of their track by approximately 2NM (see Figure 1).

Figure 1: 1534:11 - The Hurricane at 2200ft and the PA28 at 1900ft

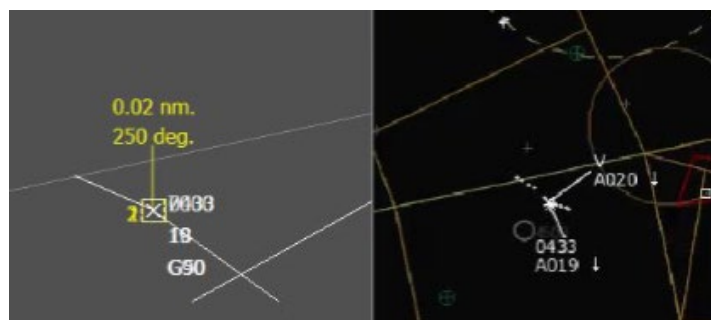
From the radar replay at 1534:37 the 0433 squawk and the 7000 squawk could be seen operating 0.02NM from each other with A001 difference in altitudes as indicated on Mode C (7000 squawk unvalidated or verified) (see Figure 2).

Figure 2: CPA at 1534:37

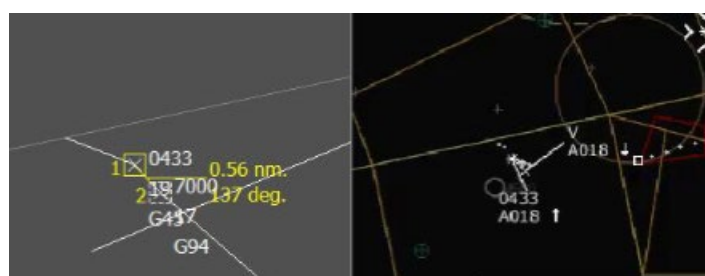
At 1534:46 the aircraft could be seen on radar to have separated, Mode C indicating the same level A018 (see Figure 3).

Figure 3: 1534:46 - The aircraft had separated

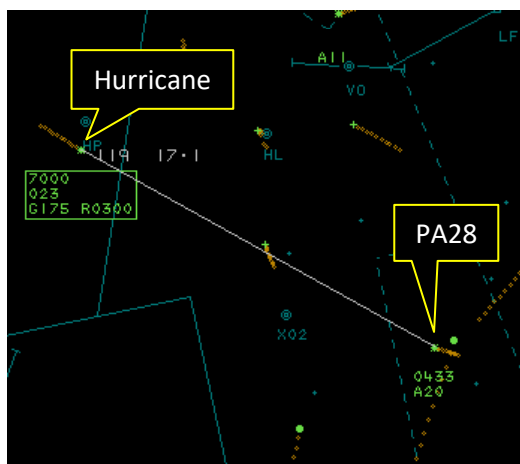
At time 1530:52, the PA28 and the Hurricane were 17.1NM apart and on reciprocal tracks (see Figure 4).

Figure 4 – 1530:52 (Controller 1 in position)

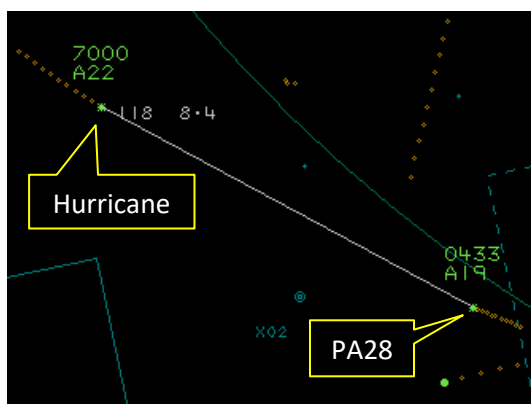
At 1532:49 the handover of the operational position was complete, and the pilot of an aircraft who had been waiting in the queue for a service entered into a lengthy RTF exchange with Controller 2 about potentially cancelling their request for a service because they could hear how busy the controller was. The controller explained that a handover of controller had been taking place, thanked the pilot for their patience and asked the pilot to pass their details, a Basic Service was subsequently agreed. The Hurricane and PA28 were in the positions in Figure 5 when this exchange took place.

Figure 5 – 1532:49 (Controller 2 in position)

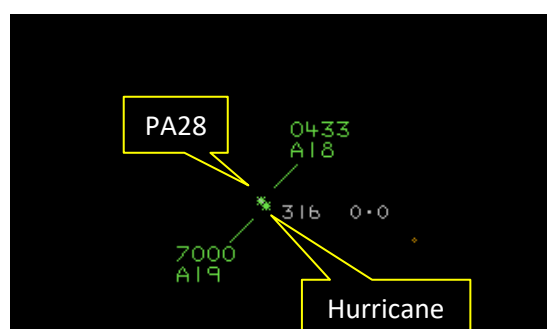
Figure 9 – 1534:37 the aircraft had passed each other

² UKAB Note: The head-to-head CPA was 0.3NM, however due to the periodicity of the radar sweep, the Airprox CPA has been assessed to be that depicted in Figure 9, albeit this is after the aircraft had crossed.
