### AIRPROX REPORT No 2023090

Date: 17 May 2023 Time: 1647Z Position: 5101N 00138E Location: 13NM SE DVR VOR

# PART A: SUMMARY OF INFORMATION REPORTED TO UKAB

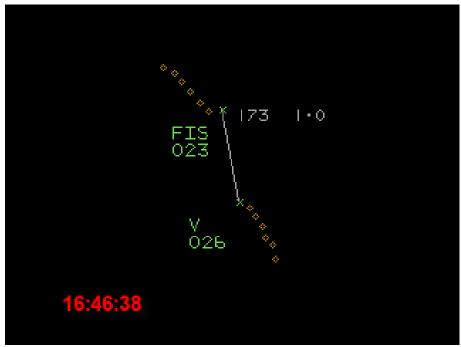
Figure 1

Analysis of the radar replay indicated that [DA62 C/S] turned left and commenced descent at 1646:38, prior to the initial communication with [Bell 505 C/S] being concluded. At this time, the aircraft were laterally separated by 1.0NM. (Figure 1).

Note: At this time, [DA62 C/S] was displaying 'FIS' (squawking 1177), with [Bell 505 C/S] displaying 'V' (squawking 7000).

On the radar update prior to Figure 1, [DA62 C/S] was indicating the same altitude as [Bell 505 C/S], displayed on the radar as FL026.

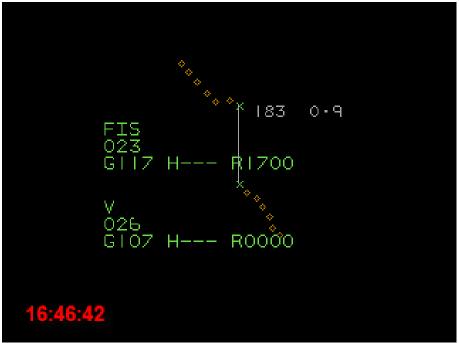
Figure 2

Closest point of approach occurred at 1646:42 and was measured on the Multi-Track Radar as 0.9NM and 300ft. (Figure 2)

Independent analysis of the NATS radar replay was conducted by the UKAB Secretariat, where separation at CPA was assessed to have been 0.8NM horizontally and 400ft vertically.
