AIRPROX REPORT No 2023112

Date: 04 Jun 2023 Time: 1815Z Position: 5123N 00005E Location: 3.5NM NNE Biggin Hill

PART A: SUMMARY OF INFORMATION REPORTED TO UKAB

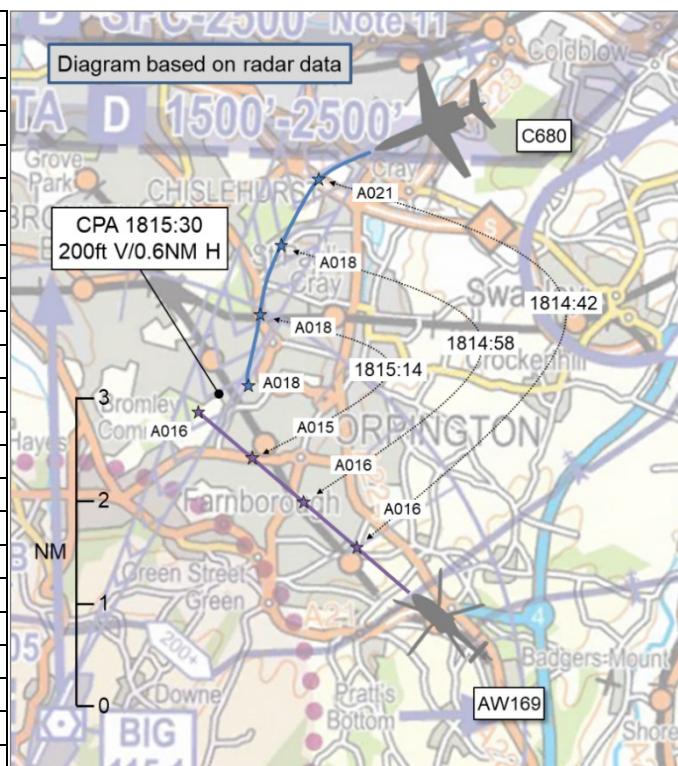
Recorded	Aircraft 1	Aircraft 2
Aircraft	C680	AW169
Operator	Civ Comm	HEMS
Airspace	London FIR	London FIR
Class	G	G
Rules	IFR	VFR
Service	Basic	Basic
Provider	Thames Director	Heathrow Special
Altitude/FL	1800ft	1600ft
Transponder	A, C, S+	A, C, S+
Reported		
Colours	NR	White, teal, grey
Lighting	NR	Nav, anti-col
Conditions	VMC	VMC
Visibility	NR	>10km
Altitude/FL	1800ft	1300ft
Altimeter	NR	QNH
Heading	NR	305°
Speed	140kt	135kt
ACAS/TAS	TCAS II	TCAS II
Alert	None	TA
Separation at CPA		
Reported	200ft V/NR H	200ft V/1.5NM H
Recorded	200ft V/0.6NM H

An analysis of the NATS radar replay was undertaken and both aircraft could be positively identified from Mode S data. The diagram was constructed and the separation at CPA determined from the radar data.

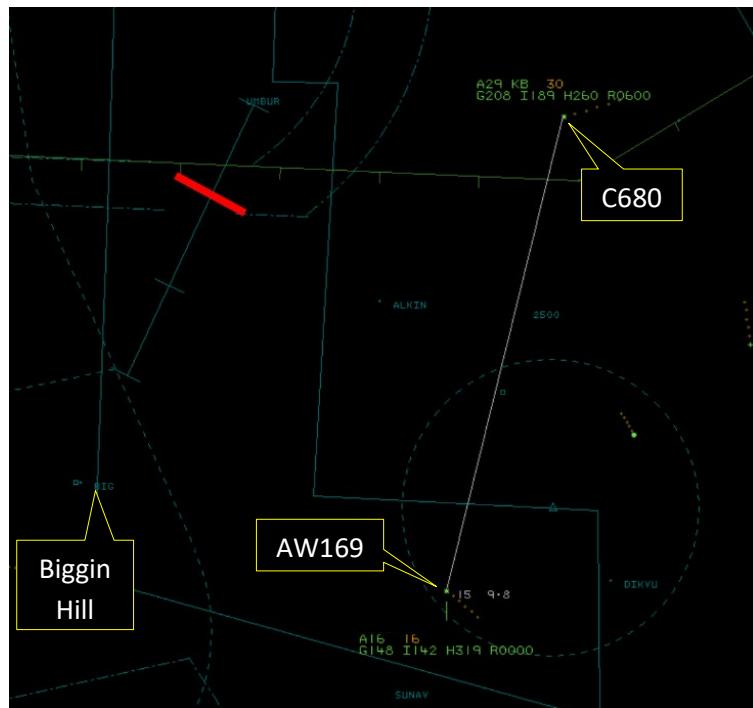
Figure 1 (1812:15). The Biggin Hill 6NM final point is marked in red. This is the point at which [the C680] would vacate controlled airspace.

The LC DIR informed the pilot of [the C680], at 1812:15, “...you’re going to remain inside controlled airspace until a six mile final where radar service will terminate. On this heading establish Runway two one”. The respective positions of [the C680] and [the AW169] at this time are shown in Figure 1.

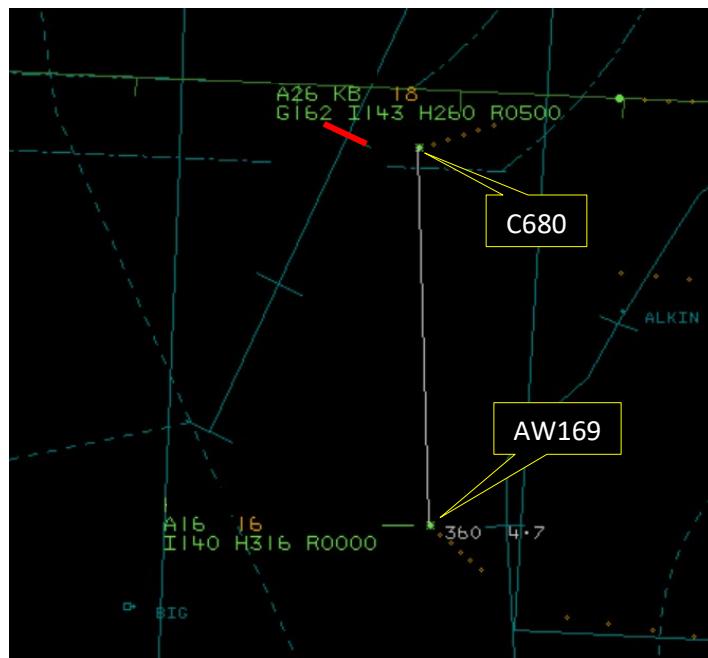
Figure 2 - 1814:15

The LL SVFR issued Traffic Information to the pilot of [the AW169] on [the C680] at 1814:15 as follows, “Traffic inbound to Biggin Hill. Right. One o’clock. Range of four miles, he’s at two thousand six hundred feet descending. It’s a business jet”. The pilot of [the AW169] responded that they were visual with the traffic.

The relative locations of each aircraft at that time can be seen in Figure 2 along with the 6NM final mark, shown by a red line.

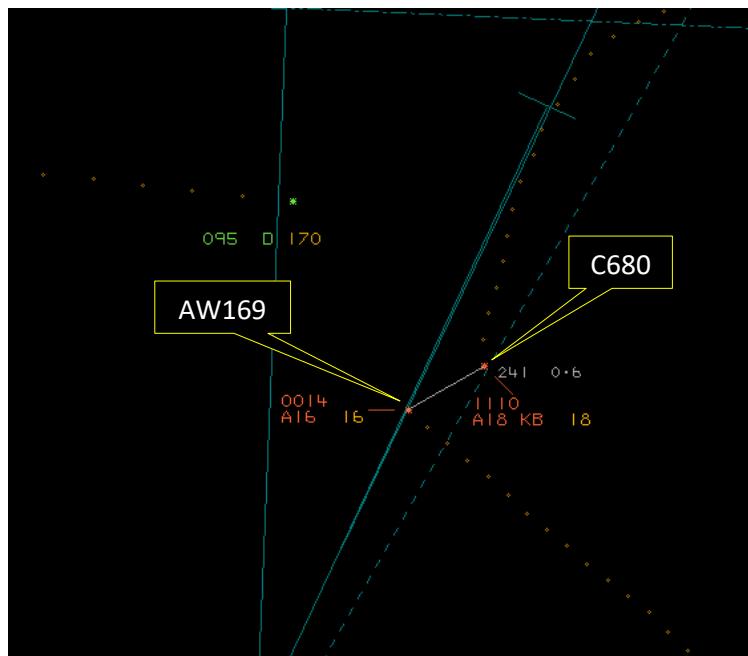
Figure 3. CPA at 1815:30

The CPA between [the AW169] and [the C680] was at 1815:30 and was recorded on multi-track radar as 0.6NM and 200ft as shown in Figure 3. The pilot of [the C680] had commenced a left turn at that time.

The CPA between [the AW169] and [the C680] occurred at 1815:30 and was recorded on Multi-Track Radar as 0.6NM and 200ft.
