AIRPROX REPORT No 2025004

Date: 16 Jan 2025 Time: 1423Z Position: 5111N 00057E Location: Wye

PART A: SUMMARY OF INFORMATION REPORTED TO UKAB

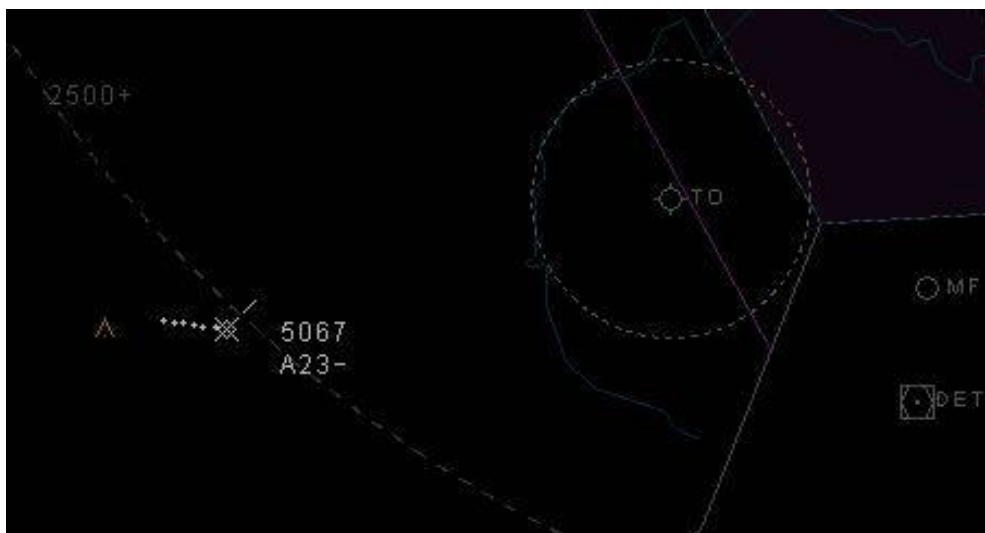
Figure 3 – Southend Radar (ORRD) at 1352:25

At 1352:25 (Figure 1), the Southend Radar controller identified [SR20 C/S], and a reduced Traffic Service was agreed due to their proximity to Rochester Airport; the controller also advised the pilot to expect the possibility of late warning of traffic.

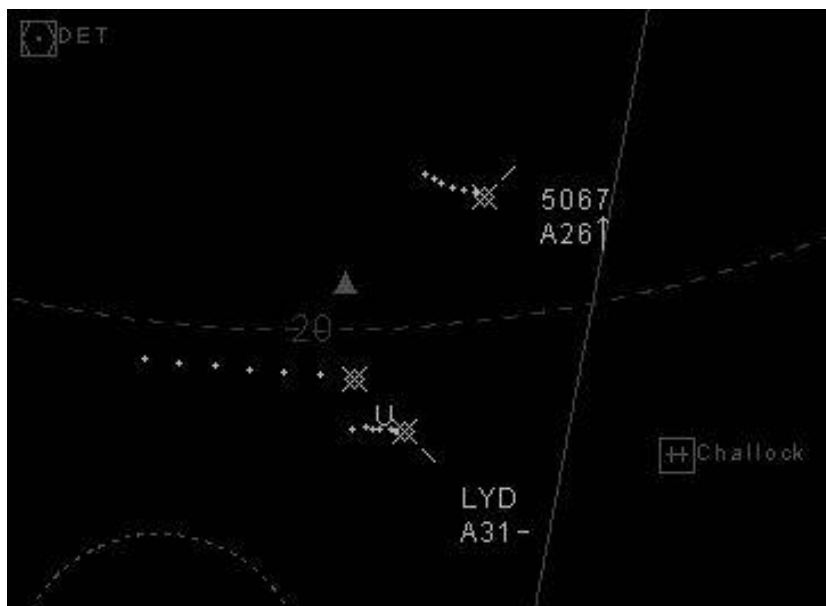
Figure 5 – Southend Radar (ORRD) at 1359:47

At 1359:47 (Figure 5), [the SR20 pilot] reported climbing to altitude 3000ft on the QNH (1034hPa). The Southend Radar controller acknowledged that, and then updated them on the previously mentioned traffic "... I have got secondary contact on that er previously mentioned traffic it's four miles now to the south south west of you indicating altitude three thousand two hundred feet on an easterly track." The reply to that transmission was clipped, however, the pilot may have replied with the word 'looking.' The traffic was squawking the Mode A code 7067* which is allocated to Lydd approach as a conspicuity code for their IFR traffic.

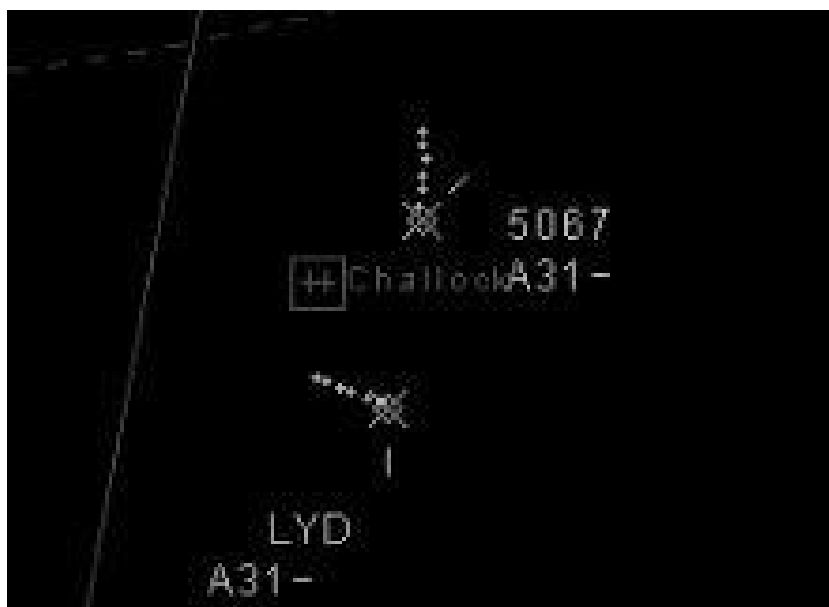
Figure 6 – Southend Radar (ORRD) at 1402:26

At 1402:26 (Figure 6), [the SR20 pilot] reported the previously called traffic in sight. The Southend Radar controller may have mis-heard the transmission because they then called the traffic to [the SR20 pilot] again, to which the pilot acknowledged.

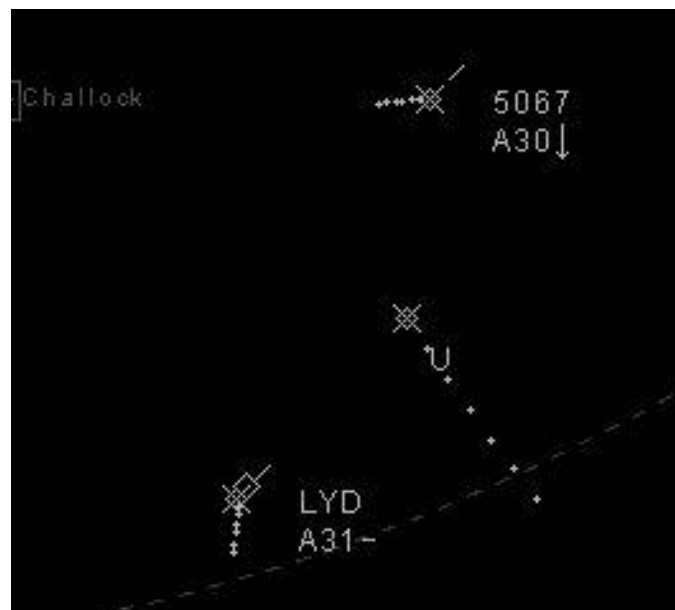
Figure 7 – Southend Radar at (ORRD) 1420:38

At 1420:38 (Figure 7), according to the recorded surveillance data, unknown traffic transponding 7067 was observed 6NM to the south-southwest of [SR20 C/S], tracking north, indicating level at

altitude 3100ft (unverified). At this time, [SR20 C/S] was tracking away from it to the east, indicating altitude 3000ft and descending.

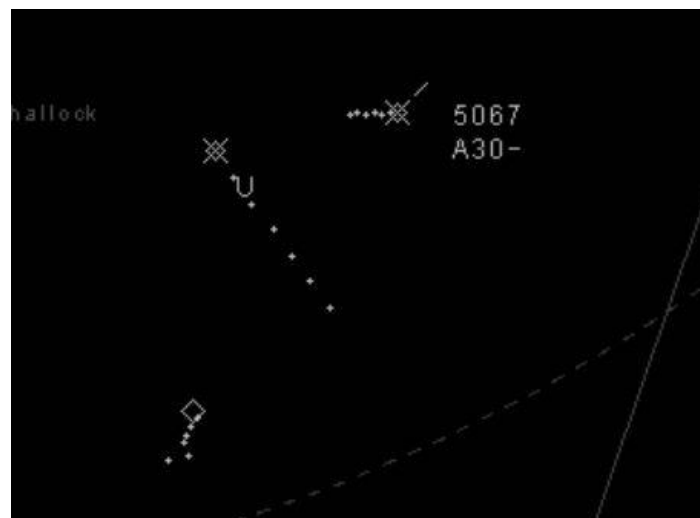
Figure 8 – Southend Radar (ORRD) at 1421:02

At 1421:02 (Figure 8), according to the recorded surveillance data, the unknown traffic's Secondary Surveillance Radar information was lost; an intermittent primary contact remained which then continued to track northbound.

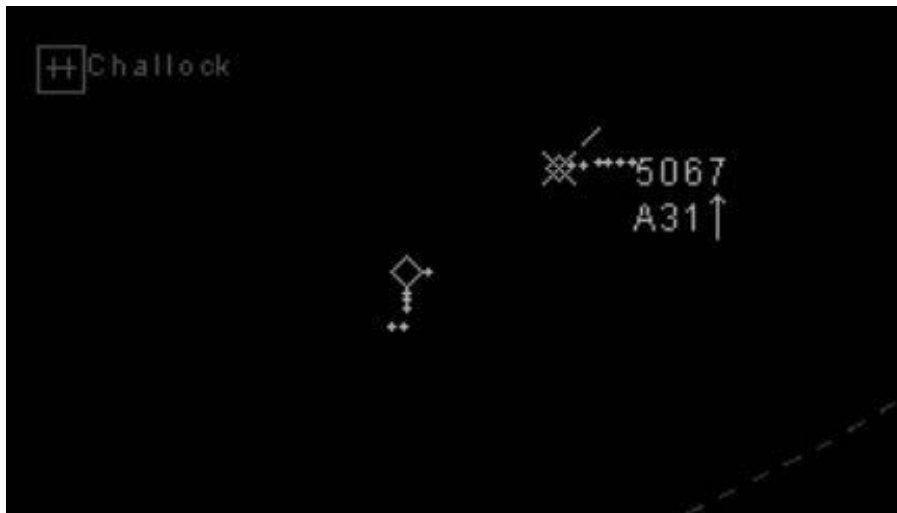
Figure 9 – Southend Radar (ORRD) at 1422:21

At 1422:21 (Figure 9), the Southend Radar controller transmitted the following to [the SR20 pilot]: “[SR20 C/S] *traffic ten o'clock three miles primary contact only no level or type information crossing ahead left-to-right.*” The pilot of [SR20 C/S] then reported the traffic in sight.

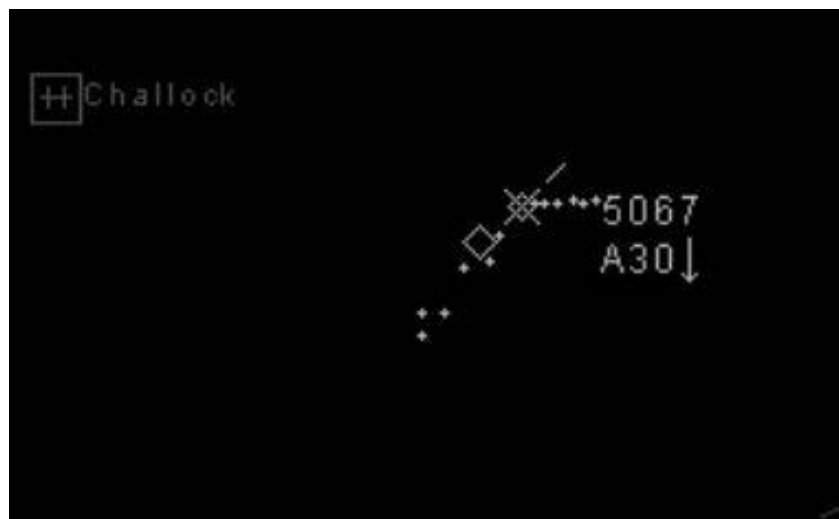
Figure 10 – Southend Radar (ORRD) at 1422:40

At 1422:40 (Figure 10), according to the recorded surveillance data, closest point of approach occurred. The primary only contact then faded from coverage on the next sweep.

At the time CPA occurred, the unknown primary contact was approximately 26NM to the south of London Southend Airport, and approximately 50NM away from the radar head, therefore, it was most likely at the limit of solid radar coverage. Because of this, it was not possible to calculate an accurate CPA distance.

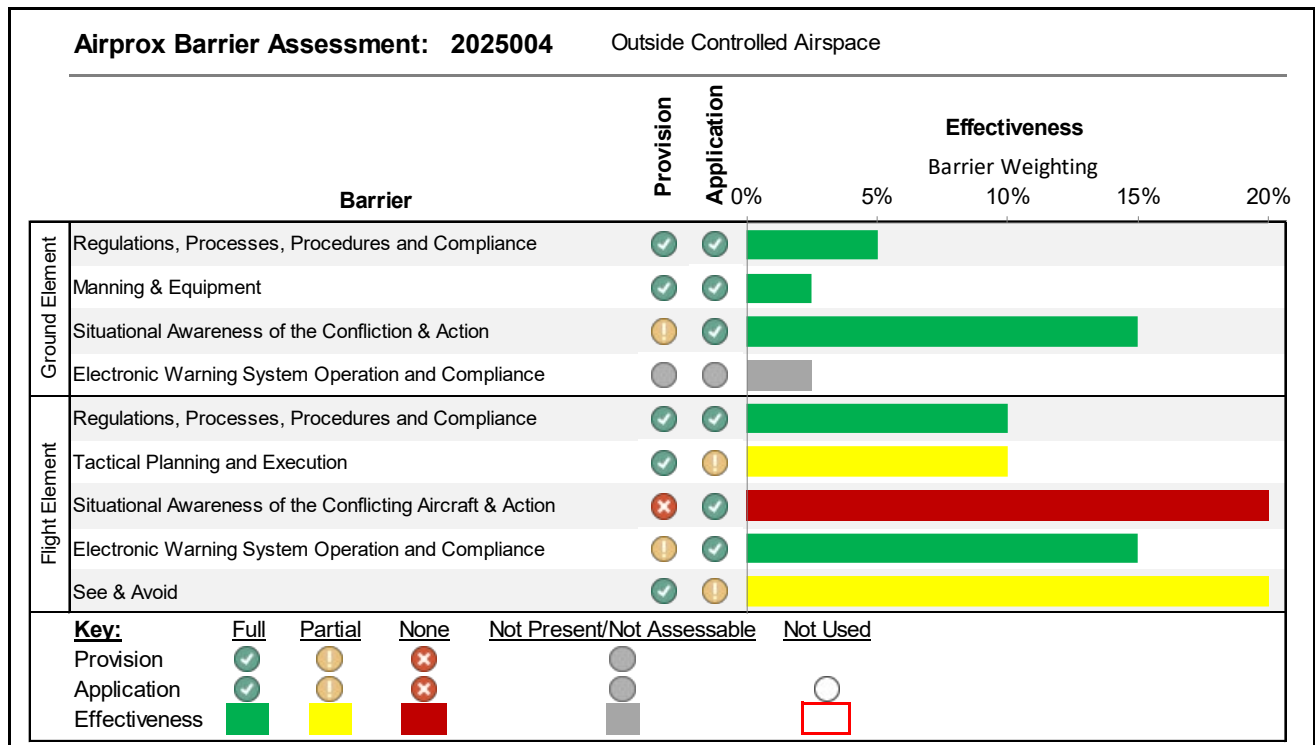
In assessing the effectiveness of the safety barriers associated with this incident, the Board concluded that the key factors had been that:

Tactical Planning and Execution was assessed as **partially effective** because the SR20 pilot had not communicated with Lydd Approach and made their climb at a point where separation had reduced to 100ft vertically and less than 0.1NM horizontally.

Situational Awareness of the Conflicting Aircraft and Action were assessed as **ineffective** because the TB10 pilot had had no situational awareness on the SR20.

See and Avoid were assessed as **partially effective** because the TB10 pilot saw the SR20 as it crossed their nose, effectively a non-sighting, and the SR20 pilot had climbed at a late stage.
