**AIRPROX REPORT No 2025015**

Date: 13 Feb 2025 Time: 1206Z Position: 5608N 00357W Location: North of Stirling

**PART A: SUMMARY OF INFORMATION REPORTED TO UKAB**

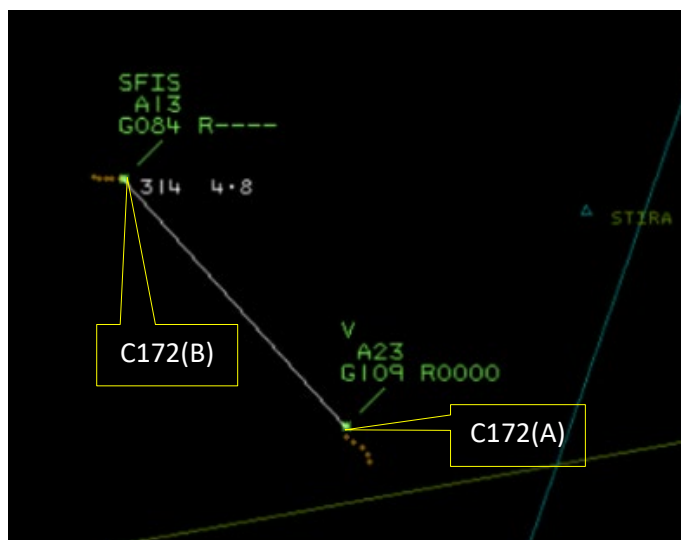
Figure 1 Time 1203:43

After the period of primary only radar coverage, as detailed above, at 1203:43 NODE began displaying Mode-A and Mode-C data from [the C172(B)] which was indicating 1300ft approximately 2.5NM west of Stirling, tracking steadily east. A radar snapshot at this time, showing the relative locations of C172(B) and C172(A), which was at 2300 feet, is shown in Figure 1.

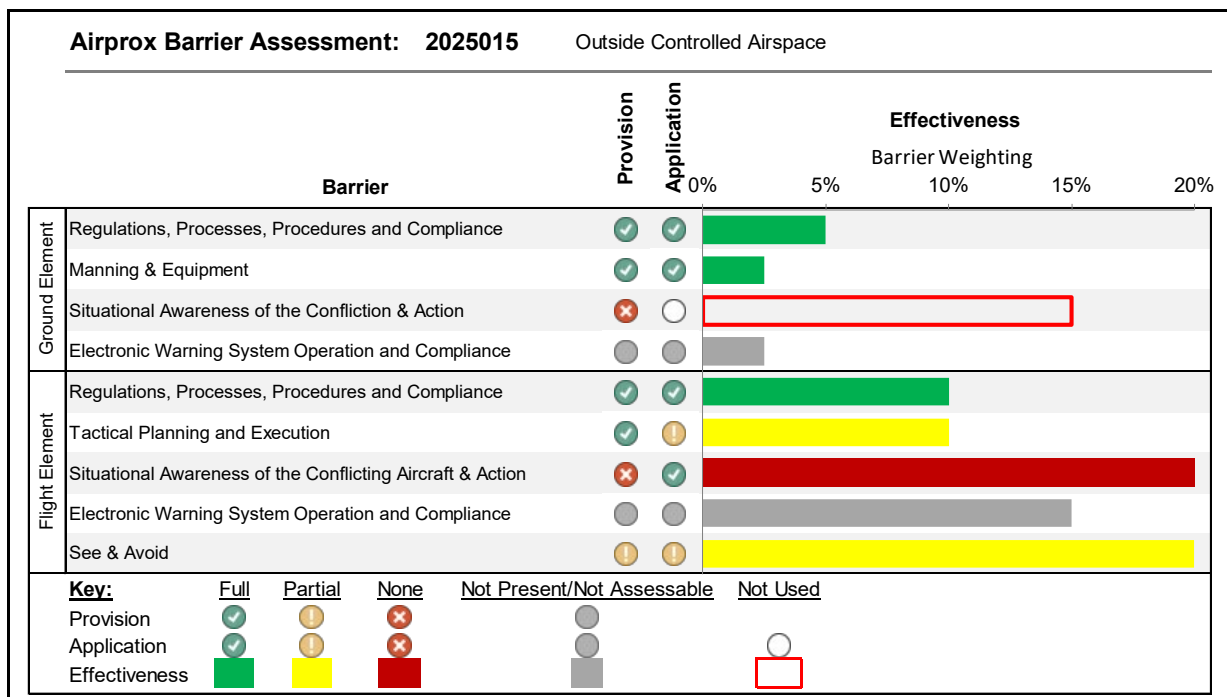
**See and Avoid** were assessed as **partially effective** because the C172(A) pilot sighted C172(B) at a late stage, and the C172(B) pilot had seen C172(A) too late to make a significant input to increase separation, effectively a non-sighting.
