AIRPROX REPORT No 2025052

Date: 13 Apr 2025 Time: 1016Z Position: 5051N 00059W Location: Havant

PART A: SUMMARY OF INFORMATION REPORTED TO UKAB

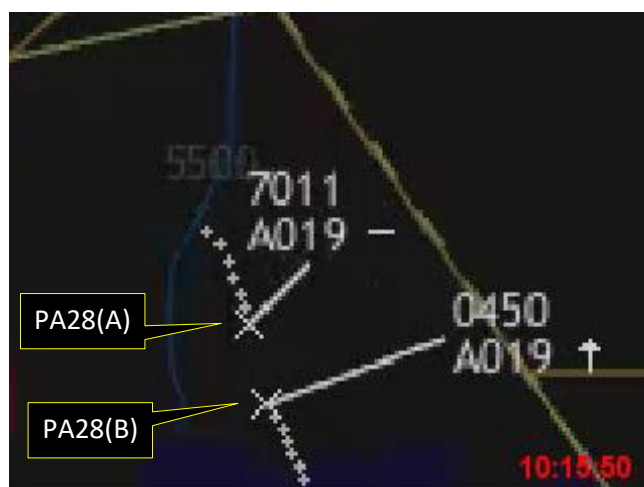
Figure 1 – Farnborough Radar

The LF-LARS controller re-positioned the labels on the radar display and subsequently broadcast at 1015:50: "[PA28(B) C/S], *just caution, there is opposite direction traffic ahead of you by half a mile, indicates the same level*". The pilot responded: "*Affirmative, we've both seen each other*". The two aircraft continued on conflicting tracks (Figure 1).

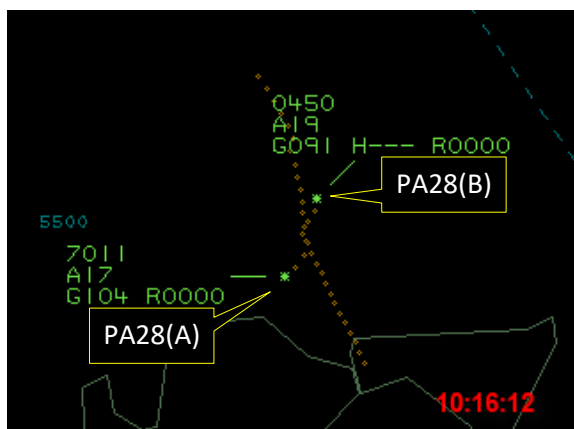
Figure 2 – NODE Radar

Radar displayed that [the pilot of PA28(B)] appeared to have maintained their track and altitude within 100ft prior to the Closest Point of Approach (CPA) and subsequently turned right, whilst [for PA28(A)], the Mode-C suggested that the pilot also maintained track and altitude at CPA, then subsequently initiated a tight right turn and descent (Figures 2 and 3).

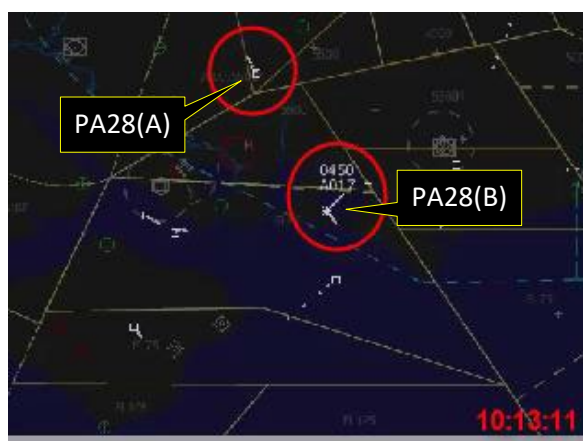
The pilot of [PA28(B)] requested, and was in receipt of, a Basic Service from the LF-LARS controller. The position of [PA28(B)] at the initial call was the boundary of the Farnborough LARS West area of responsibility, and at the edge of the controller's radar display (Figure 4).

Figure 4 – 1013:11. The pilot of [PA28(B)] applied the assigned Farnborough Mode-A squawk.

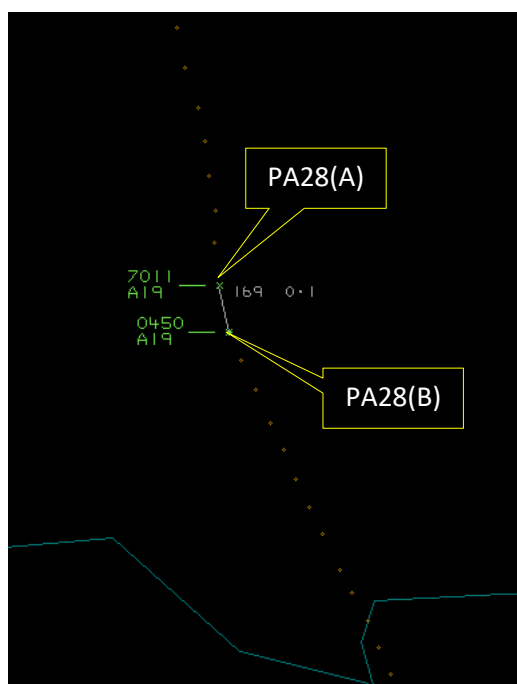
Figure 5 - 1015:58

CPA was assessed as having occurred between the radar sweeps at 1015:58 and 1016:02 (Figures 5 and 6).

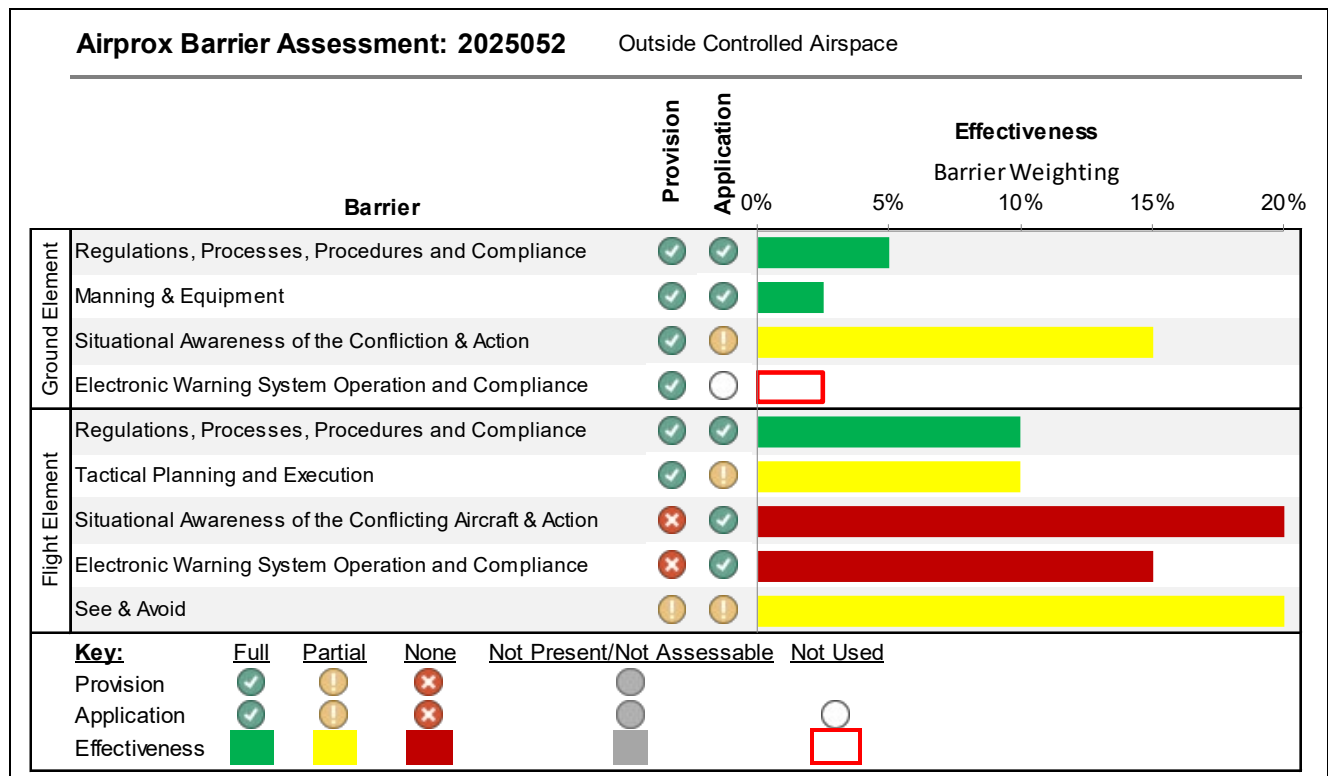
Electronic Warning System Operation and Compliance were assessed as **ineffective** because the EC device fitted to PA28(A) would not have been expected to have detected the presence of PA28(B).

See and Avoid were assessed as **partially effective** because the pilot of PA28(B) had visually acquired PA28(A) late.
