AIRPROX REPORT No 2025056

Date: 08 Apr 2025 Time: 1339Z Position: 5225N 00009E Location: 4NM west of Ely

PART A: SUMMARY OF INFORMATION REPORTED TO UKAB

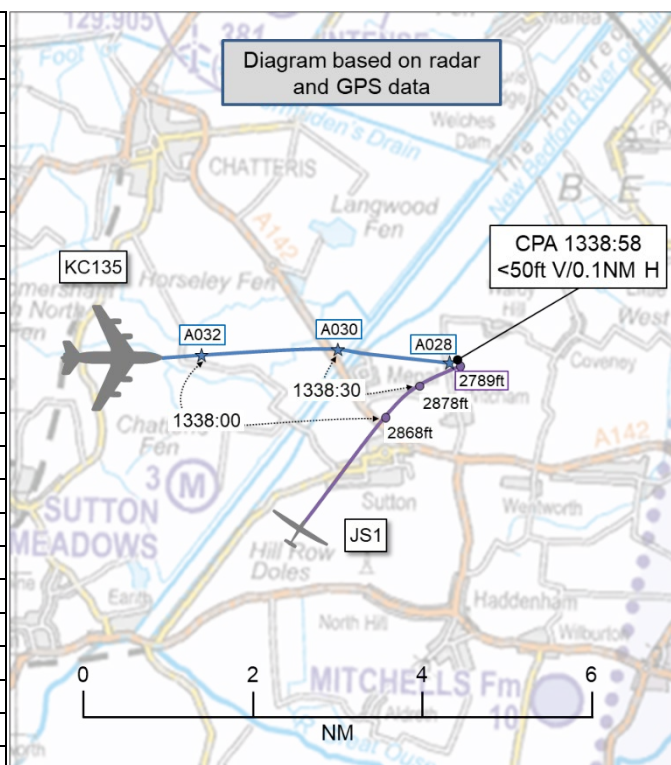
Recorded	Aircraft 1	Aircraft 2
Aircraft	KC135	JS1
Operator	Foreign Mil	Civ Gld
Airspace	London FIR	London FIR
Class	G	G
Rules	IFR	VFR
Service	Traffic	None
Provider	Mildenhall Approach	None
Altitude/FL	2800ft ¹	2789ft ²
Transponder	A, C, S+	None 'OFF'
Reported		
Colours	Grey	White
Lighting	Nav & anti-col	Nose strobe
Conditions	IMC	VMC
Visibility	NR	>10km
Altitude/FL	2000ft	2700ft
Altimeter	QNH	QNH
Heading	100°	067°
Speed	200kt	85kt
ACAS/TAS	TCAS II	FLARM
Alert	None	None
Separation at CPA		
Reported	0ft V/100ft H	N/K
Recorded	<50ft V ³ /0.1NM H

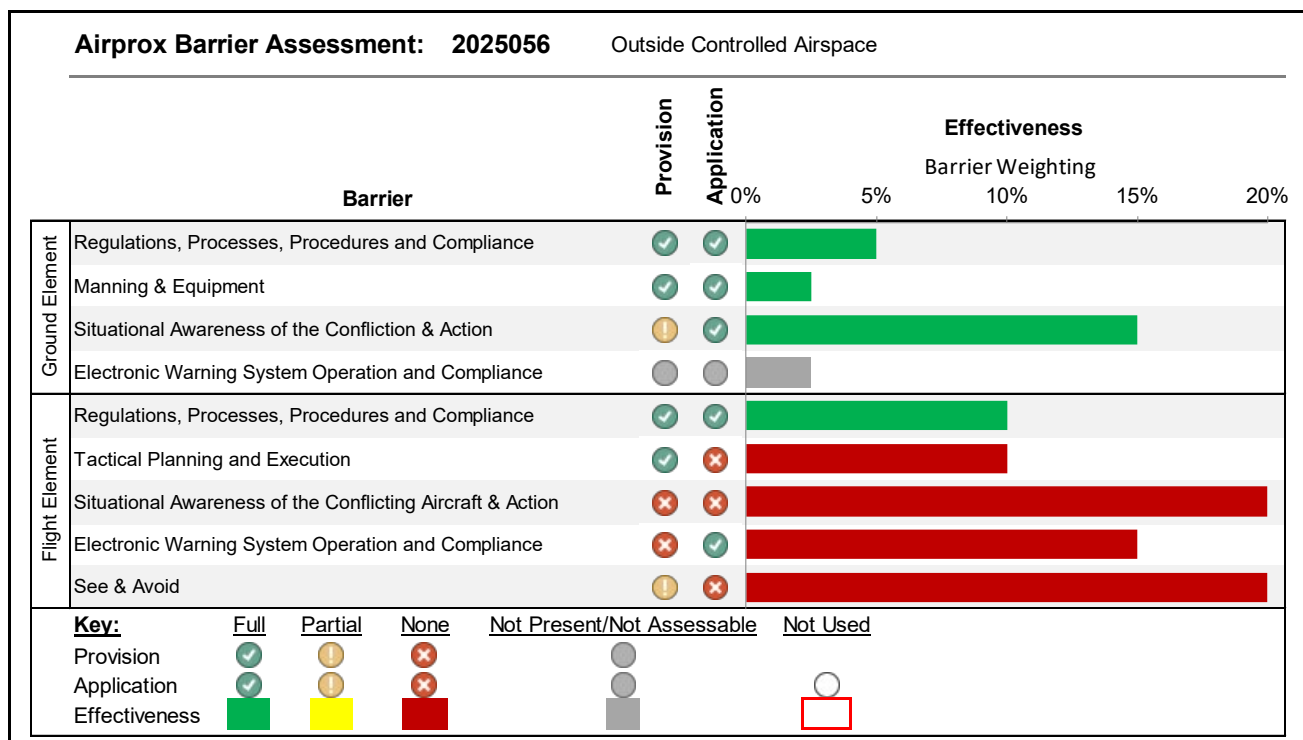
Safety Barrier Assessment⁸

In assessing the effectiveness of the safety barriers associated with this incident, the Board concluded that the key factors had been that:

Tactical Planning and Execution was assessed as **ineffective** because, given the location that the JS1 pilot was operating in, it would have been prudent to have relayed their intentions to the Mildenhall controller.

Situational Awareness of the Conflicting Aircraft and Action were assessed as **ineffective** because the JS1 pilot had no situational awareness of the position of the KC135 and the pilot of the KC135 had had only generic situational awareness of the presence of the glider from the Traffic Information passed to them by the Mildenhall controller.

Electronic Warning System Operation and Compliance were assessed as **ineffective** because the EC device fitted to the JS1 would not have been expected to have detected the KC135.

Additionally, the TCAS fitted to the KC135 had been unable to detect either the EC device or the non-operative transponder equipment in the JS1.

See and Avoid were assessed as **ineffective** because the KC135 pilot had not seen the JS1 until at or shortly after CPA, and the JS1 pilot had not seen the KC135.
