**AIRPROX REPORT No 2025078**

Date: 06 May 2025 Time: 1142Z Position: 5443N 00225W Location: 2NM NE of Cross Fell Peak

**PART A: SUMMARY OF INFORMATION REPORTED TO UKAB**

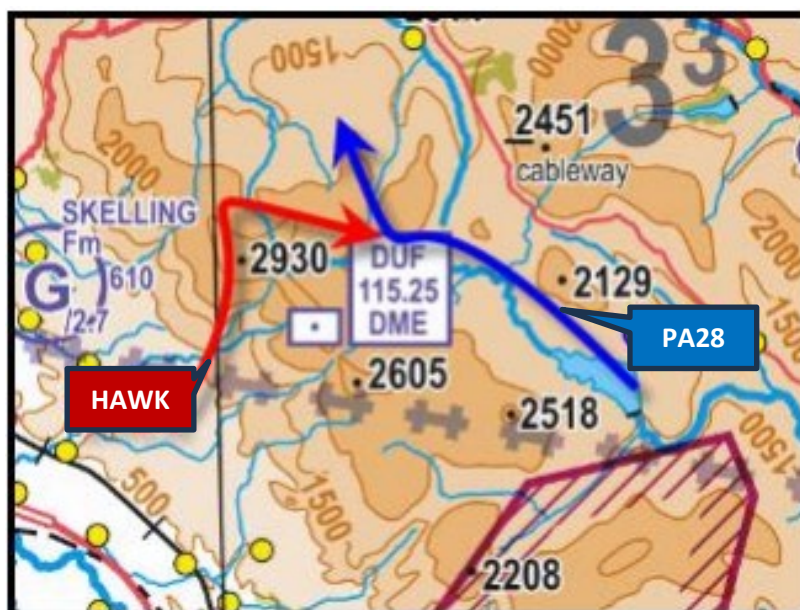
Figure 1 – Time 1141:56

[The Hawk was] operating within the Pennines, and displayed squawk 7001 (Military Fixed-Wing Low Level Conspicuity and Climb-out). It first appeared on NODE Radar at 1140:12 at altitude 1100ft, approximately 12NM southwest of [the PA28] on a converging track. The aircraft then displayed low level at around 400ft altitude. The target then disappeared from radar. At 1141:42, [Hawk C/S] re-appeared on radar at altitude 1800ft, 3.5NM west-southwest of [the PA28] which was maintaining 2700ft. [Hawk C/S] then turned east onto a conflicting track at 1141:56 (Figure 1) with a rate of climb (ROC) of 6100ft per minute (fpm) to 3500ft.

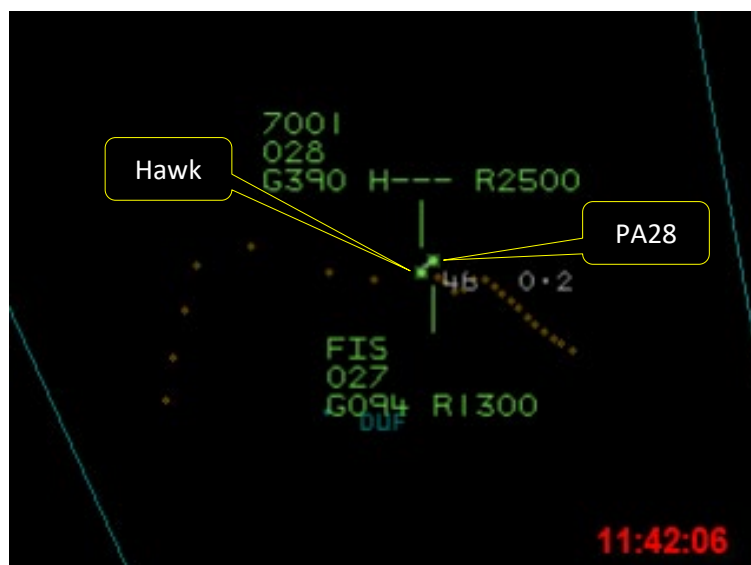
Figure 2 – CPA at 1142:06

[The PA28] was climbing through 2800ft at this time and appeared to enact a sharp left turn followed by a sharp right turn prior to the confliction (Figure 2).

The closest point of approach occurred at 1142:06 and was measured on NODE radar as 0.2NM and 100ft (Figure 2). The radar-derived rate of descent displayed [the PA28] descended 100ft at 1300fpm at this time, followed by an immediate climb on the next radar update.

NATS concluded that the Airprox occurred when the pilot of [the PA28] observed a Hawk jet turning towards their track and performed a turn and climb manoeuvre to avoid. The pilot of [the Hawk] observed a TCAS alert of [the PA28] and subsequently turned right to avoid. The Closest Point of Approach (CPA) occurred at 1142:06 and was recorded on Multi-Track Radar as 0.2NM and 100ft.
