AIRPROX REPORT No 2025158

Date: 11 Jul 2025 Time: 1518Z Position: 5149N 00201W Location: 5NM SSE Cheltenham

PART A: SUMMARY OF INFORMATION REPORTED TO UKAB

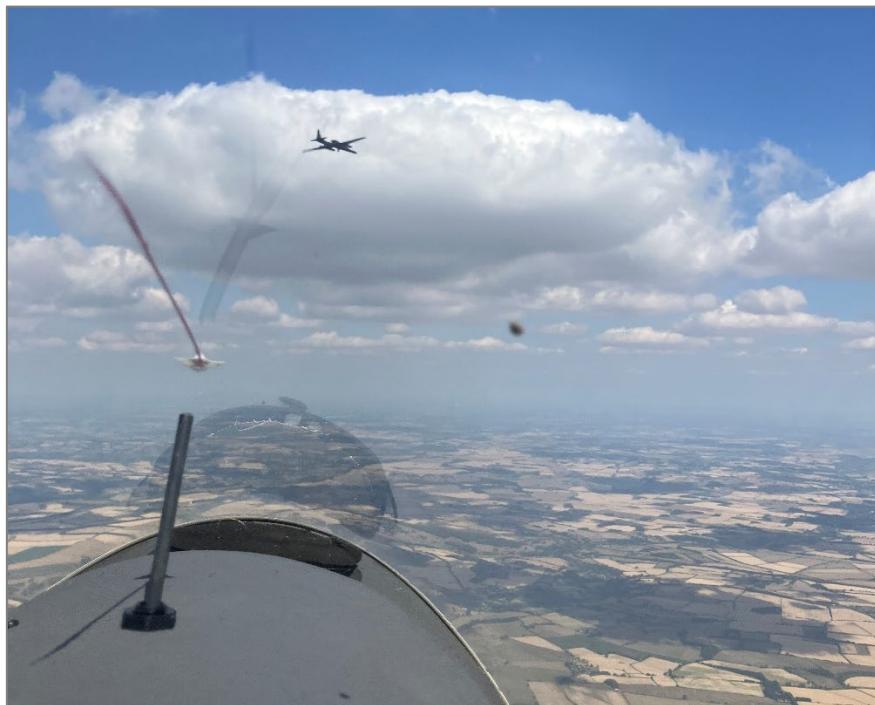
Because of the sight-line rate, both vertically and horizontally, they maintained their track of approximately 090° and their speed which, in the prevailing conditions, had given them a rate of descent of 5kt or 500ft/min. They assumed that the pilot of the U2 would have been unlikely to have seen them. As the U2 passed ahead of them, they took a photograph.

Figure 1 – A photograph taken just after CPA by the pilot of the ASG29.

Members noted that the ASG29 pilot's recall of the event suggested that they had had ample time to have assessed the situation and to have considered that urgent action had not been necessary. Indeed, taking a moment to capture a photograph of the U2 as it had passed suggested that, from their perspective, the encounter had been entirely benign. One member suggested that the gentle turn of 20° to the right may not have increased their separation from the U2 as the ASG29 pilot had opined, but may have prolonged the time that the U2 had been in a favourable position to have taken a photograph.
