**AIRPROX REPORT No 2025163**

Date: 30 Jul 2025 Time: 1639Z Position: 5222N 00112W Location: Rugby

**PART A: SUMMARY OF INFORMATION REPORTED TO UKAB**

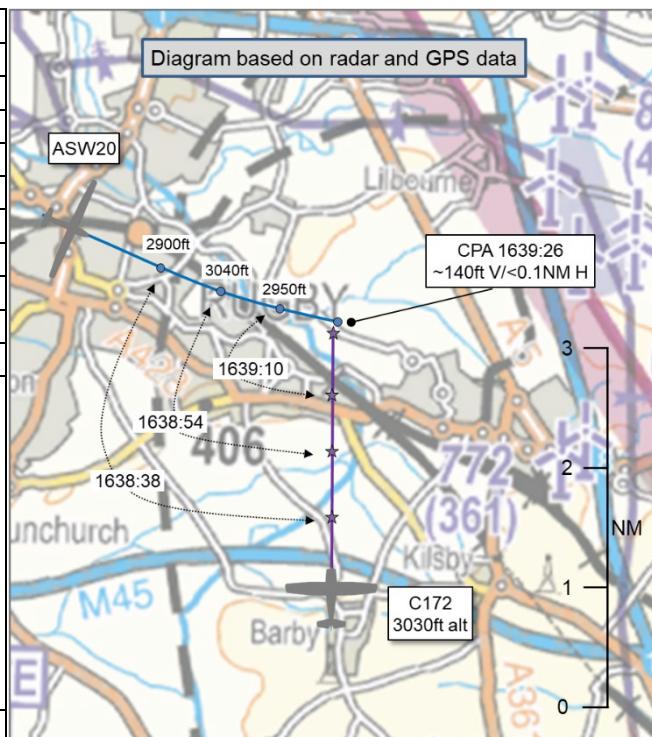
Recorded	Aircraft 1	Aircraft 2
Aircraft	ASW20	C172
Operator	Civ Gld	Civ FW
Airspace	London FIR	London FIR
Class	G	G
Rules	VFR	NK
Service	Listening Out	Basic
Provider	Cmn gliding freq	East Midlands <sup>1</sup>
Altitude/FL	~2890ft	3030ft
Transponder	Not fitted	A, C, S
<b>Reported</b>		
Colours	White	NR
Lighting	None	
Conditions	VMC	
Visibility	>10km	
Altitude/FL	3000ft	
Altimeter	QNH (1019hPa)	
Heading	100°	
Speed	75kt	
ACAS/TAS	FLARM	
Alert	None	
<b>Separation at CPA</b>		
Reported	30ft V/60ft H	NR
Recorded	~140ft V/<0.1NM H

The ASW20 was displayed as a primary return on radar. The pilot provided a GPS-track file which was combined with the available radar data to construct the diagram at page 1, allowing a direct comparison of relative altitudes at CPA. The C172 was tracked via radar and identified via Mode S data.

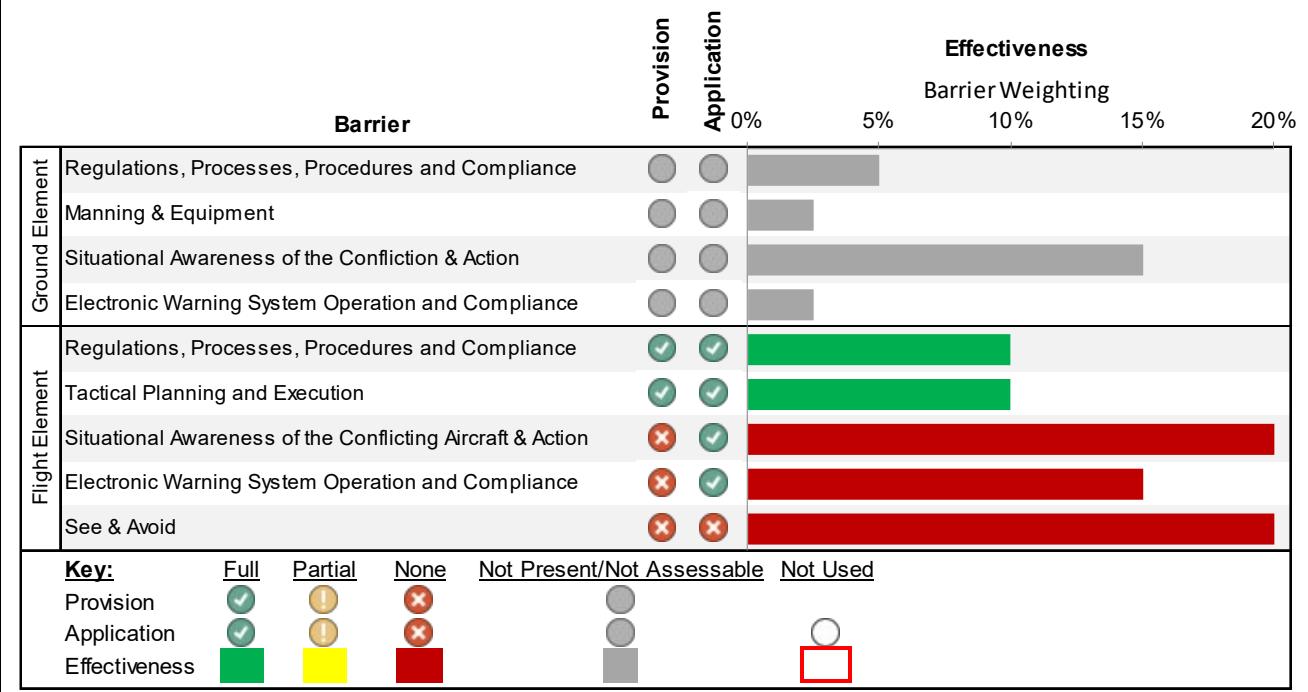
## Airprox Barrier Assessment: 2025163

**Situational Awareness of the Conflicting Aircraft and Action** were assessed as **ineffective** because the ASW20 pilot had no situational awareness of the presence of the C172.

**Electronic Warning System Operation and Compliance** were assessed as **ineffective** because the equipment carried by the ASW20 did not register any electronic emissions from the C172.

**See and Avoid** were assessed as **ineffective** because the ASW20 pilot sighted the ASW20 effectively at CPA.
