AIRPROX REPORT No 2025166

Date: 30 Jul 2025 Time: 1401Z Position: 5103N 00001E Location: 10NM SE Gatwick Airport

PART A: SUMMARY OF INFORMATION REPORTED TO UKAB

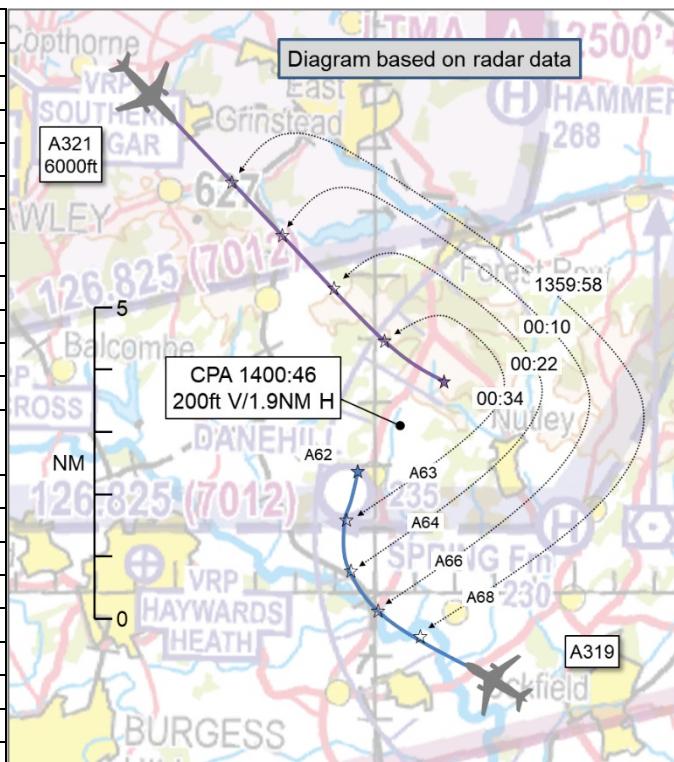
Recorded	Aircraft 1	Aircraft 2
Aircraft	A319	A321
Operator	CAT	CAT
Airspace	London TMA	London TMA
Class	A	A
Rules	IFR	IFR
Service	Radar Control	Radar Control
Provider	Swanwick KK APP	Swanwick TC SE
Altitude/FL	6200ft	6000ft
Transponder	A, C, S+	A, C, S+
Reported		
Colours	[company]	[company]
Lighting	Beacon, strobe, land	Strobe, nav, anti-col
Conditions	IMC	VMC
Visibility	NR	>10km
Altitude/FL	6100ft	6000ft
Altimeter	QNH (NR hPa)	QNH (NK hPa)
Heading	NR	~150°
Speed	220kt	250kt
ACAS/TAS	TCAS II	TCAS II
Alert	TA	TA
Separation at CPA		
Reported	300ft V/2NM H	0ft V/~1.5NM H
Recorded	200ft V/1.9NM H

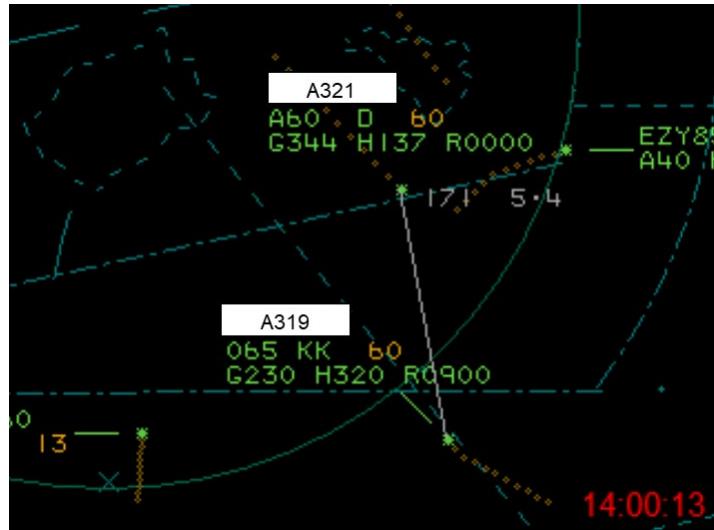
Figure 1

The TC SE controller subsequently observed [A321 C/S] south of the Gatwick Runway 26L extended centreline and at 1400:13, instructed [A321 C/S], “*Avoiding Action, turn left heading zero eight zero degrees.*” (Figure 1)

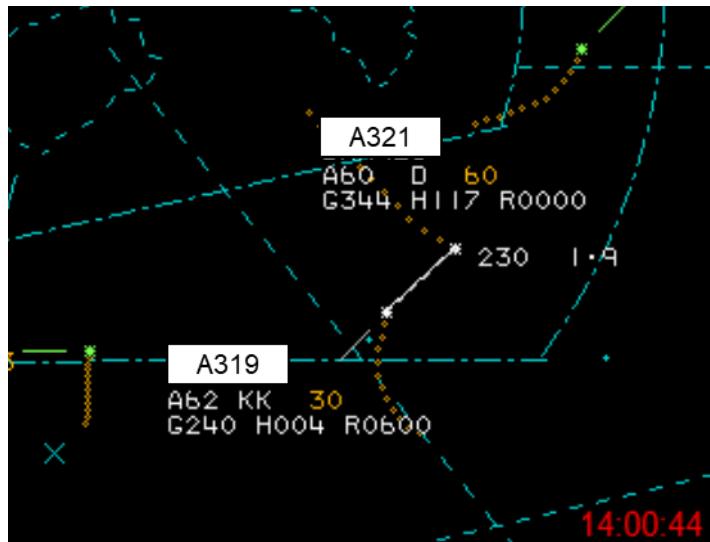
Figure 3

Minimum separation between [A319 C/S] and [A321 C/S] occurred at 1400:44, measured on the Multi-Track Radar as 1.9NM and 200ft where 3NM or 1000ft were required (Figure 3).

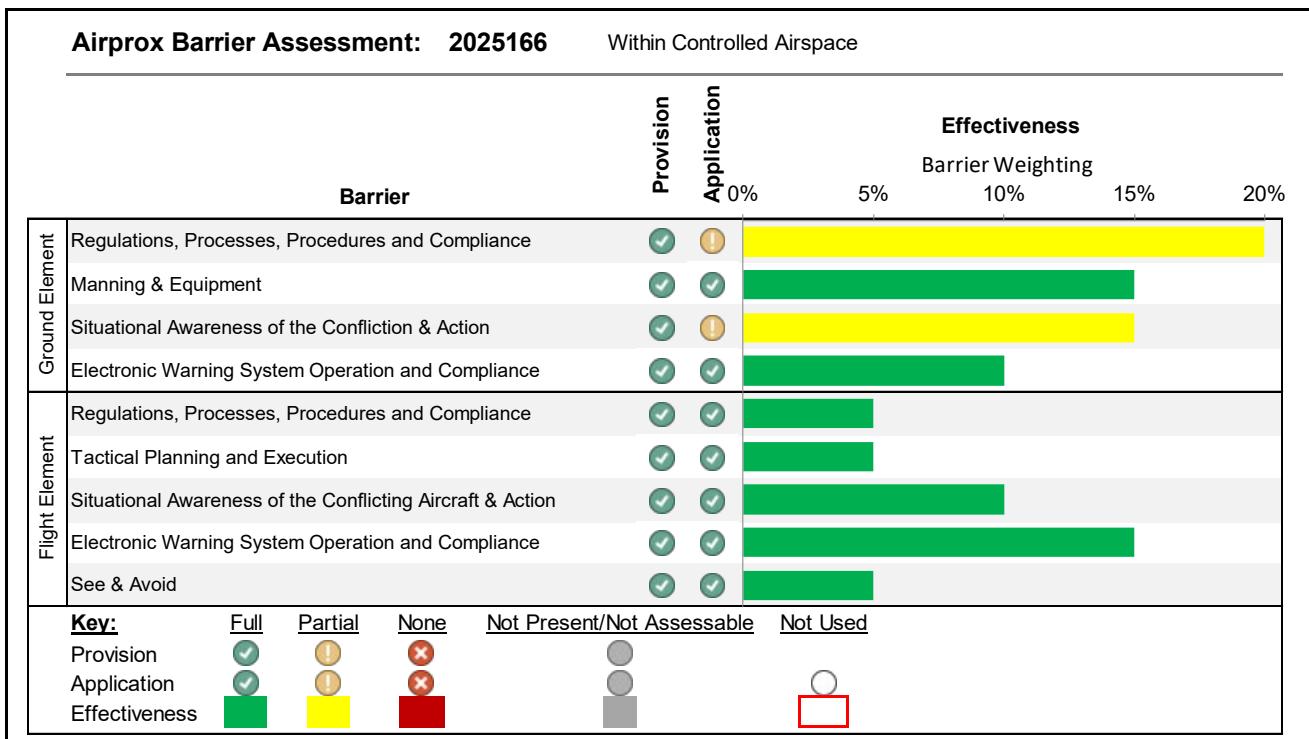
Safety Barrier Assessment²

In assessing the effectiveness of the safety barriers associated with this incident, the Board concluded that the key factors had been that:

Regulations, Processes, Procedures and Compliance were assessed as **partially effective** because the TC SE controller had released the A321 pilot from the required 250kt speed restriction, thereby reducing the time available to detect conflict and increasing the radius of any avoiding action turn.

Situational Awareness of the Conflict and Action were assessed as **partially effective** because the position of the A321 within the Gatwick RMA was temporarily absent from the TC SE controller's working memory and was not detected by the KK APP controller until activation of STCA.
