**AIRPROX REPORT No 2025174**

Date: 08 Aug 2025 Time: 1718Z Position: 5056N 00032W Location: E of Coldwaltham

**PART A: SUMMARY OF INFORMATION REPORTED TO UKAB**

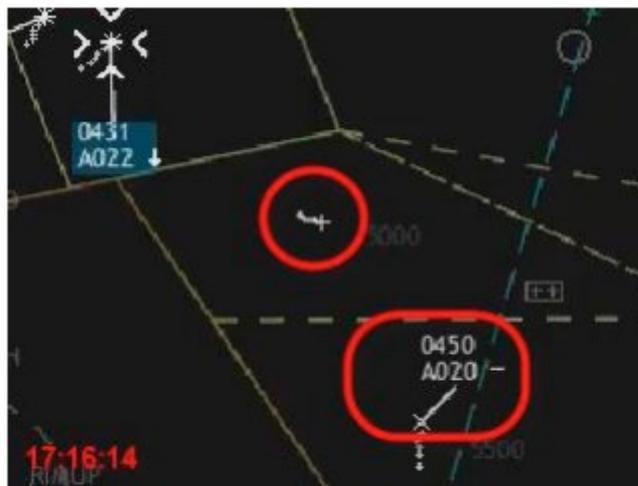
Figure 1 -Farnborough Radar

The [Farnborough ATC report] stated that the pilot of [the PA28] contacted the Farnborough LARS West frequency at 1706 (all times UTC) and was issued with a Basic Service. A Farnborough squawk of 0450 was issued with the Farnborough QNH provided. Farnborough Radar review displayed [the PA28] tracking north at an altitude of 2000ft. A primary track was displayed on radar tracking east, potentially in conflict with [the PA28]. A 0431 squawk [uninvolved aircraft] was highlighted at the time that was in potential conflict with a 7000 squawk with no Mode-C data displayed, which the LF-LARS controller may have been monitoring, although the controller report or RT could not corroborate this (Figure 1).

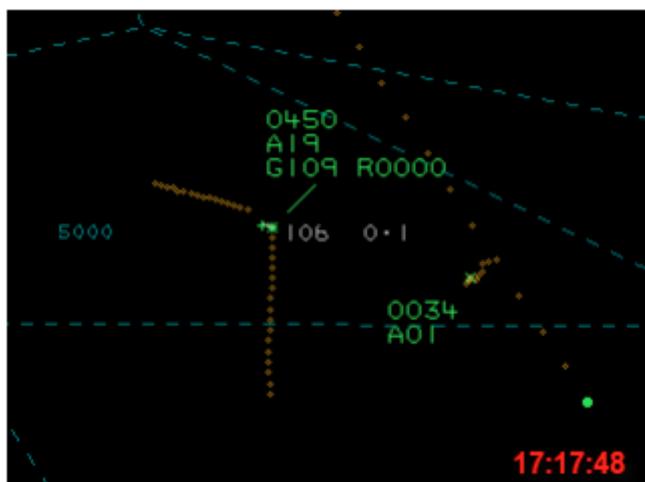
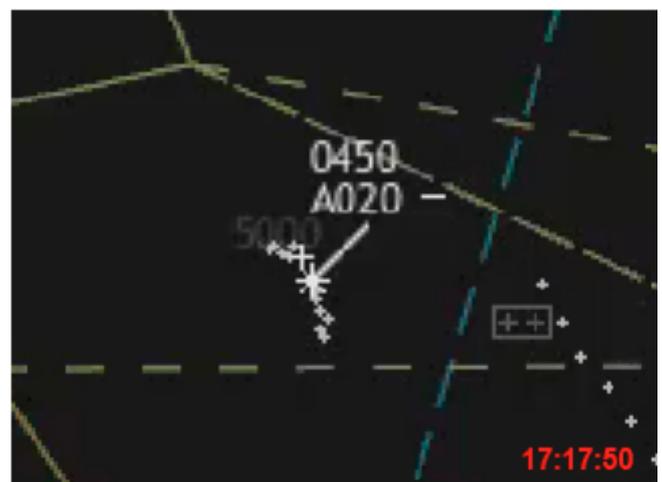
Figure 2 – NODE Radar

The subsequent closest point of approach between [the PA28] and the unknown primary contact occurred at 1717:48 and was displayed on NODE Radar as 0.1NM with altitude data unavailable (Figures 2, 3).

NOTE: Difference in radar times and Mode-C altitude displayed are due to differing radar update rates.

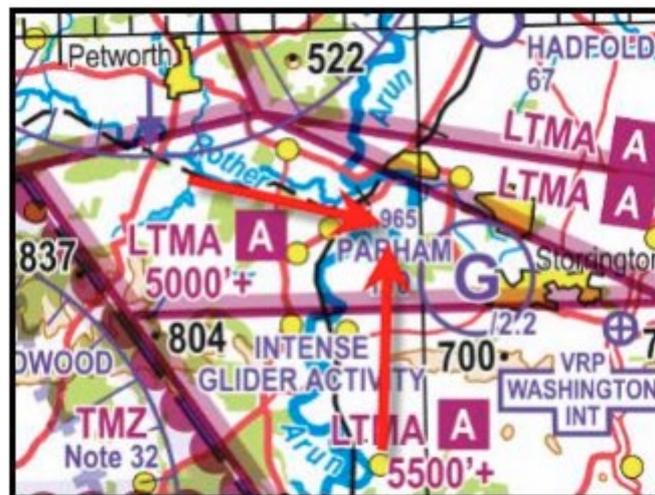
Figure 4

The PA28 was [routeing approximately west] receiving a Basic Service from Farnborough LARS West. The ASK21 glider was operating [in the vicinity of Parham gliding site] (Figure 4).

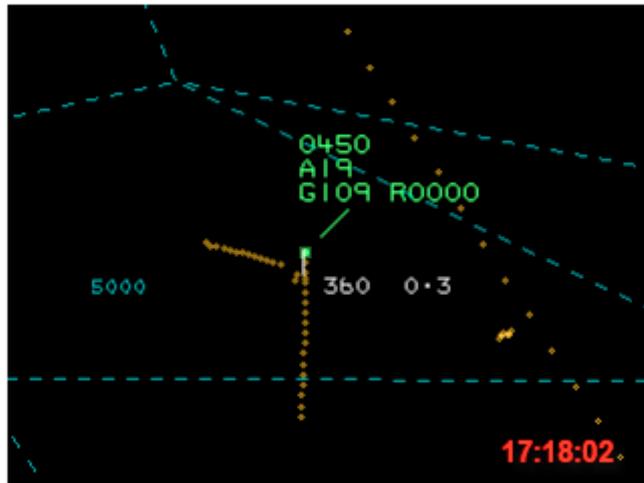
Figure 5

Review of NODE radar indicated no evidence of [the PA28] enacting any avoidance manoeuvre, whilst the radar trails of [the ASK21] suggested an avoidance manoeuvre may have been taken (Figure 5). This correlated with the pilot's report.

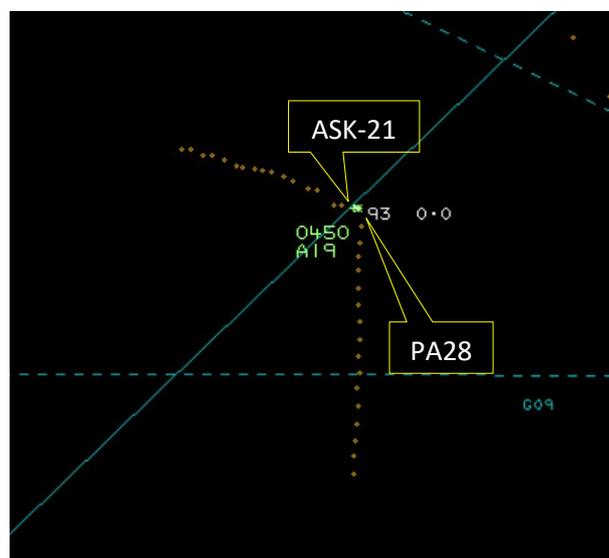
Figure 6 – Time 1717:54

An analysis of the NATS radar replay was undertaken; a primary track was detected that matched the GPS navigation file provided by the ASK21 pilot and a northerly track was detected that was coincident with the GPS navigation file provided by the PA28 pilot. The PA28 was seen to be operating on Mode A and C only, using the Farnborough LARS squawk 0450 (Figure 6).

Further analysis of aircraft tracking data was undertaken and neither aircraft was detected using either ADS-B or Mode S data. The ASK21 was detected through data transmitted by its electronic conspicuity device. Analysis of the GPS navigation data was undertaken to compare aircraft elevation and CPA was assessed to have occurred at 1717:54 with less than 0.1NM lateral and approximately 100ft vertical separation.
