AIRPROX REPORT No 2026013

Date: 14 Feb 2026 Time: 1228Z Position: 5018N 00512W Location: St. Agnes

PART A: SUMMARY OF INFORMATION REPORTED TO UKAB

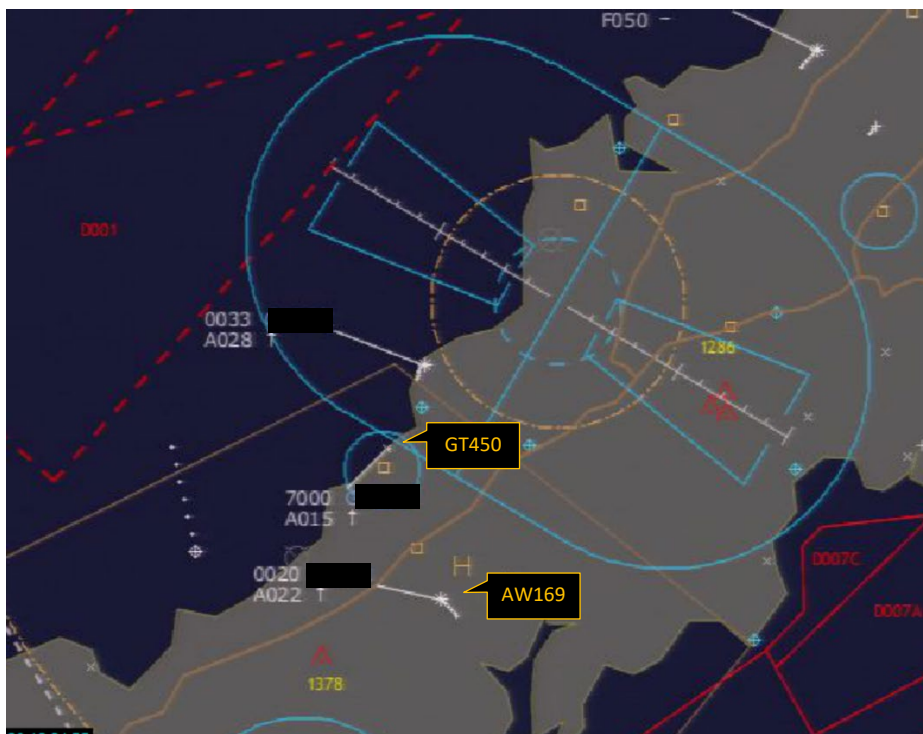
Figure 2 – 1224:55

At **1224:55** the GT450 became visible on the controller's display, approximately 6NM to the north-northwest of the AW169. The secondary label included the aircraft's registration/callsign (Figure 2).

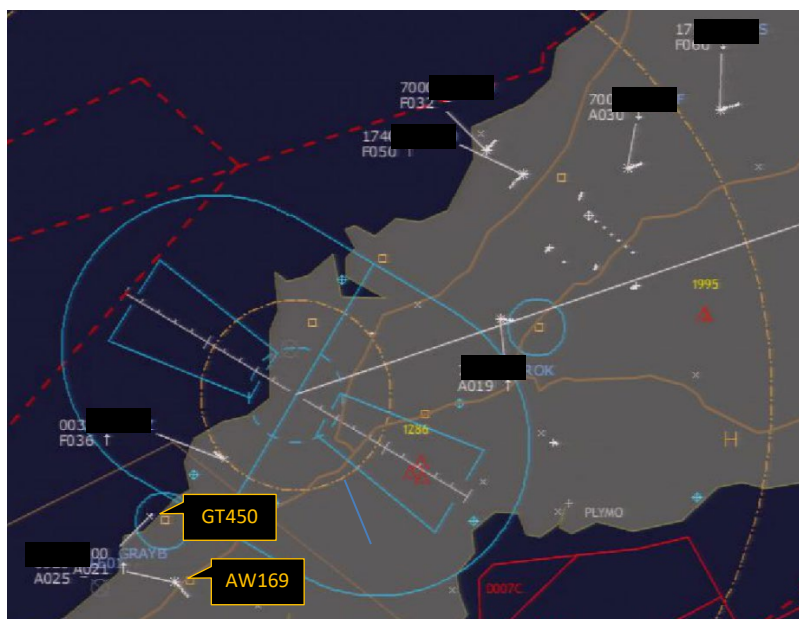
Figure 3 – 1226:08

At **1226:08** another pilot reported on frequency to the northeast of Newquay and a Basic Service was agreed. The secondary return for the GT450 had reappeared by this time (Figure 3).

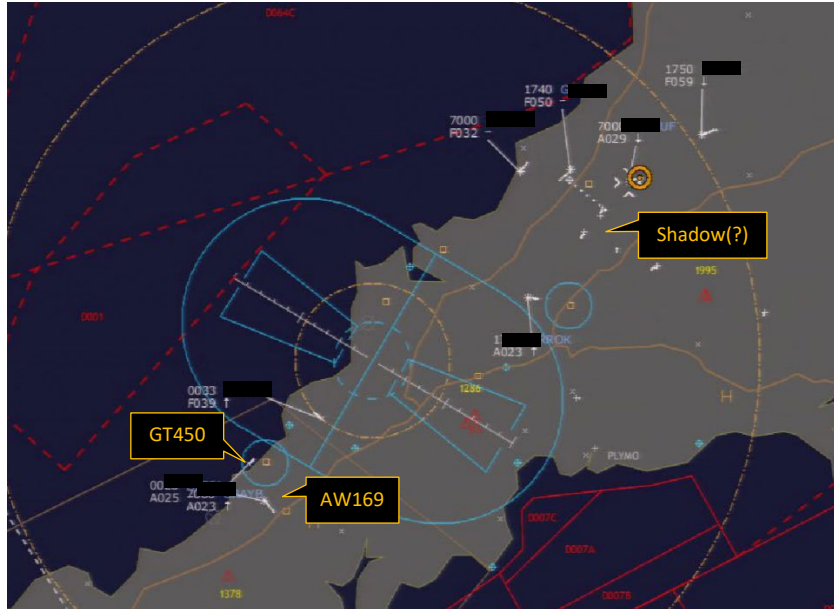
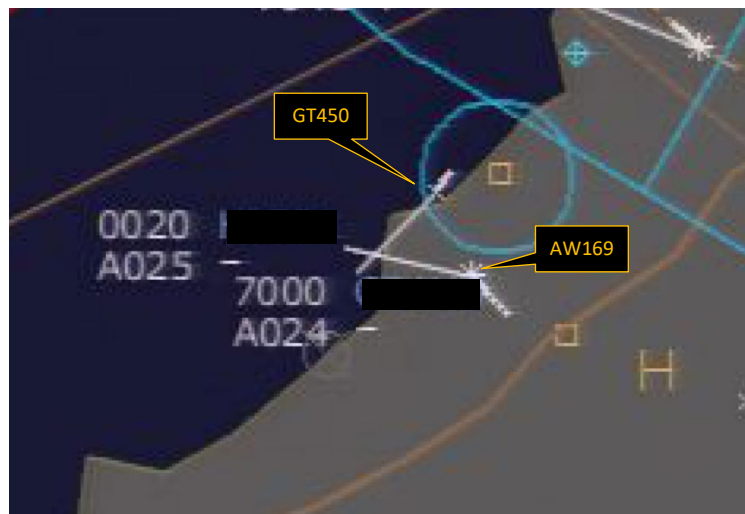
Figure 4 – 1226:59

At **1226:59** the controller passed specific Traffic Information to the pilot of a Shadow microlight believed to be approximately 15NM northeast of Newquay (non-transponding): “(callsign), *still not identified you, but however you do have traffic in your 12 o'clock about a mile away, opposite direction.*” The AW169 and GT450 were now approximately 2NM apart (Figures 4 & 5).

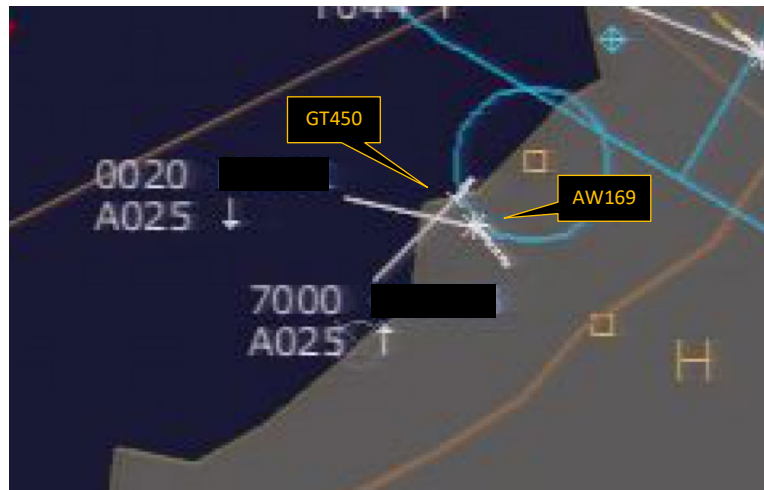
Figure 6 – 1227:25

At **1227:25** the controller passed more Traffic Information to the pilot of the Shadow: “*got traffic also just in your right 2 o'clock about 3000ft routing southwest-bound*”, with the AW169 and GT450 now approximately 1NM apart at the same level (Figure 6).

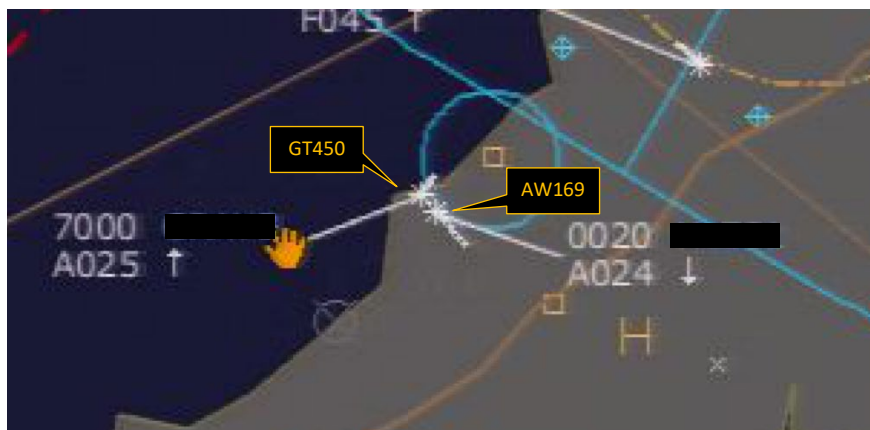
Figure 7 – 1227:31

At **1227:31** the cursor on the controller's surveillance display was seen to move to and then adjust the secondary label of the AW169 followed by that of the GT450 (Figure 7).

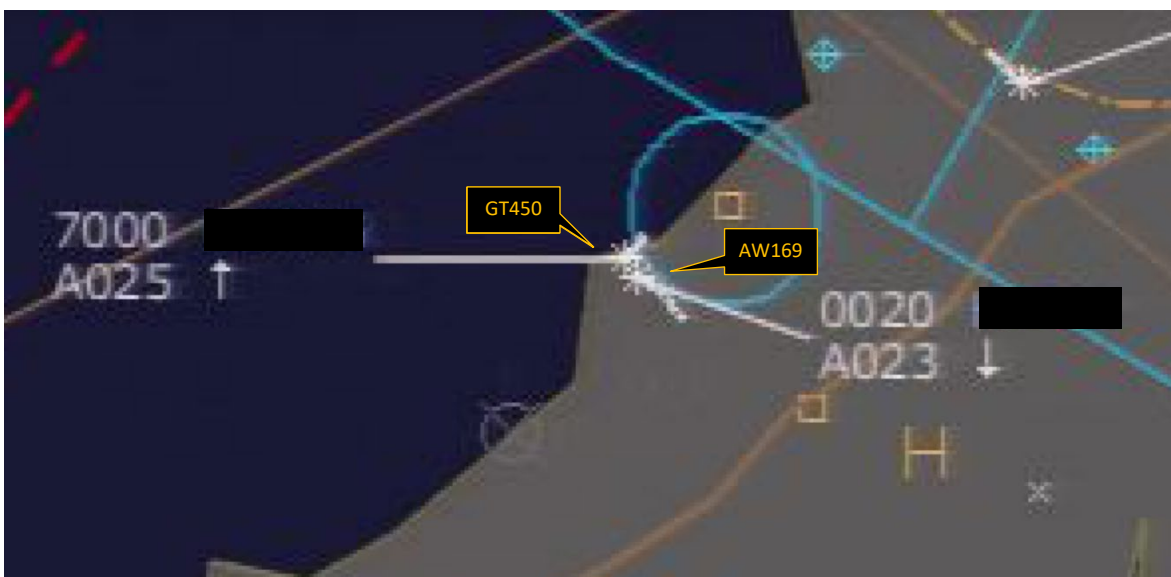
Figure 8 – 1227:35

At **1227:35** the controller approved a change of frequency for the pilot of the Shadow. The AW169 and GT450 were approximately 0.5NM apart with the AW169 observed to have commenced a descent (Figure 8).

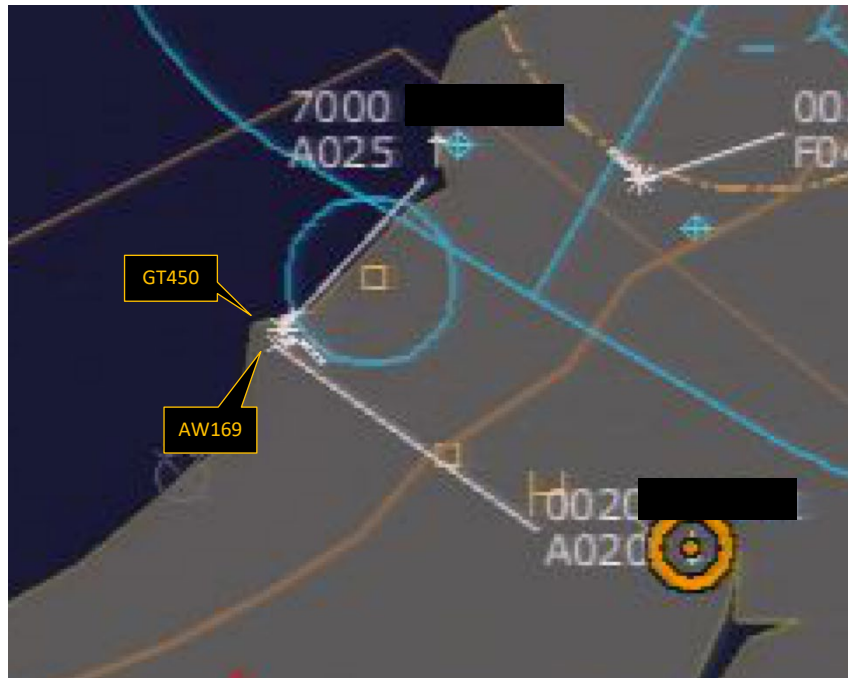
Figure 9 – 1227:47

At **1227:47** the controller passed the following to the pilot of the AW169: *“(AW169 C/S) keep a good lookout, it looks like there is traffic getting airborne out of Perranporth to the south.”* The AW169 pilot reported already having received a TCAS RA descent instruction and was in the process of climbing again (Figure 9).

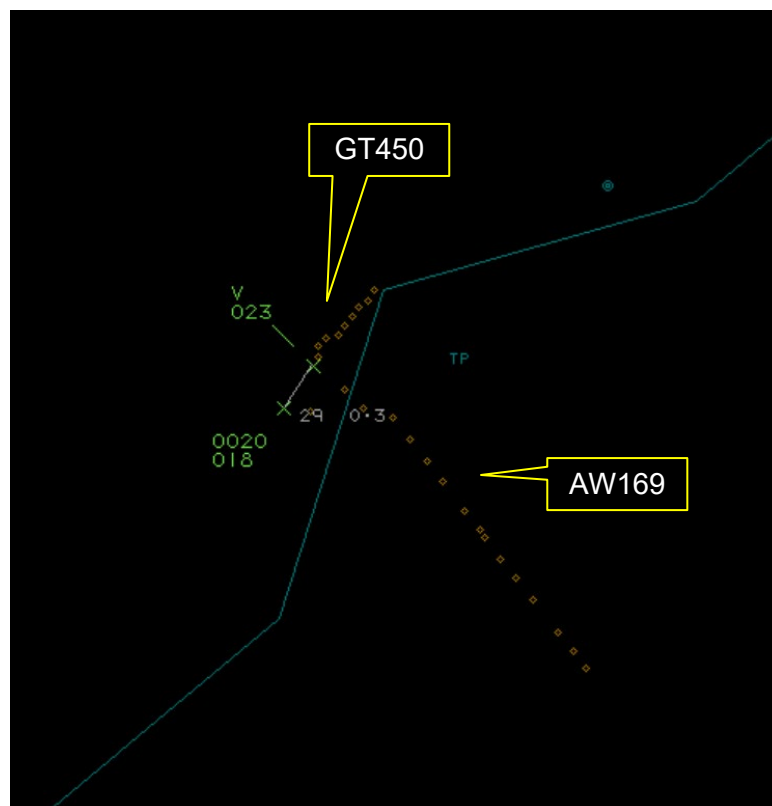
Figure 10: At CPA (1227:43) 500ft V/0.3NM H

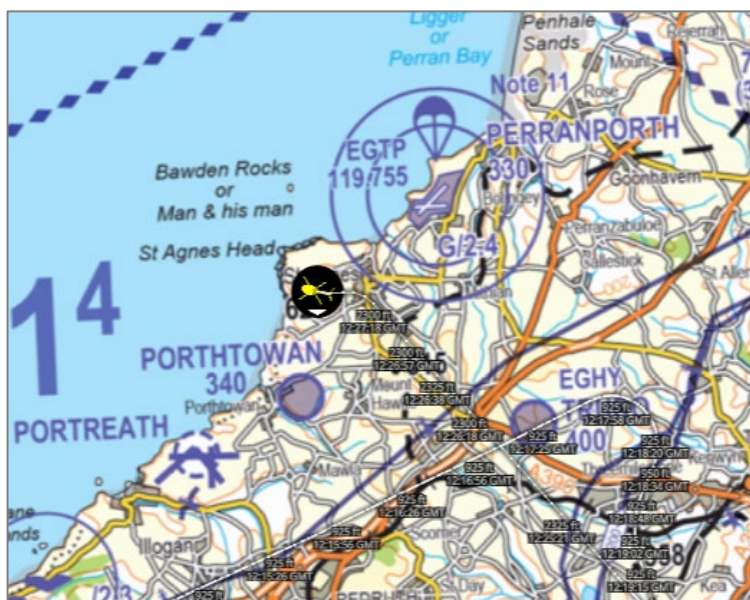
Figure 11: ADS-B data showing the AW169 at CPA. The GT450 did not show on the ADS-B tracking tools available to the UKAB Secretariat.
