**AIRPROX REPORT No 2026022**

Date: 18 Mar 2026 Time: 1116Z Position: 5341N 00003E Location: 2NM S of Withernsea

**PART A: SUMMARY OF INFORMATION REPORTED TO UKAB**

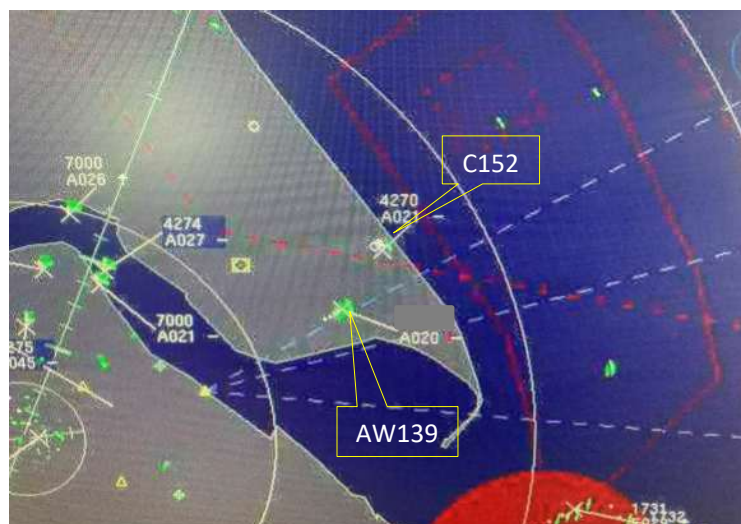
Figure 2 – Time 1115:24

1115:24 The off-going ATCO used the Radar 2 position to telephone Anglia Radar to pre-note the [AW139] and stated to the oncoming ATCO “[AW139 C/S] has traffic, left 11 o'clock, 2 miles, same height, its [on a direct heading towards] the other one”. The Radar 2 position had Cromer selected which showed the [AW139] and [the C152] in SSR (Figure 2).

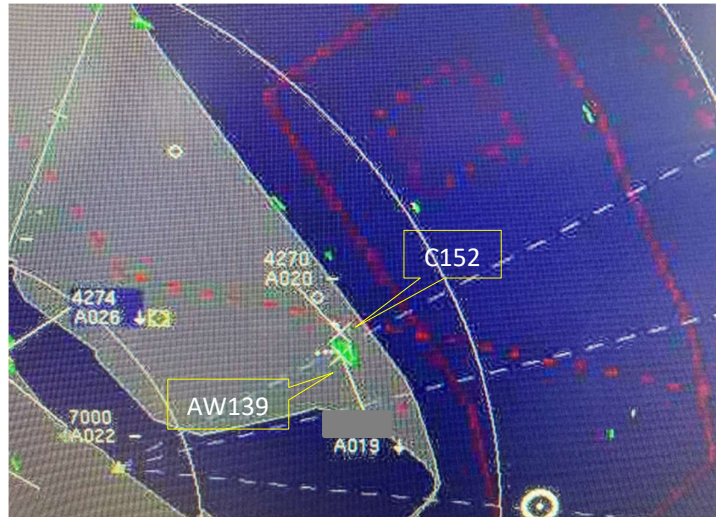
Figure 3 – Time 1115:30

1115:30 [The controller announced] “[AW139 C/S] *traffic left, 11 o'clock, 2miles indicating similar altitude*”. Level information was provided by the off-going ATCO from the Radar 2 position using Cromer [radar] feed [to the] Radar 2 screen (Figure 3).

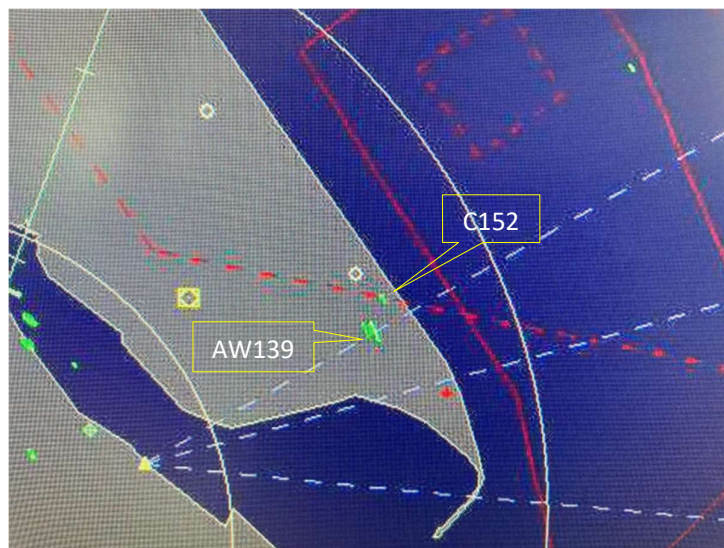
Figure 4 – 1116:13

1116:13 [The controller:] in the pre-note, [the Anglia Radar controller] identified [the AW139] and instructed [the pilot] to contact Anglia Radar on 125.275MHz. There was no mention of conflicting traffic by either controller (Figure 4).

[The AW139] turned right, [the C152] was slightly left of its 12 o'clock [position] at less than 1NM.
