**AIRPROX REPORT No 2026023**

Date: 14 Mar 2026 Time: 1232Z Position: 5050N 00111W Location: ivo Lee-On-Solent Airfield

**PART A: SUMMARY OF INFORMATION REPORTED TO UKAB**

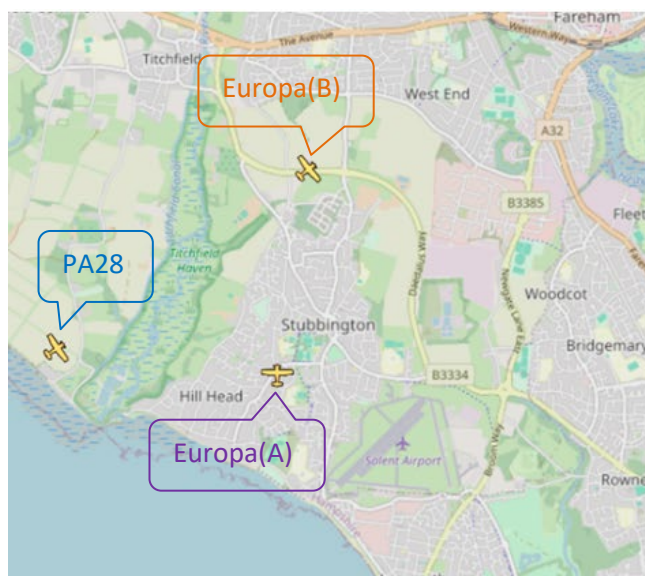
Figure 15 – Time 1230:10

Further analysis of third-party aircraft tracking software was undertaken and both aircraft were detected using ADS-B sources. The PA28 and Europa were both seen in the right-hand circuit for RW23 at Lee-On-Solent at 1230 (Figures 15 and 16).
