**AIRPROX REPORT No 2026051**

Date: 22 Apr 2026 Time: 1405Z Position: 5221N 00010E Location: 4NM SW of Ely

**PART A: SUMMARY OF INFORMATION REPORTED TO UKAB**

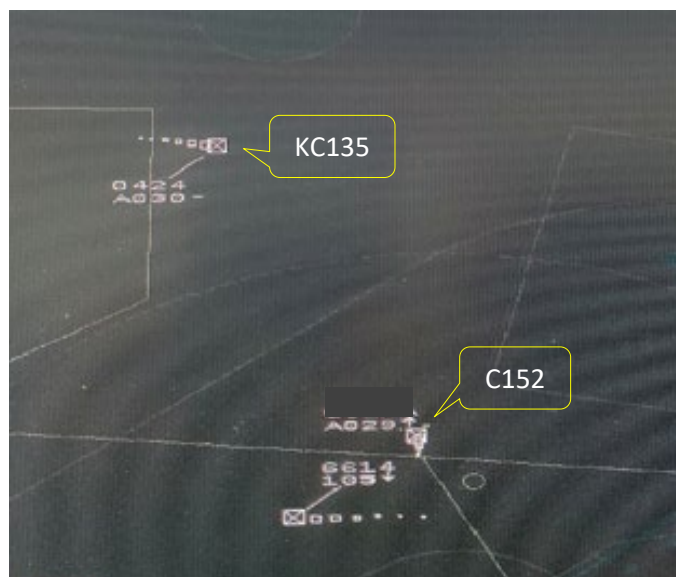
Figure 1- Time 1402:06

On completion of the ATCO handover, the two aircraft were approximately 8NM horizontally and 100ft vertically apart.

At this time, the heavy [KC135], #0424, was crossing left-right ahead of [the C152] on present tracks.

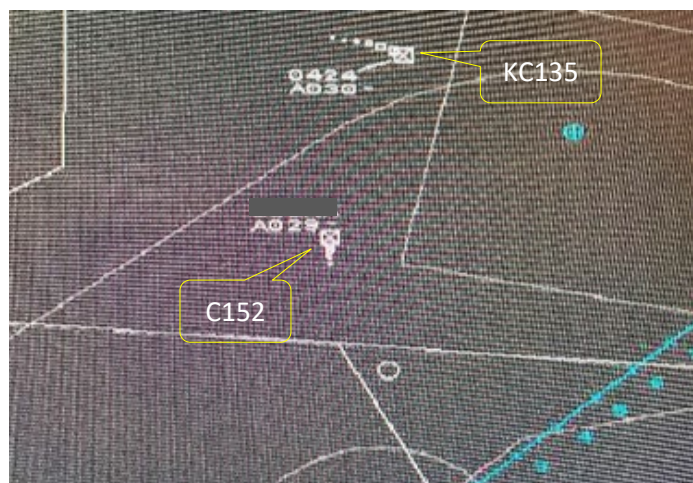
Figure 2 – Time 1403:34

At 1403:34 the heavy KC135 appeared to start commencing the right turn at the Initial Approach Fix (IAF) IRDAB for RW10 at Mildenhall.

Before commencing the turn, as the KC135 passed over the IAF, the Lakenheath ATCO provided Traffic Information to the KC135 [pilot] on the C152. They asked the pilot if they would take a climb above and this is where the Lakenheath [controller] believed that the KC135 pilot had accepted a climb to avoid, yet their response was unclear from their recordings. No climb was issued by the ATCO at this point. Further Traffic Information was provided once 4NM apart.

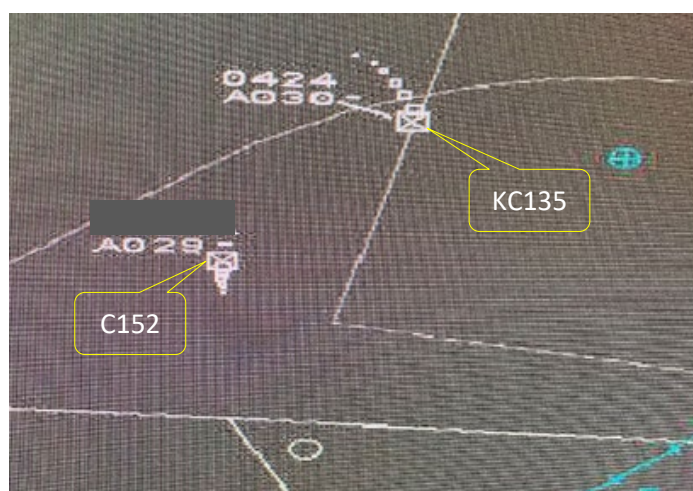
Figure 3 – Time 1404:00

At 1404:00 the Lakenheath ATCO offered a heading of 180° to avoid. This was not read back, but a few seconds later the KC135 pilot requested a climb. The [pilot of the] aircraft was given a climb to altitude 6000ft and was readback.

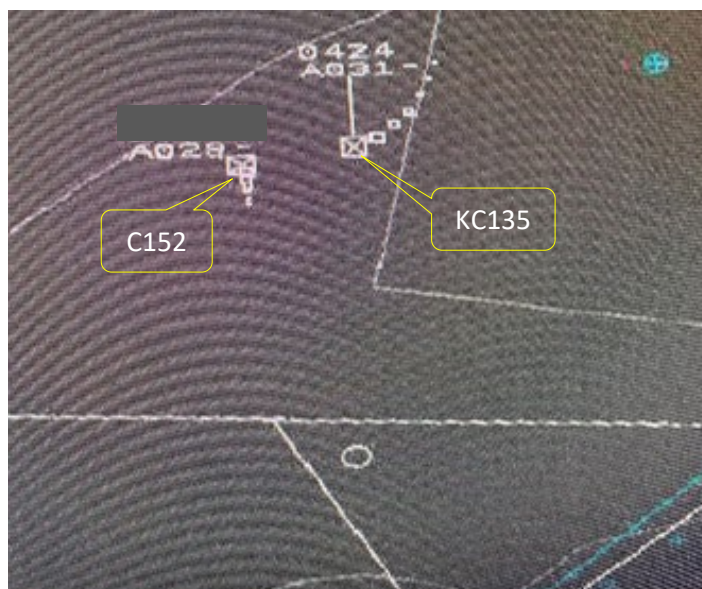
Figure 4 – Time 1404:30

The KC135 [pilot] reported traffic in sight. They did not appear to take the heading previously offered and instead appeared to self-deviate from the holding pattern whilst continuing to climb (Figure 4).

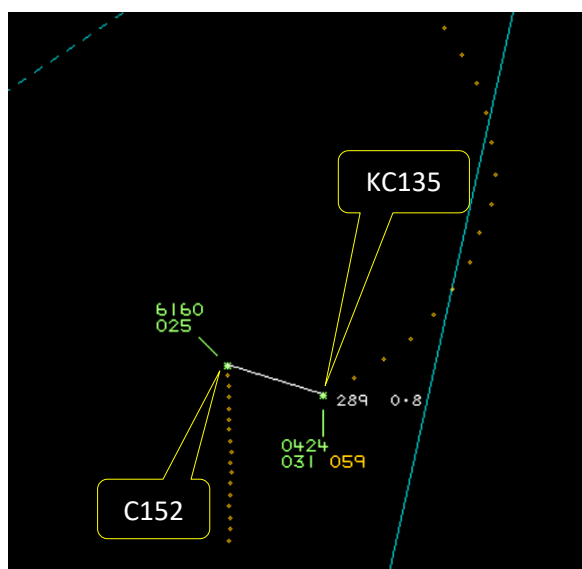
Figure 1 – CPA 1404:38

An analysis of the NATS radar replay was undertaken and both the KC135 and C152 were identified using Mode S data (Figure 1).

Further analysis of aircraft tracking software was undertaken and only the C152 was detected using ADS-B data sources.
