**AIRPROX REPORT No 2026063**

Date: 29 Apr 2026 Time: 1915Z Position: 5624N 00319W Location: 2.5NM SE Perth Aerodrome

**PART A: SUMMARY OF INFORMATION REPORTED TO UKAB**

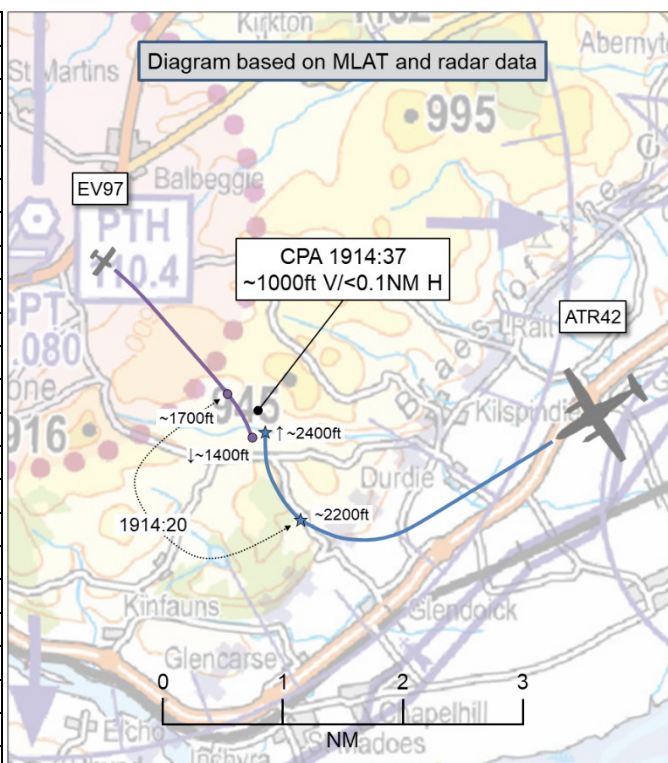
An analysis of the NATS radar replay was undertaken and the ATR42 could be positively identified from Mode S data (Figure 2). At the moment of CPA, the ATR42 was observed in a climb through FL019. A suitable correction was applied to determine its altitude. The EV97 first appeared on the

radar replay at 1917:15 (more than 2min after CPA), at FL017, 4.7NM southeast of Perth Airfield (approximately 4NM east of ABDED). The EV97 was observed before CPA by reference to MLAT and GPS-based data sources.

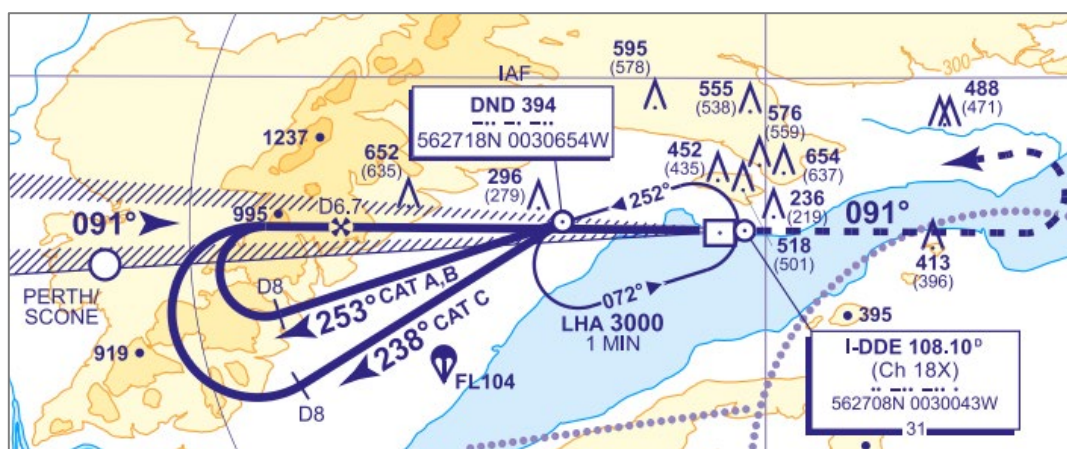
Figure 1 - Dundee ILS/DME RW09

The entry for Dundee Airport in the UK AIP (Instrument Approach Chart - Dundee ILS/DME RW09) includes the following notes:

- 3 The Category C Instrument Approach Procedure infringes the Perth ATZ at 1800FT above Perth aerodrome elevation. Pilots must notify ATC of their intention to conduct a Category C approach on first contact.
- 4 The eastern edge of the perth ATZ lies 9.5NM west of THR RWY 09. To prevent conflict with possible VFR traffic in the Perth ATZ, pilots should not extend the outbound leg of the base turn beyond the prescribed procedural distances.

The Board first considered the actions of the pilot of the ATR42, and members reviewed the entry in the UK AIP for the particular procedure that they had been conducting. It was noted that the prescribed track would have taken them into (or within close proximity to) the Perth ATZ had the encounter have taken place within the hours of operation of Perth aerodrome. Members next noted that the ATR42 pilot had been in receipt of a Procedural Service from the Dundee controller, and recalled the wording of CAP 774 UK Flight Information Services:

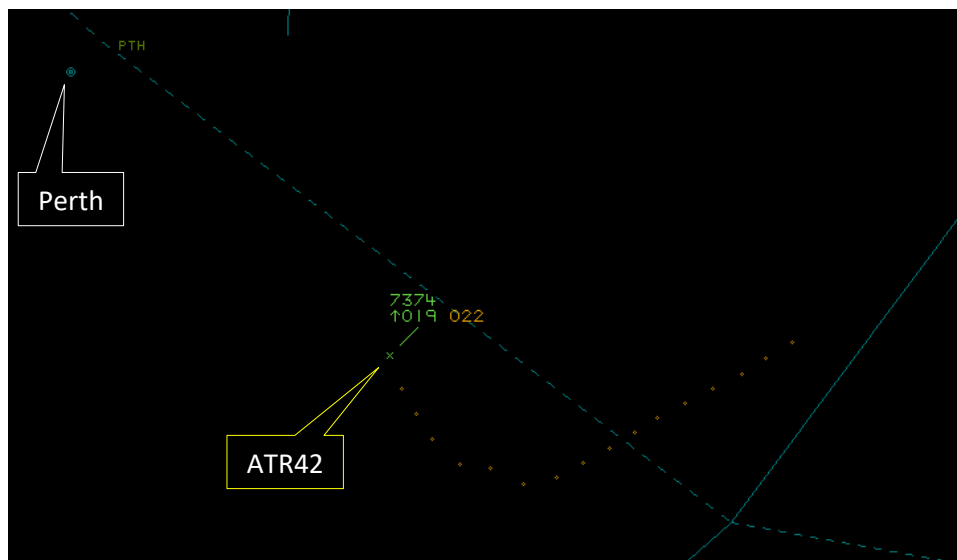
Figure 2 – CPA at 1914:37

The diagram has been constructed by combining the data sources. The altitudes of the aircraft have been shown as estimates due to rapidly changing values and, in the case of the EV97, somewhat sporadic data points.
