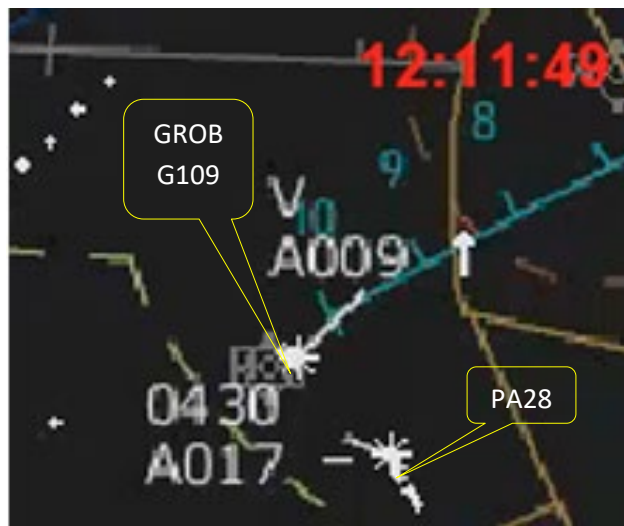
Figure 1

At 1211:49 (Figure 1) the LF-LARS issued the pilot of [the PA28] with Traffic Information on [the Grob G109] (V) *"believed to be a glider, just left of your twelve o'clock by a mile crossing left right, indicating one thousand feet below and climbing."* The pilot initially replied *"looking"* before immediately reporting *"we have one contact below us"*, the LF LARS replied, *"I think that's the one, it was indicating climbing so be careful"*.

The LF-LARS [controller] issued Traffic Information to the pilot of [the PA28] regarding [the Grob G109] at 1211:49 (Figure 1 above). The pilot of [the PA28] continued their northerly track and flew within 1NM of Lasham and into conflict with [the Grob G109], who subsequently reported the encounter as an Airprox.

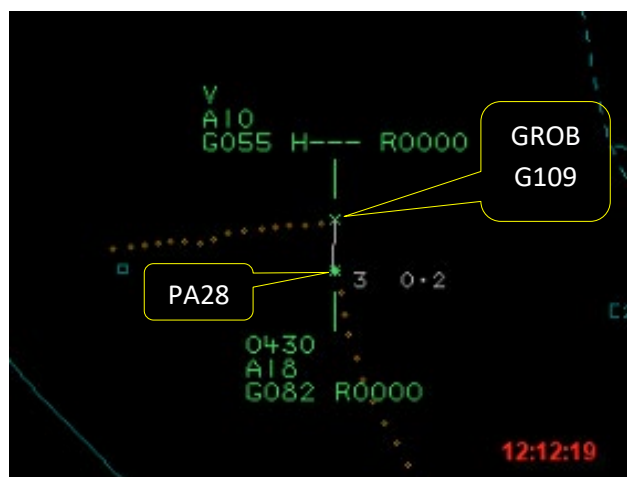
Figure 2

The Closest Point of Approach between [the PA28] (0430) and [the Grob G109] (V) occurred at 1212:19 and was recorded on the NODE Multi-Track radar as 0.2NM and 800ft (Figure 2).

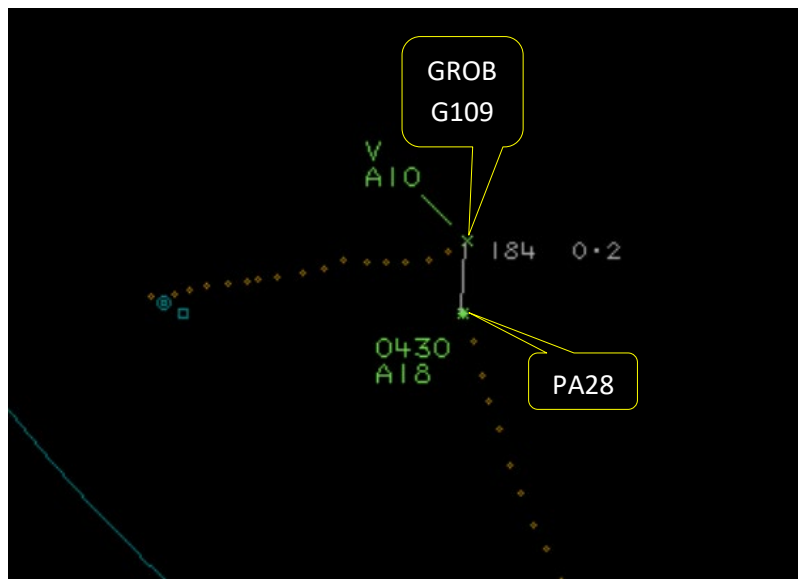
Figure 3 – CPA 1212:22

An analysis of the NATS radar replay was undertaken and both aircraft were positively identified using Mode S data (Figure 3).

Further analysis of third party aircraft tracking software was undertaken and neither aircraft was detected using ADS-B sources. Both pilots provided their GPS track data, which was coincident with the radar tracks, however, the PA28's GPS altitude data was unreliable and not used for analysis. CPA was assessed to have occurred at 1212:22 with 0.2NM lateral and 800ft vertical separation.
