**AIRPROX REPORT No 2026080**

Date: 21 May 2026 Time: 1530Z Position: 5225N 00138E Location: IVO Beccles

**PART A: SUMMARY OF INFORMATION REPORTED TO UKAB**

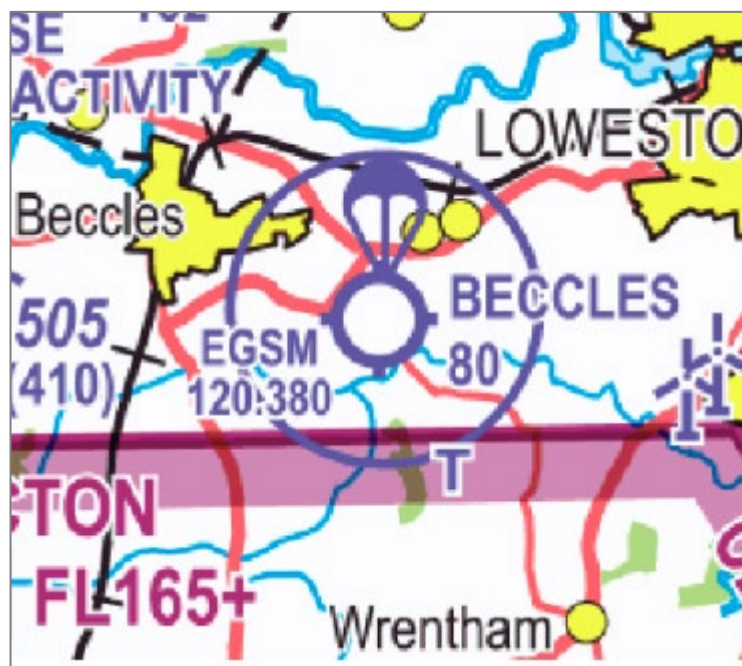
Figure 1

Beccles Airfield was an unlicensed airfield operating with an Air Ground Radio position. The airfield was within Class G airspace, however the 1:500,000 Southern England VFR chart depicted Beccles as a civil airfield with parachuting activity (Figure 1).

The London FISO advised the pilot of [the S10] that Beccles was active with paratropping, which was acknowledged by the pilot.

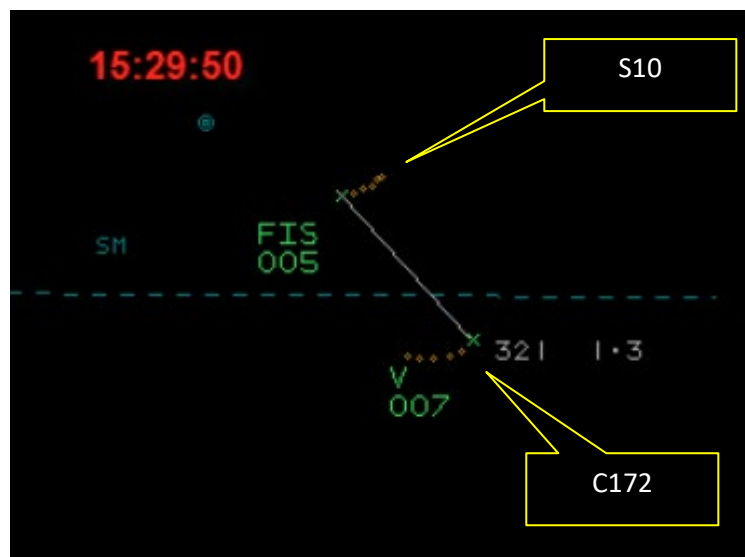
Figure 2

As [the C172] (displayed as V) turned in the traffic circuit at Beccles, The S10 (FIS) was positioned between [the C172] and Beccles (Figure 2).

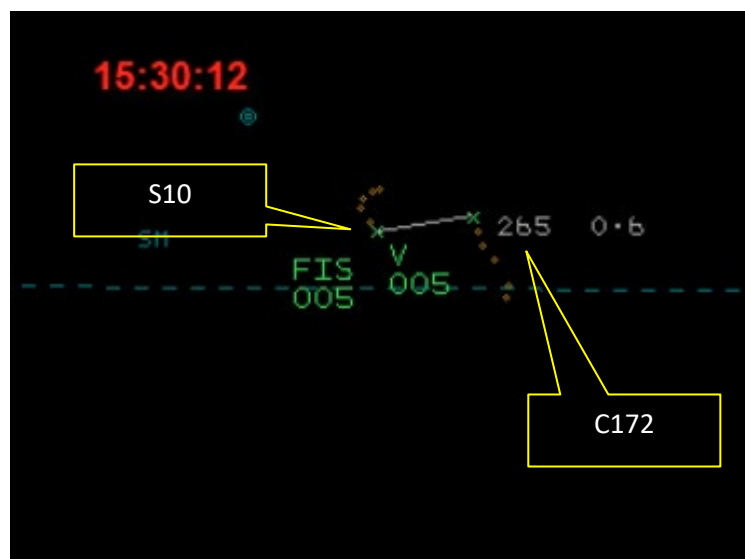
Figure 3

The closest point of approach between [the two aircraft] occurred at 1530:12, measured as 0.6NM and 0ft (Figure 3). There were no separation requirements within Class G airspace.

London FIS was a non-radar position and therefore the proximity of [the S10] to Beccles airfield and the potential conflict with [the C172] was not apparent to the London FISO.
