**AIRPROX REPORT No 2026094**

Date: 31 May 2026 Time: 1427Z Position: 5055N 00312W Location: 4NM NNE Dunkeswell

**PART A: SUMMARY OF INFORMATION REPORTED TO UKAB**

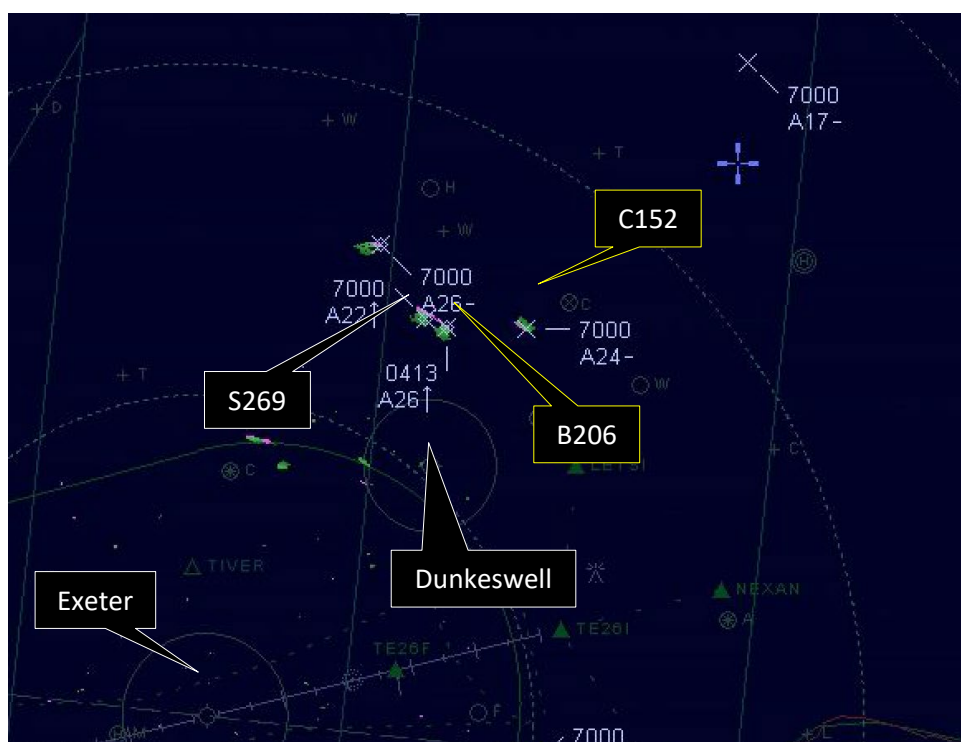
The controller responded “*negative, there is one on your left-hand-side indicating 2600ft and another one 3 miles northwest of you also indicating 2600ft*” (Figure 1).

Figure 1 – Aircraft positions at 1424:45 (Exeter radar)

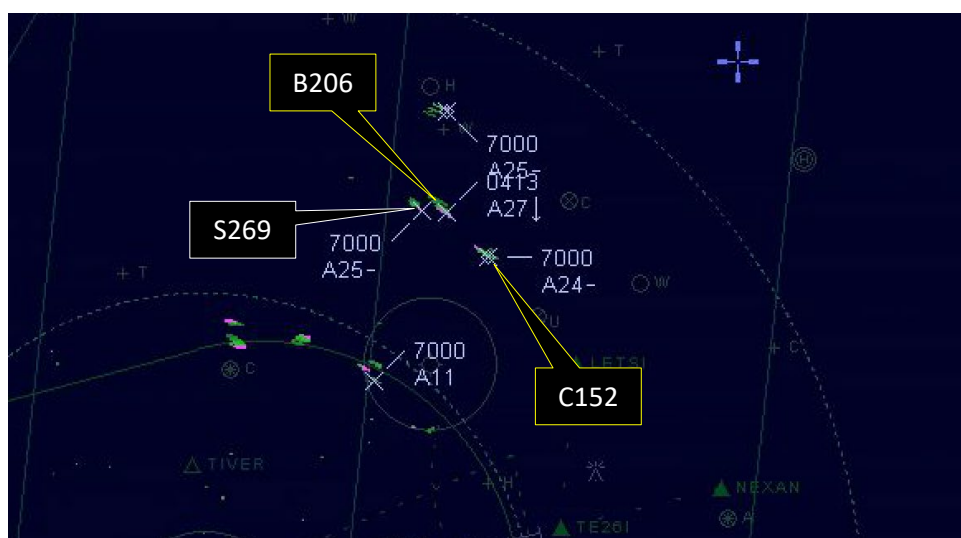
At 1426:10, the controller informed the pilot that they had “*another aircraft about a mile south-east of you indicating 2400ft*”. The pilot initially responded that the traffic was “*not in sight*”.

Figure 2 – Aircraft positions at 1426:10 (Exeter radar)

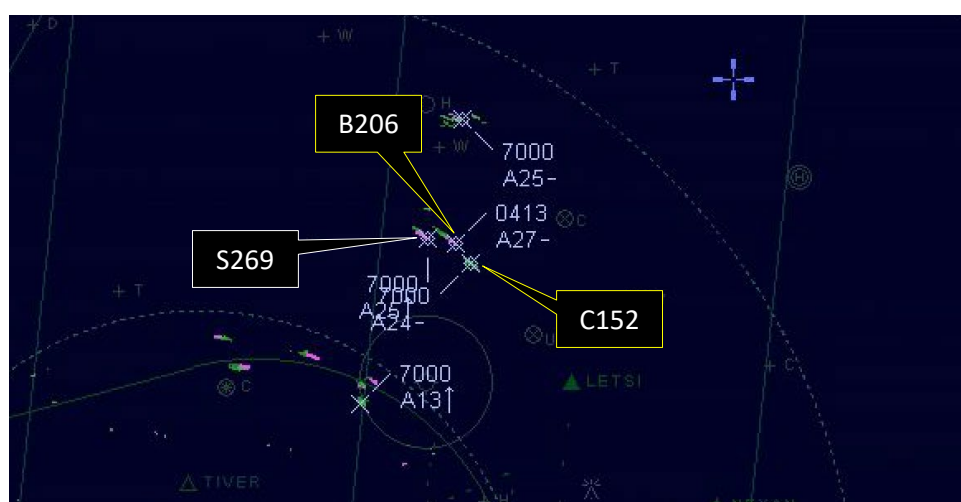
Then, at 1426:30, the pilot reported that they had the traffic in sight.

Figure 3 – Aircraft positions at 1426:30 (Exeter radar)

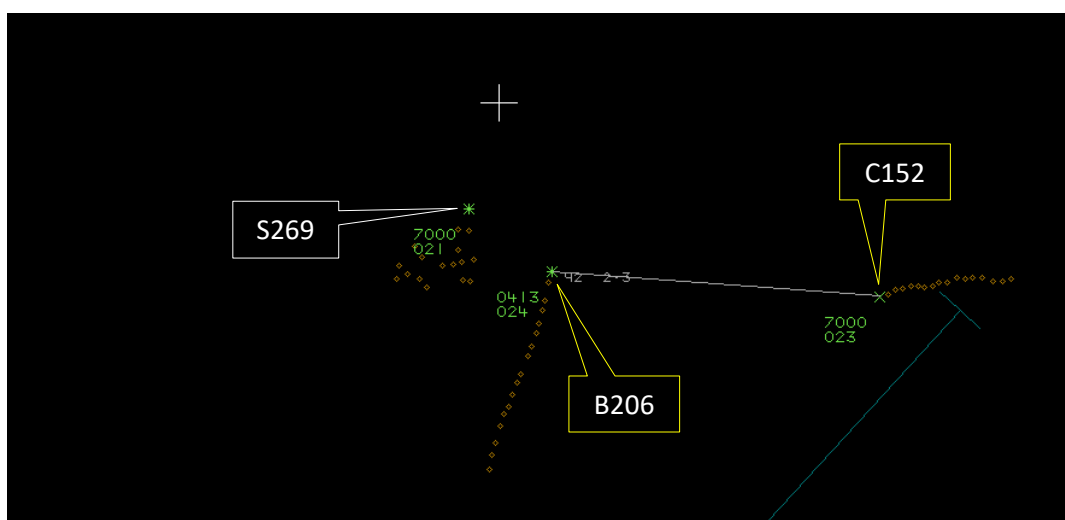
An analysis of the NATS radar replay was undertaken, and both aircraft could be positively identified from Mode S data (Figure 4). Neither aircraft was observed by reference to ADS-B data sources.

The aircraft were depicted on the radar replay flying at Flight Levels. A suitable correction was applied to determine their altitudes. The pilot of the C152 kindly supplied GPS track data for their flight. The diagram was constructed by combining the data sources. The C152 has been shown in the diagram with altitude based on GPS data. The track of the B206 has been shown with a partially dotted line to indicate its probable track due to moments of poor radar performance.

Figure 4 – Aircraft positions at 1424:46 (NATS radar). The white cross represents the location of the Wellington Monument.
